Technical Service Bulletin (TSB)
Rear Window Molding Detachment

| REFERENCE: | TSB: 23-024-25 GROUP: 23 - Body | Date: | June 17, 2025 | REVISION: | - |
| VEHICLES AFFECTED: | 2024 (FG) FIAT 500e This bulletin applies to vehicles built on or after January 15, 2024 (MDH 0115XX) and on or before September 03, 2024 (MDH 0903XX) equipped with KB - Vehicle Family (Sales Code 5IG). | | | MARKET APPLICABILITY: <input checked="" type="checkbox"/> NA <input checked="" type="checkbox"/> MEA <input checked="" type="checkbox"/> SA <input type="checkbox"/> IAP <input checked="" type="checkbox"/> EE <input type="checkbox"/> CH NOTE: This bulletin applies to the North American, South American, Middle East and Africa and Enlarged Europe markets | |

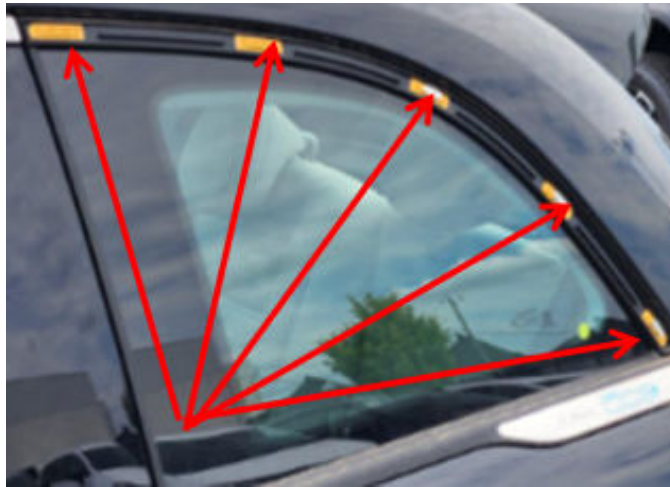
Fig. 1

1. Manually check the correct attachment of the molding by pushing on the clip position shown in [Fig. 1](#).

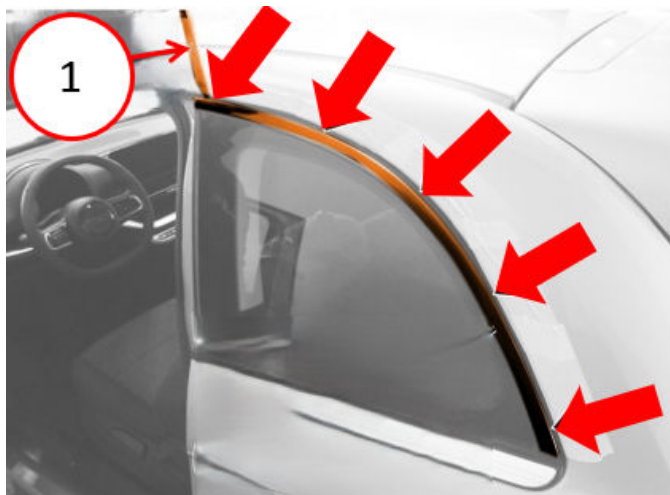
Fig. 2

Removing Trim

4. Open the front door.
5. Apply a double layer of paper tape to the bodywork to protect the paintwork.
6. Using a trim stick, remove the trim from the seal clips and retaining clips then remove and discard the trim [Fig. 2](#).

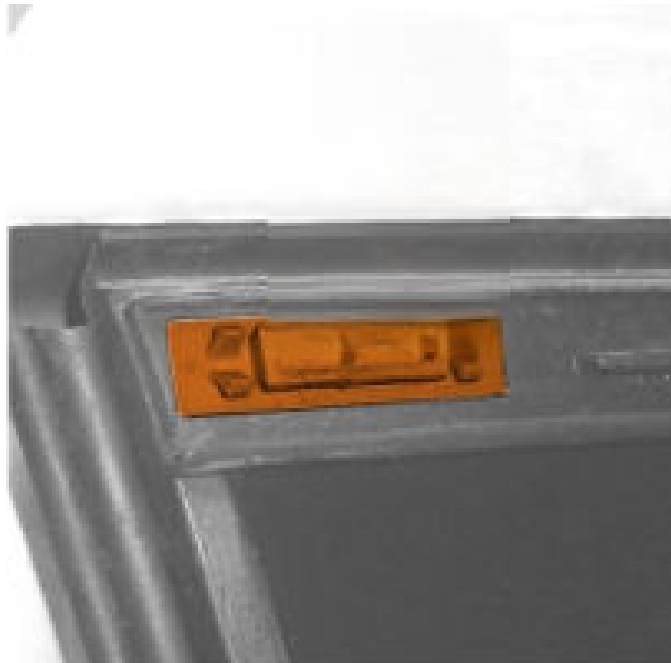
Fig. 4
Seal Clip

7. Check that the retaining clips and the seal clips are not damaged [Fig. 3](#), [Fig. 4](#).

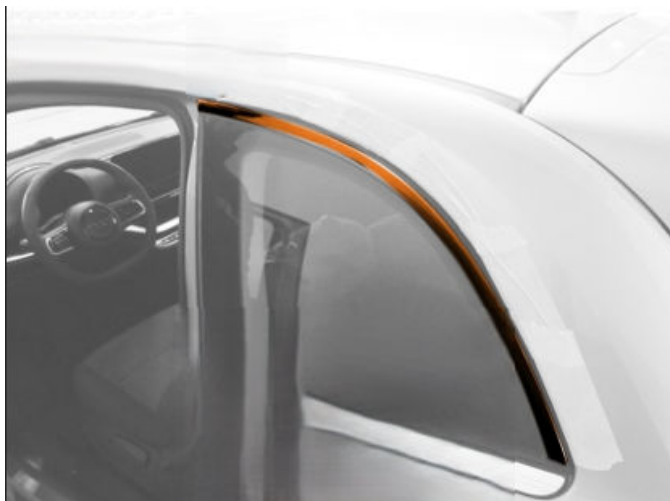
Fig. 5
NEW Trim In Place

- Put the **NEW** trim in place by first lining up the trim retainer on the door pillar side to the corresponding seal clip [Fig. 5](#).

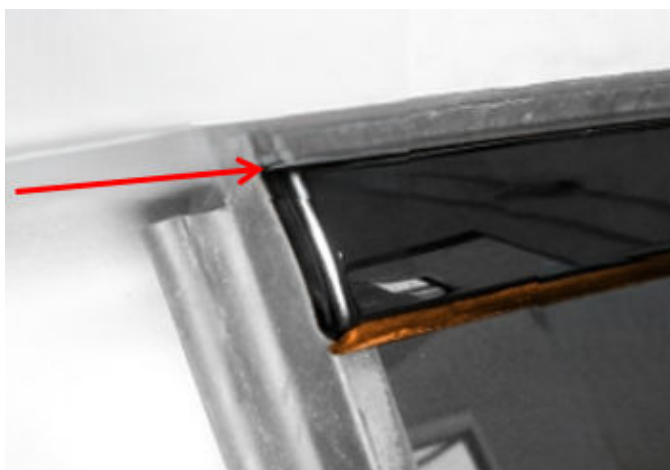
Fig. 6
Trim In Position

- Position the trim so that it is parallel with the upper lip profile of the seal [Fig. 6](#).

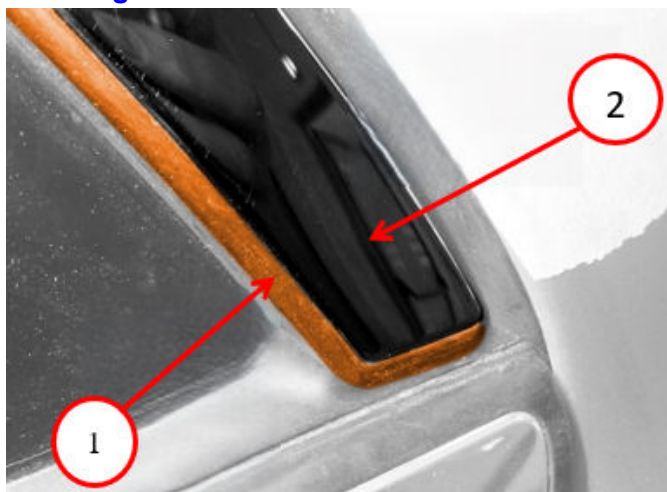
Fig. 7
Trim In Place

1 - Lower Lip Of The Seal
2 - Trim

NOTE: Make sure that the lower lip of the seal has not been pinched by the trim and remains positioned outside the trim [Fig. 7](#).
