eCascadia eAxle Spring Seat Orientation

Field Service Campaign: SF714

Published Date: 5/16/2025

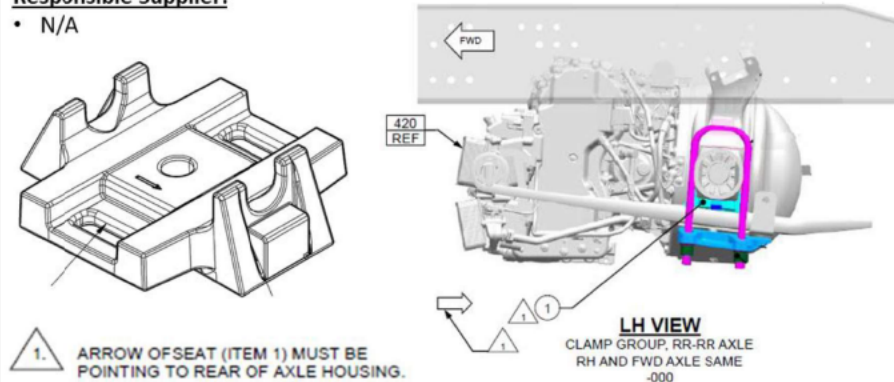
- eAxle spring seats can be installed backwards, resulting in HV cable routing issues that are not detected until HV cables rub through, from contacting chassis components.
- 3 6X4 eCascadias have been found with incorrectly installed seats, so far; one had rubbed-through HV cables.

- Axle seat can physically be installed either way; installation diagram must be referenced to know which direction the arrow on the casting is supposed to point.
- eAxles have no drivelines, so incorrect axle angle does not cause vibration or other easily detectable symptoms.
- This axle seat part number is used on many Airliner configurations.

- Field Service Campaign SF714
  - Inspect for incorrectly installed axle seats.
  - If found, reorient axle seats then inspect HV cable routing and repair as needed.
