M2+ Headlamp Wiring Routing Concern

Technical Service Bulletin 54-374

Published: 04/10/25

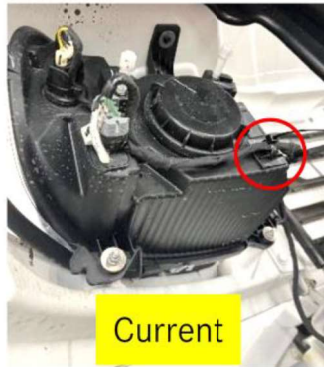
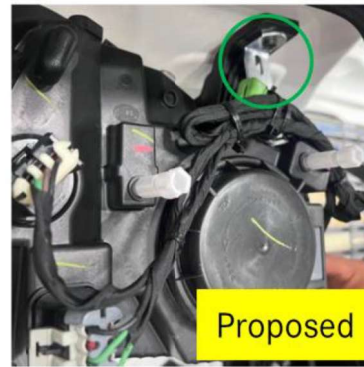
- Loose harness getting caught on fastener & bracket, rubbing fender.
- Topic from 42N ILCS, found at dealership.

- Adhesive square mount – insufficient durability

- Replace adhesive square and zip tie with angle bracket and fir tree
- D-bill to be created under maintenance release (P25CAB+M3), then discontinued with LTCA EWR change over. PDC has agreed to update the close in specs.
- Actual production clean date 06-10-24

- Service Bulletin – same change as production containment
- Description / authorization (service solution / bulletin)?
- Target 06/21/24
