# Hood Headlight Wiring Too Short

## TSB-54-099-WST

► 49X

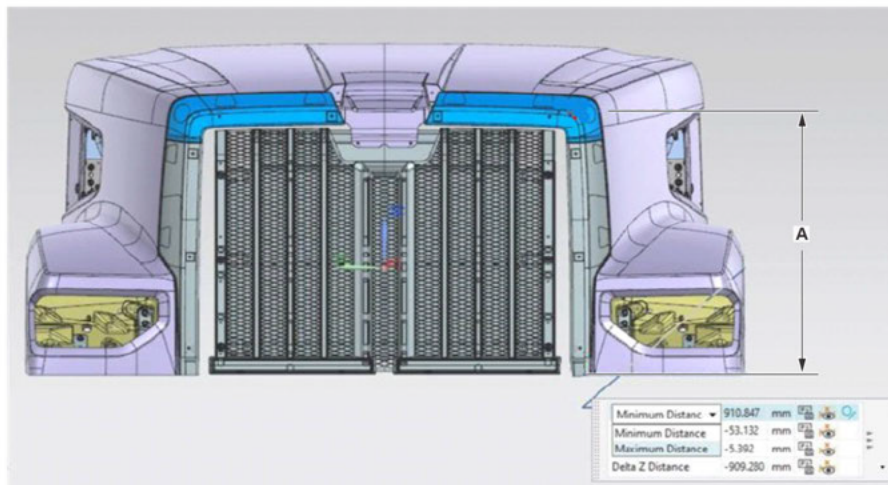
Fig. 1, X-Series Power Hood (Non-Sloped Hood)

This bulletin applies to Western Star 49X vehicles that are equipped with the X-series power hood (non-sloped hood), manufactured March 17, 2022, through September 23, 2024. The grille height of the power hood is approximately 909 mm, whereas that of the standard hood is approximately 801 mm. See Fig. 1.

A. Grille height of the power hood = 909 mm (approximately).

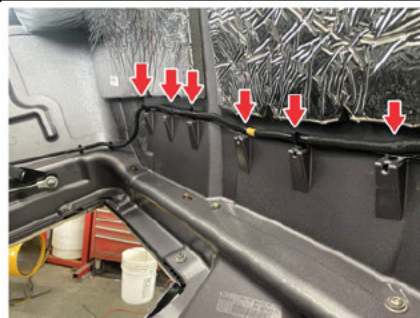
Fig. 2, Intended Hood Harness Routing

In certain Western Star 49X vehicles equipped with the X-series power hood, the hood harness may be too short to route per the original design intent. The intended routing is shown in Fig. 2.

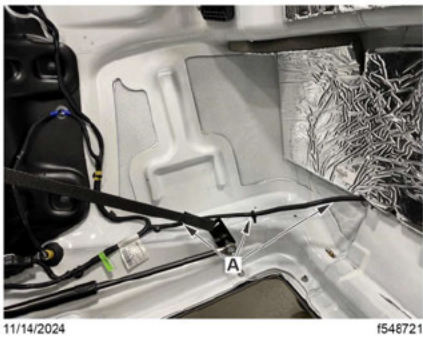
Fig. 3, Hood Harness Pulled Tight

If the hood harness is too short, during assembly, the harness may have been routed in such a way that it does not reach the mounting perches, as shown in Fig. 3, and some of the fir-tree cable ties are left out of their proper mounting locations on the hood. If the harness does not follow the path shown in Fig. 2, and is routed as shown in Fig. 3, follow the steps below to reroute the harness.

A. Due to the wiring harness being too short, the fir-tree cable ties are not properly secured in the designated holes on the hood.

5. ☐ Install the fir-tree cables ties in the five holes drilled in the hood. Secure the harness in place with the help of these cable ties.
6. ☐ Make sure to attach fir-tree cable ties to any missed hole locations along the routing patch, shown in Fig. 3.
7. ☐ Remove any extra unused cable ties from the hood harness.
8. ☐ Close the hood.

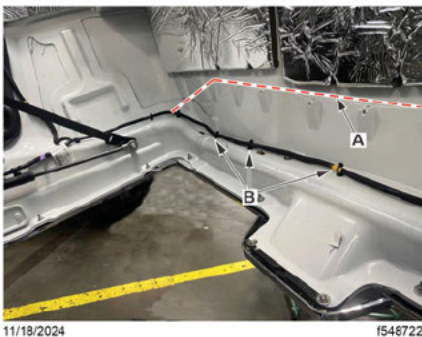
Fig. 4, New Routing Path of the Hood Harness

A. Design intent routing path.

B. New routing path created. Added five holes and fir-tree cable ties (three shown).

1. ☐ Park the vehicle on a level surface, shut down the engine, and set the parking brake. Chock the tires.
2. ☐ Open the hood.
3. ☐ Drill five 17/64-inch holes along the hood at the approximate locations, shown in Fig. 4.
4. ☐ Route the harness along the path shown in Fig. 4.
