# Service Bulletin

Bulletin No.: PIP6032B

**Subject: CVT Transmission Leaks from the Oil Filter Housing and/or the Cooler Lines**

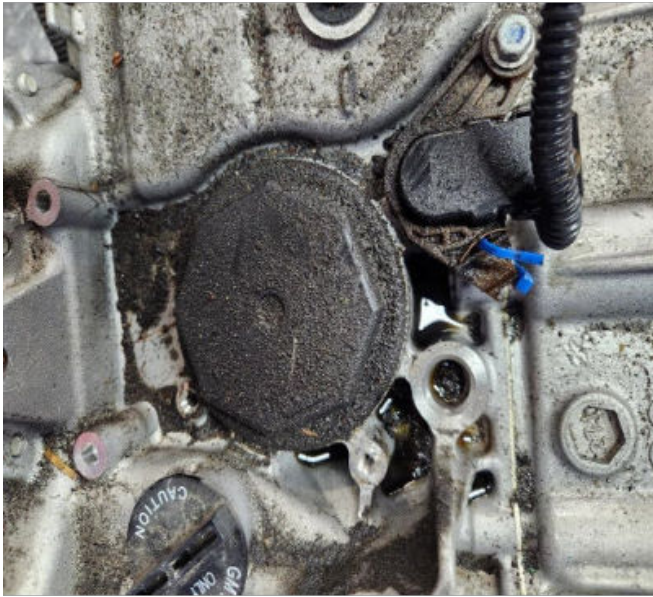
6750284

Upon inspection the technician may find a leak coming from the top of the transmission.

This may be caused by a rolled or damaged oil filter housing O ring.

Leak on top of the transmission.

If this concern is found please replace the oil filter housing and take care to lubricate the O ring Prior to installation.

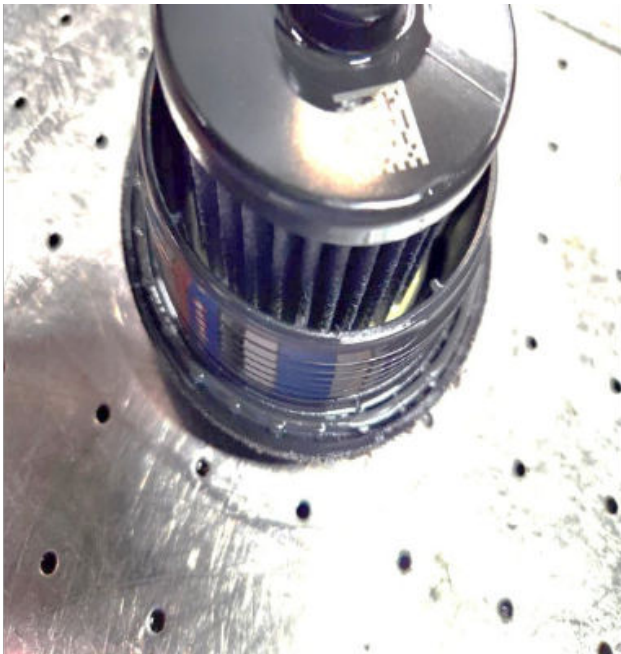
6750285

Damaged/Rolled Oil Filter O Ring.

These Seals should always be lubricated prior to installation.

Failure to do so can cause the O Ring to twist and roll or become distorted.

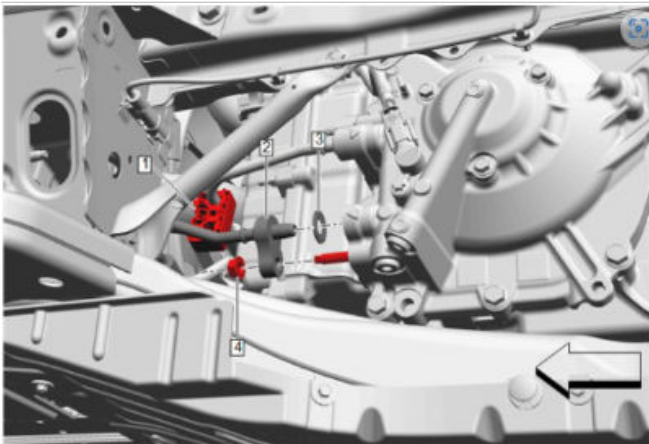
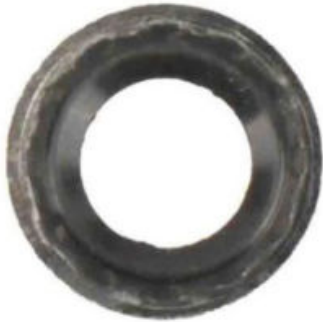
6782717

There have been cases seen where Technicians or assembly plant issues can leave these seals off.

These seals resemble A/C Line seals as they are metal with a rubber sealing surface internal.

An example of these seals is seen below Item 3 is the seal.

If a leak is found in this location replace the damaged or missing seals, drive the vehicle and verify there are no leaks.

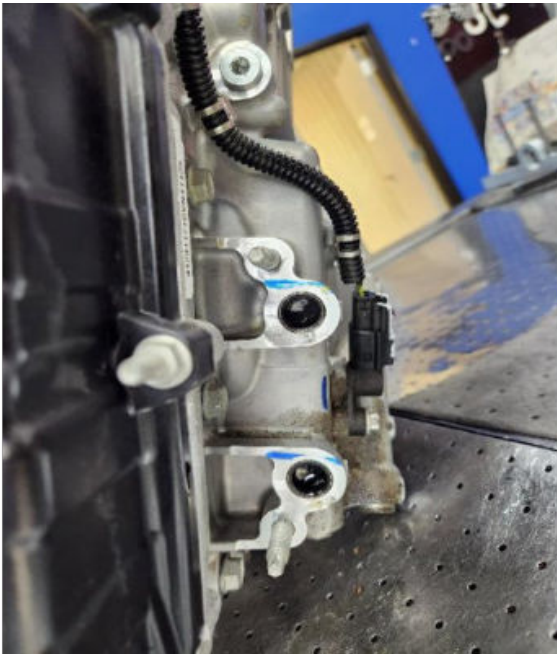
6750295

There are secondary shipping seals installed in the cooler line ports on the transmission from the supplier.

The seals are pierced when the cooler lines are installed, and will contain the majority of the leak .

These Seals WILL remain in the transmission and no attempt should be made to remove them as seen in the picture below .
