Service Bulletin

Bulletin No.: PIP6062

Subject: Diagnostic Tip: Potential Engine Harness Chafing No Start No Crank Reduced Power Message Misfire ABS Lamp SES Lamp CAN Buss issues Various DTCs

Brand:	Model:	Model Year:		VIN:		Engine:	Transmission:
		from	to	from	to		
Chevrolet	Colorado	2023-2025		All	All	2.7 L3B/L2R	All
GMC	Canyon	2023-2025		All	All	2.7 L3B/L2R	All

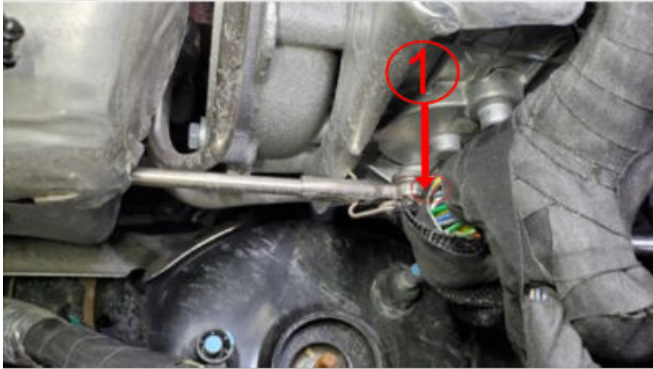
6899857

Involved Region or Country	North America
Condition	Possible No start, No Crank, Reduced Power Message, misfire, ABS lamp, SES lamp, CAN Buss issues, various DTCs.
Cause	Potential engine wiring harness chafed at Turbocharger heat shield or on Wastegate linkage.

Pictures below show wiring harness damaged by the Wastegate linkage.

If you encounter one of the above mentioned vehicles that is experiencing one or more of the following conditions No start, No Crank, Reduced Power Message, misfire, ABS lamp, SES lamp, CAN Buss issues, various DTCs please inspect the engine wiring harness at the turbocharger Wastegate actuator linkage or heatshield area for potential damage and refer to the latest SI information for any wiring or terminal repairs.
