Service Bulletin

Bulletin No.: PIT6403

Subject: Inside Rear View Mirror Camera Image Misaligned

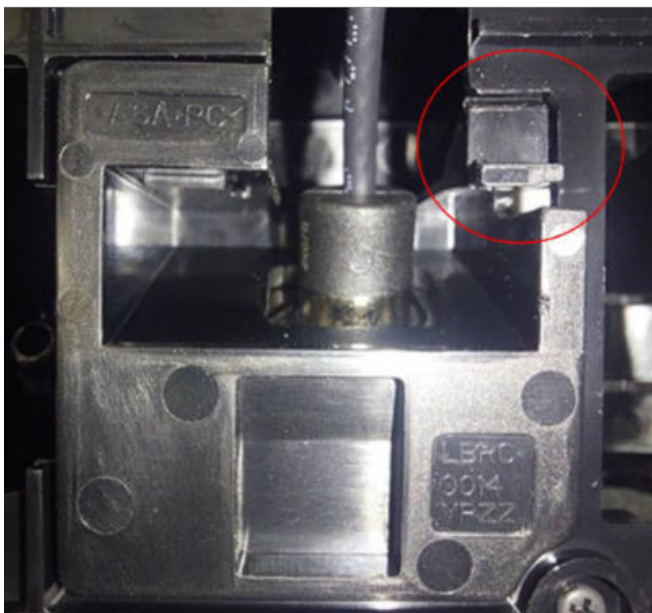
6969757

Involved Region or Country	North America
Additional Options (RPO)	DRZ
Condition	Some customers may comment that the inside rearview mirror image is misaligned downward and showing a low view.
Cause	The cause of this condition may be the camera bracket not fully seated / snapped into position causing camera misalignment, as shown below

To correct this concern, access the B352 Video Display Inside Rearview Mirror Camera following SI instructions for Video Display Inside Rearview Mirror Camera Replacement. Inspect the camera bracket and reseal the bracket, ensuring the retainers are fully seated. There should be no need to remove the camera from the bracket.

Note: A fully seated bracket will not have any movement.
