# Service Bulletin

Bulletin No.: PIC6613

**Subject: Whistling Sound While Driving at Highway Speeds**

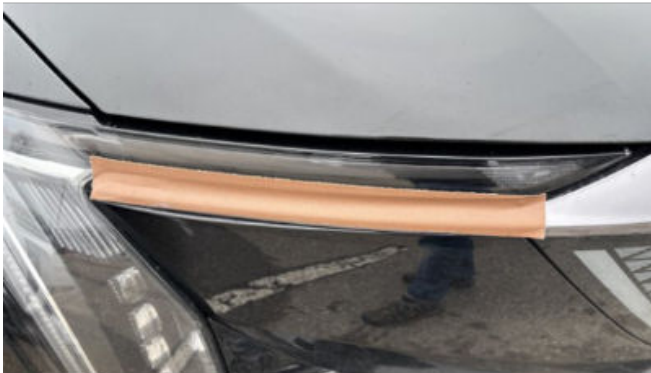
6970183

To determine if the source of the noise is coming from the gap between the headlamp assembly and the fascia, tape off the affected area. See images below.

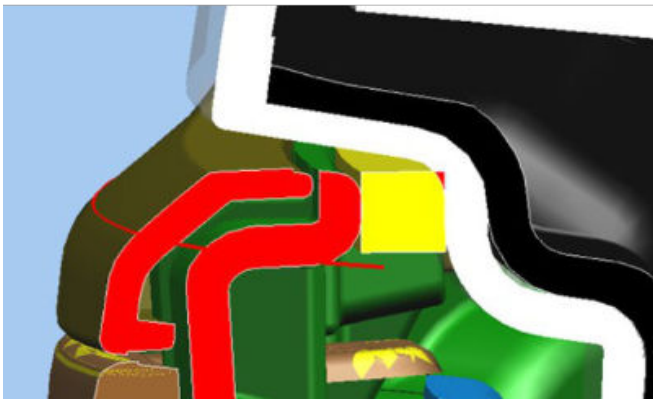
6970185

The location of the foam strip, as seen in the image below, is identified in yellow.

If the whistling sound is eliminated, the technician will need to install a piece of foam between the headlamp assembly and the fascia.
