# Service Bulletin

Bulletin No.: PIT5832V

Date: June, 2025

### Subject:

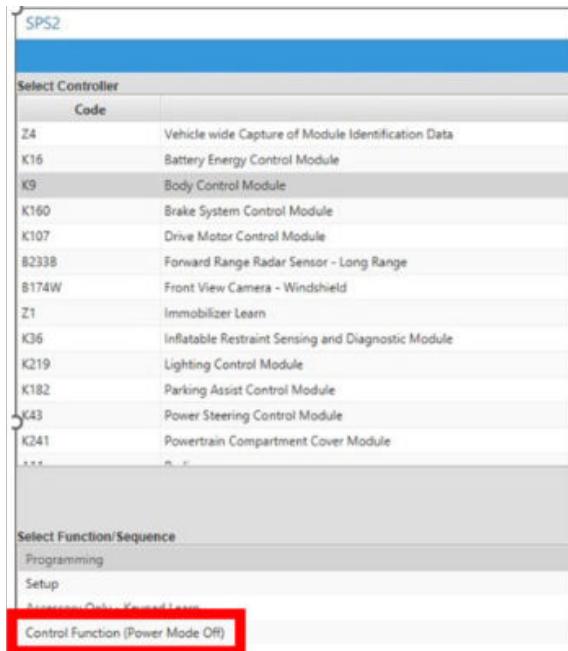
## PHOTO A

Error Type	Description	Remedy
Pre-Conditions	Vehicle will not shut Off.	For passive start vehicles unable to power OFF: SPS Programming → BCM → Control Function Power Off SEE PHOTO A BELOW
VTD Secure Access Locked pop up message appears	Unable to complete a module setup due to a VTD error.	Confirm Replace & Program was selected if the module was replaced. If not, run SDAC then retry the setup. SEE PHOTO B & E BELOW

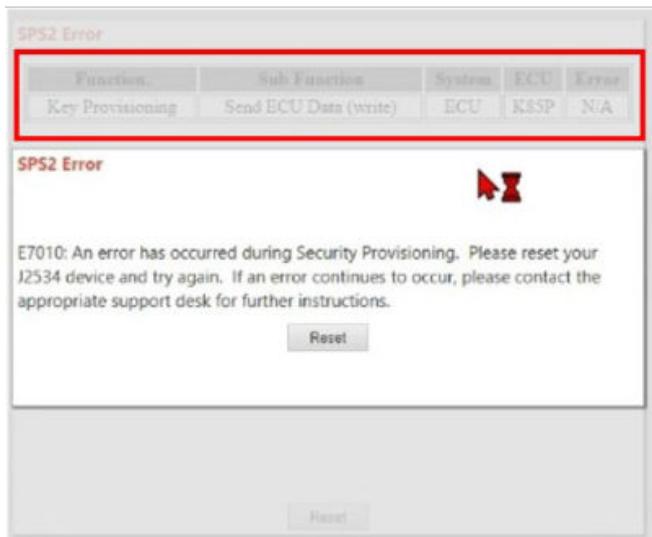
**Photo D**

Error Type	Description	Remedy
The ECU box reads a global ID which points to a specified ECU	<p>The system failure indicates an ECU failure and specifies which ECU failed.</p> <p>SEE PHOTO D BELOW</p> <p>In Photo D example, the Global ID is listed as K85, which is for the Restraints Occupant Classification System Module . The module's name can be found by looking at the global codes listed under "Control Module References" document in SI for the vehicle that is being working on</p>	<p>Try SDAC after each step (stop if successful):</p> <p>SEE PHOTO E BELOW</p> <ol style="list-style-type: none"> <li>1. Ensure the K56 Serial Data Gateway module is fully programmed to the latest software.</li> <li>2. Reprogram the failing module if an update is available.</li> <li>3. Pull the fuse supplying power to the failing module. If the fuse is a three-prong fuse which powers multiple modules, a two-prong fuse will be needed to power the unaffected module. Then run SDAC.             <ol style="list-style-type: none"> <li>a. If SDAC completes after removing the fuse, reconnect the fuse and attempt to run SDAC.</li> <li>b. If SDAC fails for the same module, that module will need to be replaced.</li> <li>c. If SDAC fails again for a different module, ensure vehicle pre-conditions are met (OFF). Read codes to identify any communication or programming faults.</li> </ol> </li> </ol>

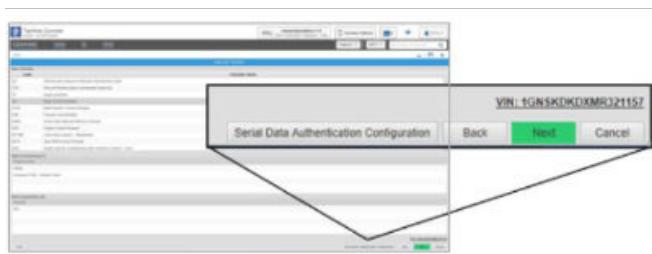
**Photo E**

Error Type	Description	Remedy
Configure Link in Sub Function box	Communication issue between tool, Serial Data Gateway Module (K56), or other controllers via Ethernet.	<p>Try SDAC after each step (stop if successful):  <b>SEE PHOTO E BELOW</b></p> <ol style="list-style-type: none"> <li>1. Ensure the K56 Serial Data Gateway module is fully programmed to the latest software.</li> <li>2. Check for aftermarket devices or harnesses plugged into the DLC.  <b>SEE PHOTO C BELOW</b></li> <li>3. Use a hardwired connection from the PC to the MDI. Reset TLC if switching from wireless.</li> <li>4. Perform a global reset by disconnecting the 12V battery negative cable for 1 min.</li> </ol> <p><b>Note: EV Global Reset:</b>  Before disconnecting battery cables on electric vehicles:</p> <ol style="list-style-type: none"> <li>1. Ensure the ignition is OFF.</li> <li>2. Using a digital multimeter, check the 12 V battery voltage.</li> <li>3. If the voltage is 13.5 V or above, Battery Maintenance Mode is active.</li> <li>4. Wait for the T18 Battery Charger to deactivate before disconnecting the battery negative cable.</li> <li>5. Follow the Battery Negative Cable Disconnection and Connection procedure found under the Starting, Charging, and Low Voltage Energy Storage category.</li> </ol>

The system box reads "SERVER"	This is not a vehicle related issue. SPS is unable to reach servers to complete the requested task.	<p>Check PC internet connection and retry SDAC.  <b>SEE PHOTO E BELOW</b></p> <p>Wait 2 hours and try again</p> <p>If still a concern, wait one day and try again, If no success, Contact Techline Support</p>
