**HYUNDAI**
Technical Service Bulletin

GROUP	NUMBER
ENGINE MECHANICAL	25-EM-005H
DATE	MODEL(S)
JUNE 2025	SANTA CRUZ (NXT)

SUBJECT: INTEGRATED THERMAL MANAGEMENT (ITM)
REPLACEMENT & ECU SOFTWARE UPDATE – DTC P218100

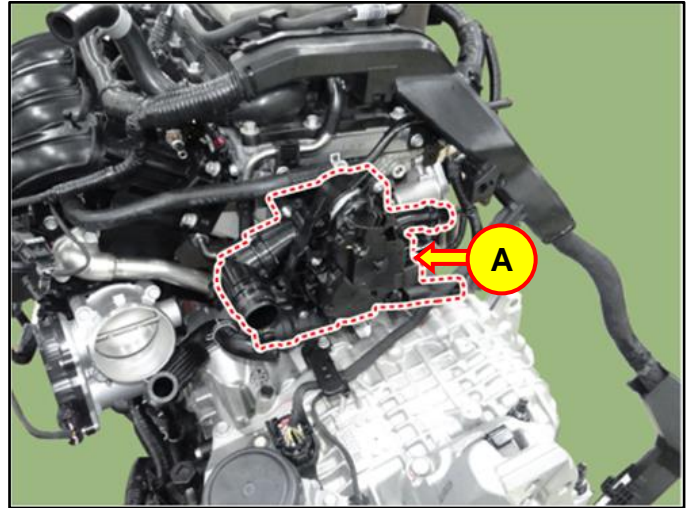
1. Utilize the GDS to detect DTC P218100:
Cooling System Performance:
 - If DTC P218100 is present, then replace the ITM (A) by referring to the shop manual.
 - **Engine Mechanical System > Cooling System > Integrated Thermal Management > Repair procedures**
 - If DTC P218100 is **NOT** present, then the service procedure is now complete.

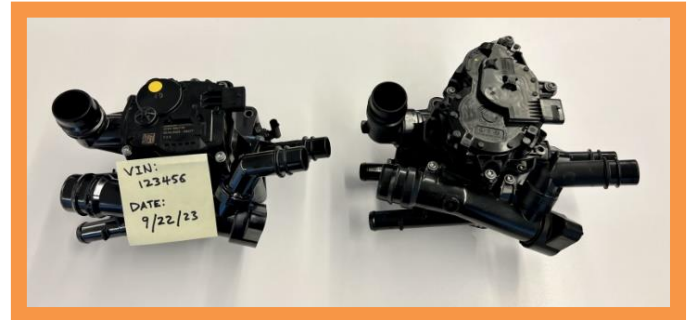
NEW (QQH)

OLD (OE)

Using STUI, take a photo of the new (QQH) part next to the removed, old part.
