Technical Service Bulletin	GROUP BODY	NUMBER 25-BD-009G
	DATE JUNE 2025	MODEL(S) GV70 (JK1A) GV70 ELECTRIFIED (JK1A EV)
SUBJECT: HOOD LATCH RELEASE CABLE

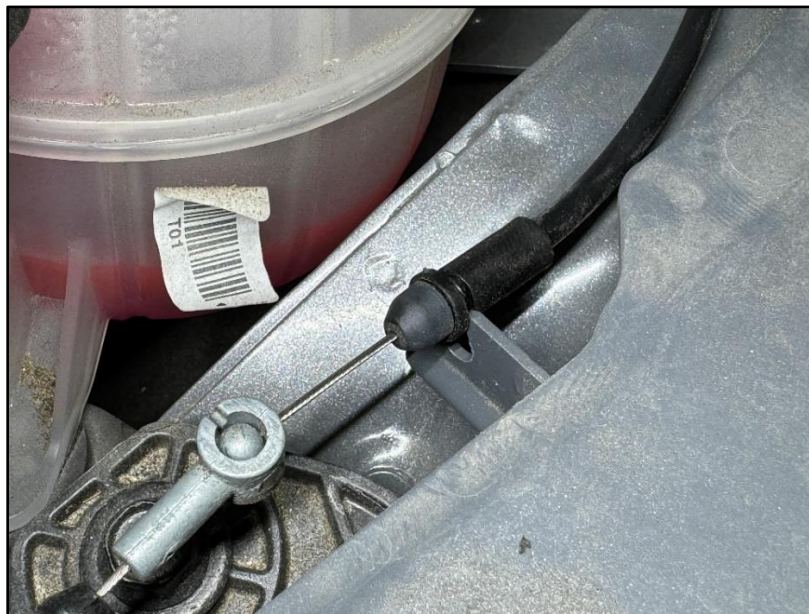
Description: Some GV70 (JK1A) and GV70 Electrified (JK1A EV) vehicles may exhibit a condition where the hood does not open when the in-cabin hood release lever is engaged. This may be due to the release cable not being securely mounted in its bracket. This bulletin provides instructions to access and properly seat the hood release cable into its mounting bracket.

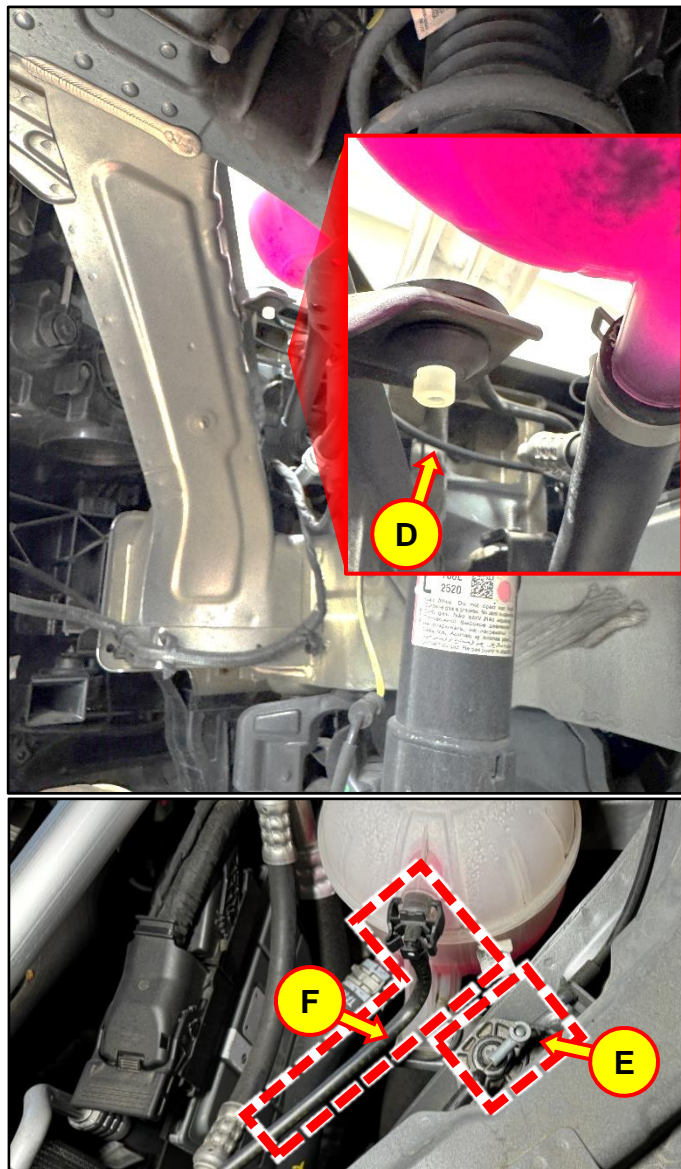
5. Reach into the engine bay through the gap in the wheel well and feel along the top of the body fender to find the hood latch release cable (D).

Locate the metal cable/ball connector (E) to confirm you have identified the release cable and **NOT** the coolant hose (F).

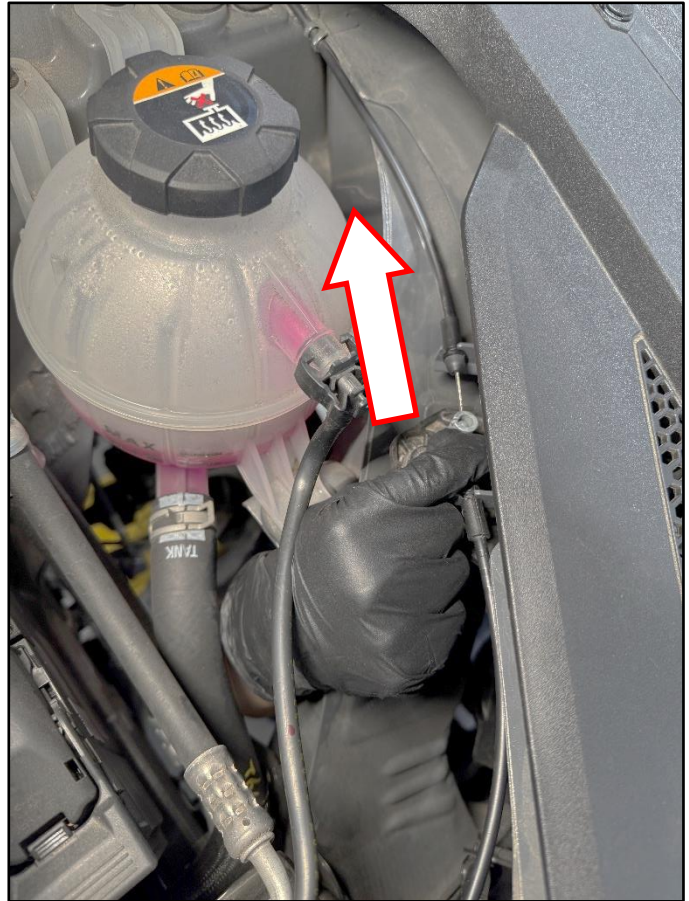
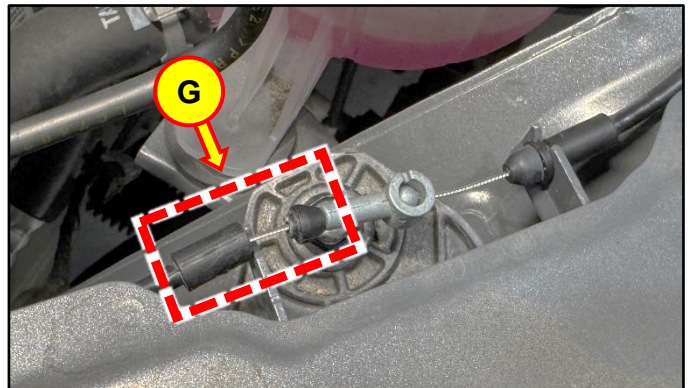
DO NOT pull the cable by its plastic fittings. Doing so may damage them (G).

6. Pull the hood latch release cable by its metal cable/ball connector toward the rear of the vehicle to open the hood.

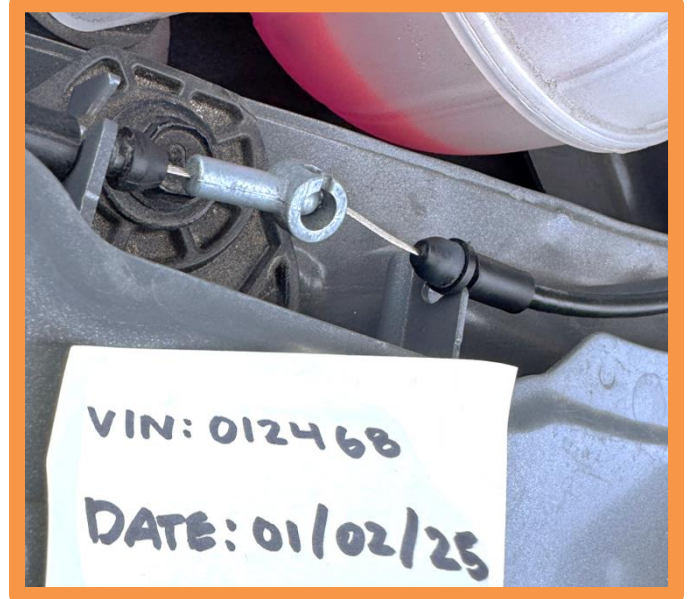
Using STUI, take a photo of the hood release cable's existing position **NOT** fully seated into the mount with the last 6 digits of the VIN and the date of repair on a piece of paper.
