SERVICE BULLETIN

NUMBER: 15-236-18R

DATE: 12/04/18

SUBJECT: Reprogramming File Availability for Optimization of Harman Gen 3.1
 and Gen 3.1α Audio and Navigation Head Units

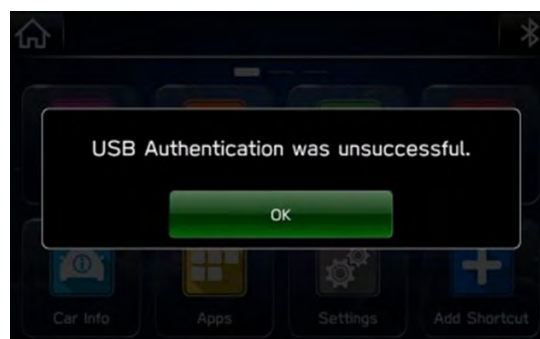
NOTE: If an attempt is made to install the wrong “grade” file into the wrong grade head unit (EXAMPLE: “Base” update file into a “Base Plus or Mid” or “High” head unit), the USB Authentication error screen below will be displayed:

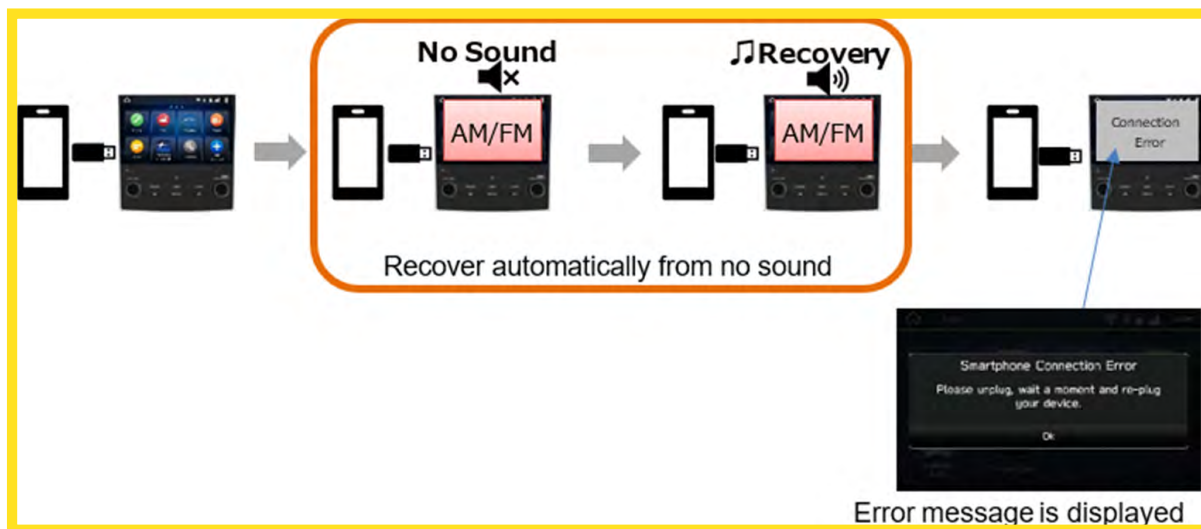
Case1: "Smartphone Connection Error" is displayed

Situation: If an iPhone is already connected via USB when the AM/FM radio automatically recovers from a no sound, a connection error occurs with the iPhone displaying a popup message stating "Smartphone Connection Error". See below.

Countermeasure: Re-connecting the USB cable from the iPhone would restore normal operation.

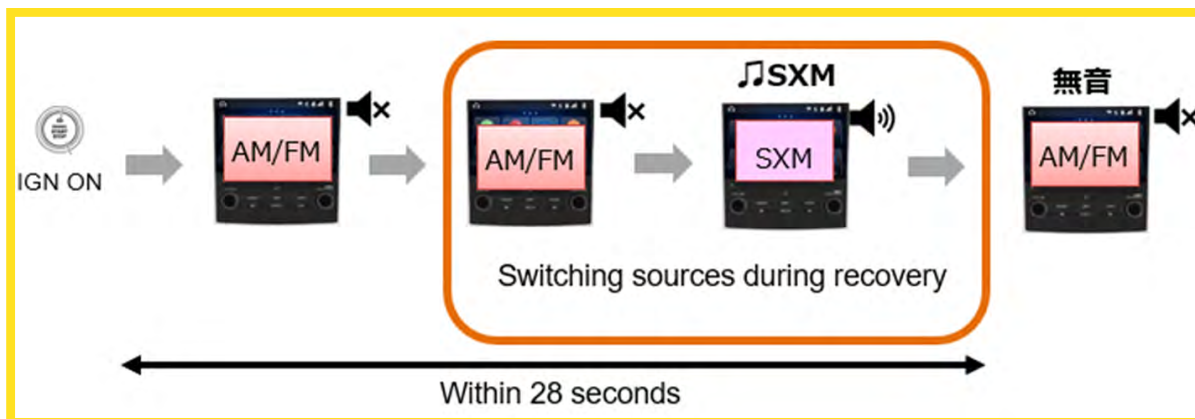
Case2: Continue no AM/FM radio sound due to switching other sources

Situation: If the AM/FM radio experiences a loss of sound after turning the ignition on, it recovers automatically within approximately 28 seconds. However, switching sources (such as to SXM or Bluetooth Audio) during this recovery period prevents the automatic restoration, resulting in continued no AM/FM radio sound. See below.

Countermeasure: Turning the ignition OFF and ON.

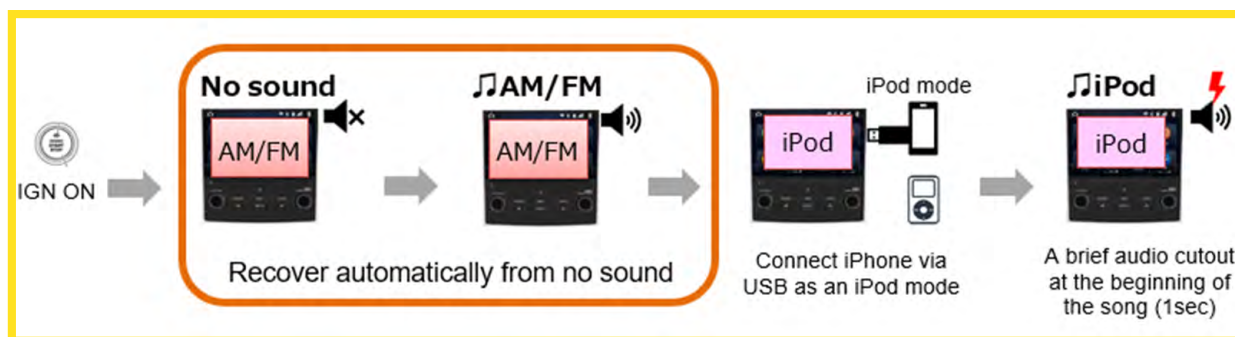
Case3: Audio cutout when playing music from iPhone as iPod (only applicable for the models up to iPhone 13)

Note: Only iPhone models up to iPhone 13 can be connected as an iPod. iPhone 14 and later models do not support iPod mode and only function in charging mode.

Countermeasure: Turning the ignition OFF and ON.

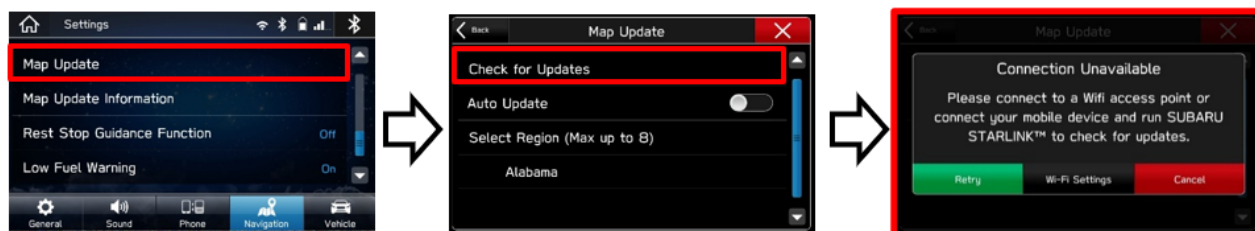
This software update was solely prepared to renew the electronic certificate programmed in the head unit to enjoy Map update Over the Air (MOTA) service. Only applied to HIGH trim Head Unit.

When customer attempts MOTA update after 12/2/2024 on the head with an outdated electronic certificate the following error pop-up will be displayed.

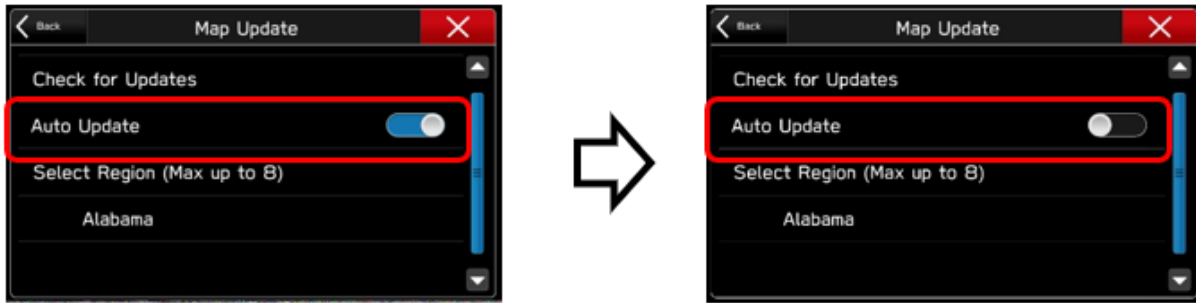
This popup is the same as the one that appears when Wi-fi connection is not available.

If you have set “Auto Update” to ON, after 12/2/2024, “Connection Unavailable” screen will pop up every time after Wi-fi connection. If you change Auto Update to OFF, the pop-up will not display.
