**SERVICE BULLETIN**

**APPLICABILITY:** 2025 WRX  
2025 Forester Hybrid

**NUMBER:** 15-326-25  
**DATE:** 06/17/25

**SUBJECT:** FOTA (Firmware Over-The-Air) Reprogramming for DENSO Gen 4.5 Audio Navigation Infotainment Systems via DCM

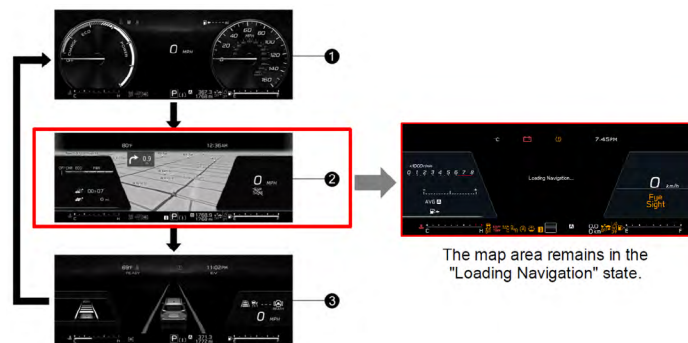
This update addresses an issue in “Map Mode” on the digital instrument cluster, where the map may fail to display and remain on “Loading Navigation” state.
