**PRODUCT CAMPAIGN BULLETIN**

**APPLICABILITY:** 2025 MY Forester (SHEV) **NUMBER:** WRC-25  
**SUBJECT:** Safety Recall and Stop Sale- Insufficiently Tightened Child Seat Anchor Bolts **DATE:** 06/20/25

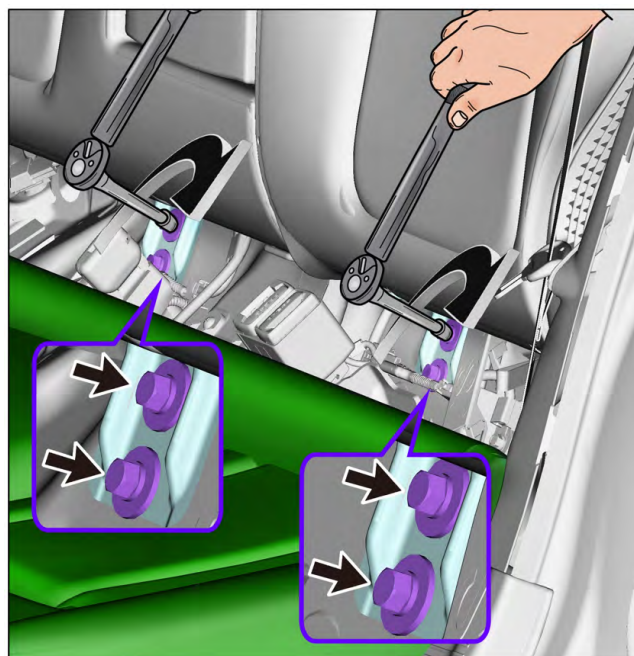
The affected vehicles may have been manufactured with insufficiently tightened child seat anchor bolts. Over time, an affected attachment bolt may become loose, leading to possible separation from the vehicle frame.

**STEP 3:** Using a torque wrench, tighten all four bolts securing the plate anchors to **25N·m (18.44ft-lbs)**.
