SERVICE PROGRAM BULLETIN

APPLICABILITY: 2017 MY Forester (turbo) **NUMBER:** WRA-25
 2017 MY WRX **DATE:** 06/27/25

SUBJECT: Rear Catalyst (Center Exhaust Pipe)
 Non-Compliance

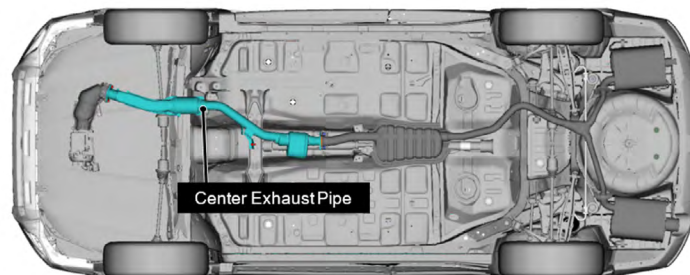
COMPONENT CONFIGURATION:

Defective Part

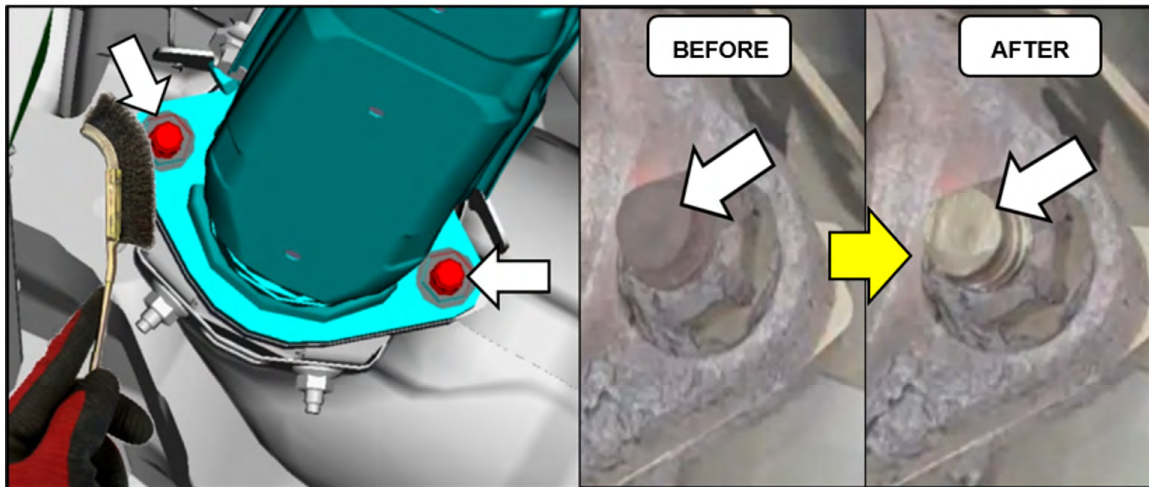
NOTE: The amount of rust may vary depending on the vehicle. The example image below is to be used as reference.

STEP 5: Using a wire brush, remove all rust located on both nuts and studs of the front center exhaust pipe connection.

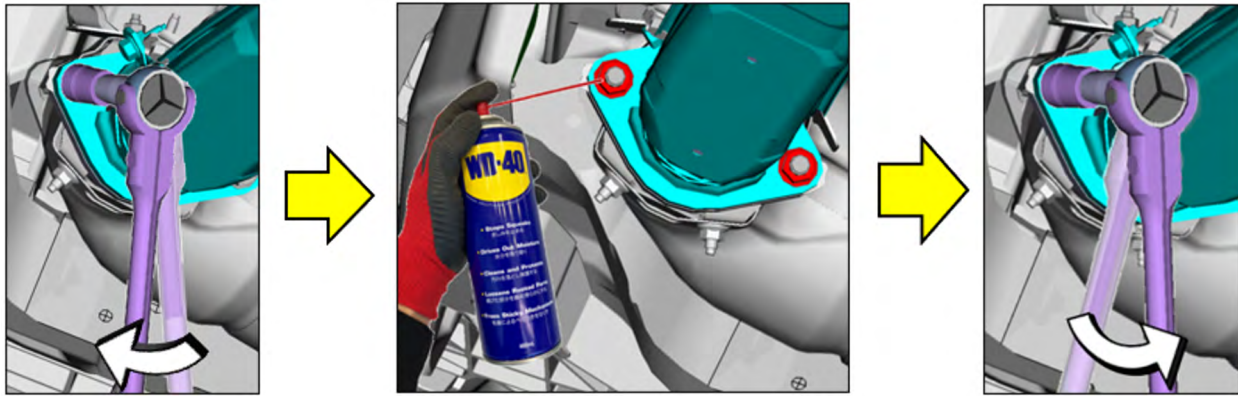
CAUTION: When encountering cases of the stud becoming excessively damaged during removal, replacement of the affected stud will be required. Refer to the service procedure outlined in the **APPENDIX B** section of this bulletin and then proceed to Step 14.

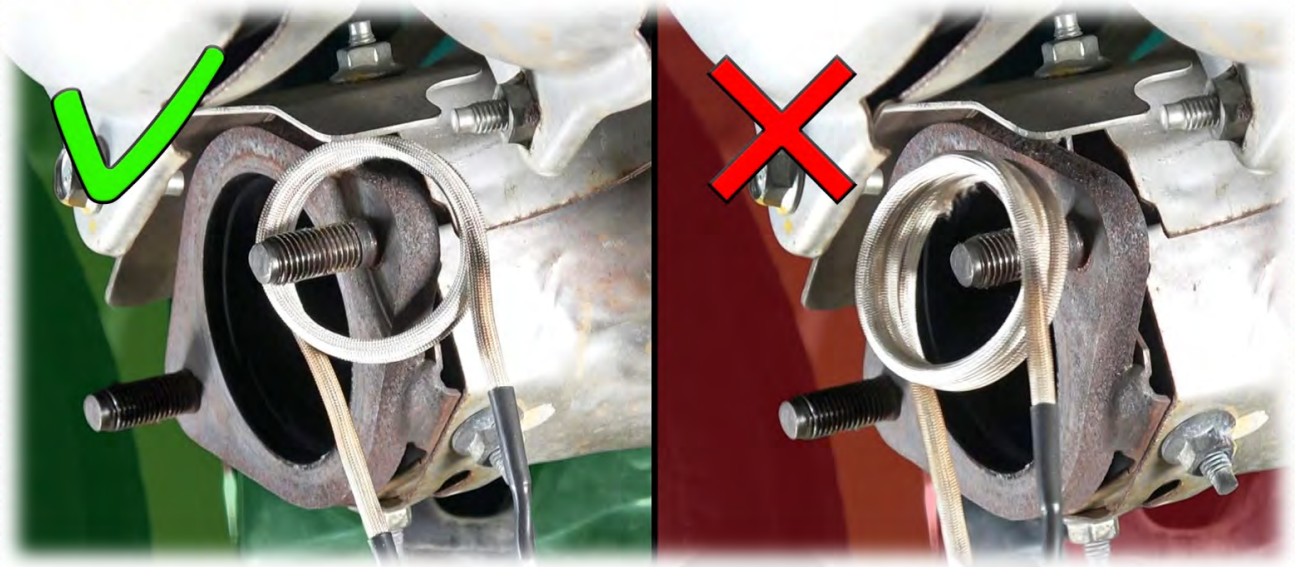
The IH heater coil should be set to heat the base of the stud bolt and the front and back of the flange. If the heating method is incorrect, the target temperature (250° C) will not be reached, and the bolt will not loosen.
