Preview Solution CBR-2474-1

## AMT - G Counter Shaft Brake (CSB) Oil Intrusion - Models VN (4), PR (4)

Published 4 June 2025

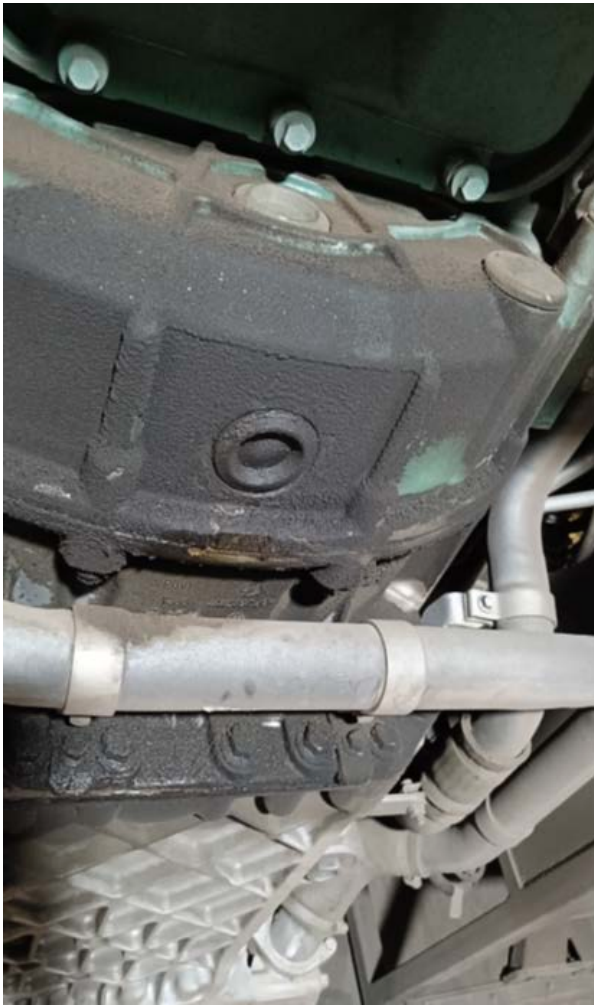
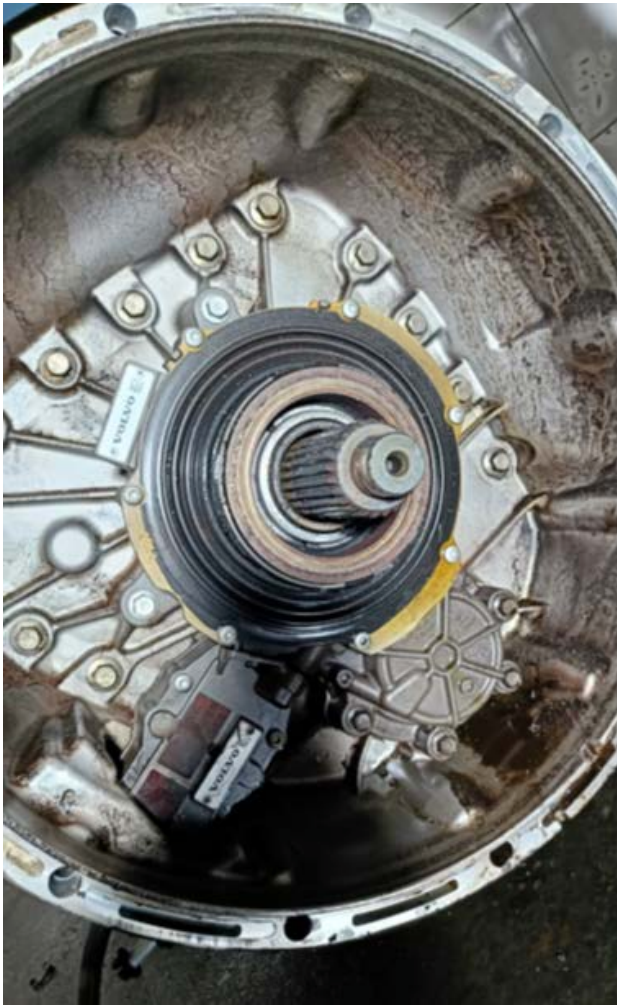
Oil leakage may be observed from the bottom of the flywheel or clutch housing. The following symptoms indicate potential oil intrusion:

- Presence of oil inside the clutch housing (typically not black like engine oil)
- CSB housing visibly wet with oil
- Oil residue on or near the bottom of the **Concentric Clutch Actuator (CCA)** vent area
- Oil observed inside the **Clutch Valve Unit (CVU)** air passages and vent
- Hardened CSB seals with embedded clutch material (as seen in previous AMT-F cases)
- Surface damage or contamination on the CSB cover

#### 4. Required Repairs

If oil intrusion is confirmed:

- Replace the **Clutch Valve Unit (CVU)**
- Replace the **Concentric Clutch Actuator (CCA)**
- Replace the **Countershaft Brake (CSB) cover** if surface damage is present

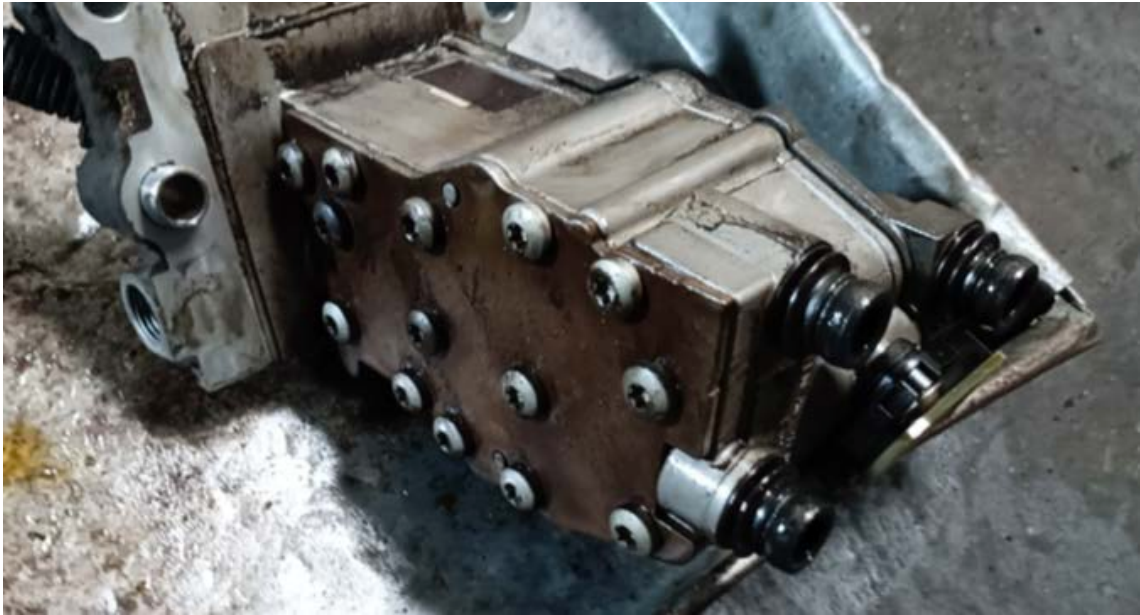
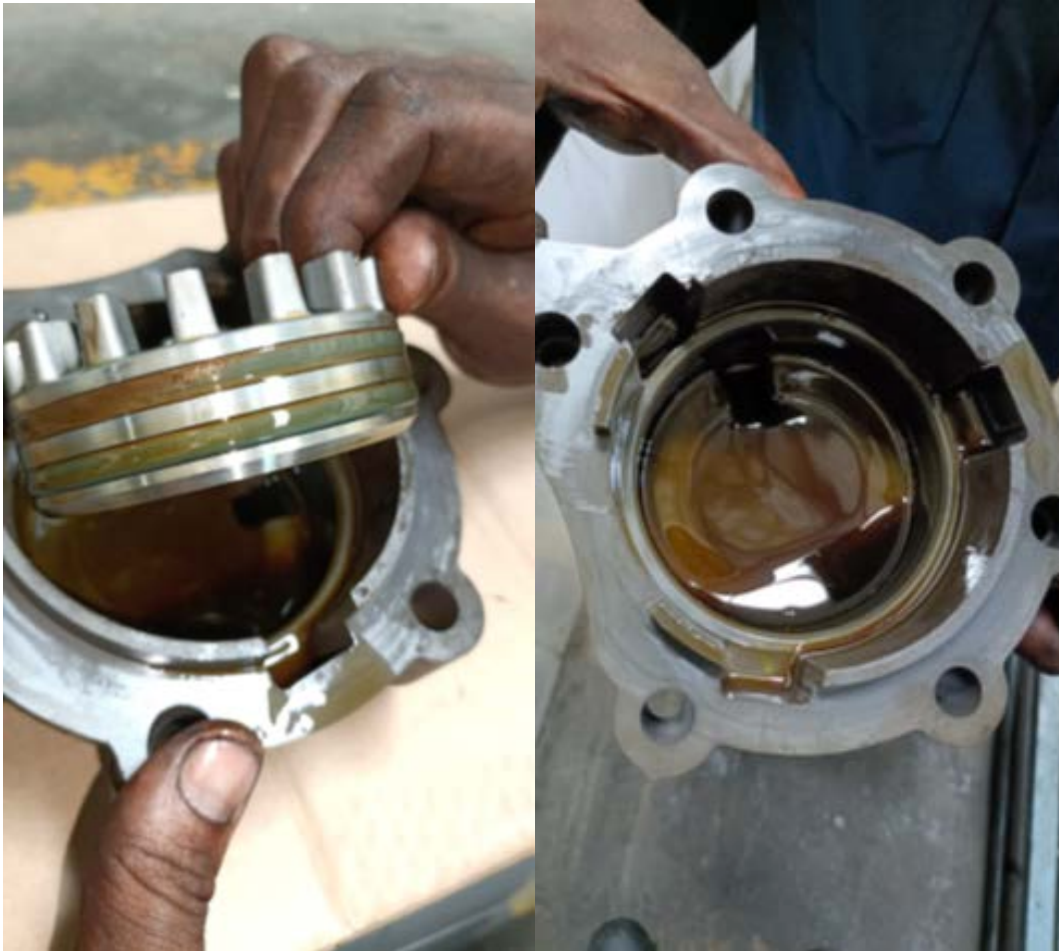
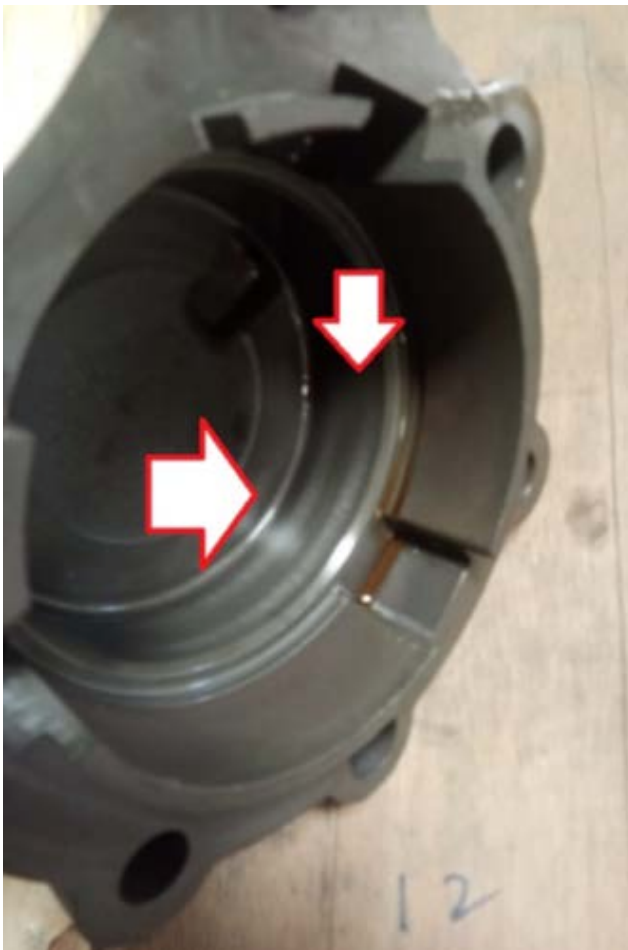
- **Remove the Clutch Valve Unit (CVU)** and inspect the internal air passages and vent for oil.
- **Inspect the Countershaft Brake (CSB)** housing for visible oil and residue.
- **Examine the Concentric Clutch Actuator (CCA)** vent area for external oil contamination.
- **Check CSB seals** for hardening or signs of clutch material embedding.
- **Assess the CSB cover** for damage caused by debris.

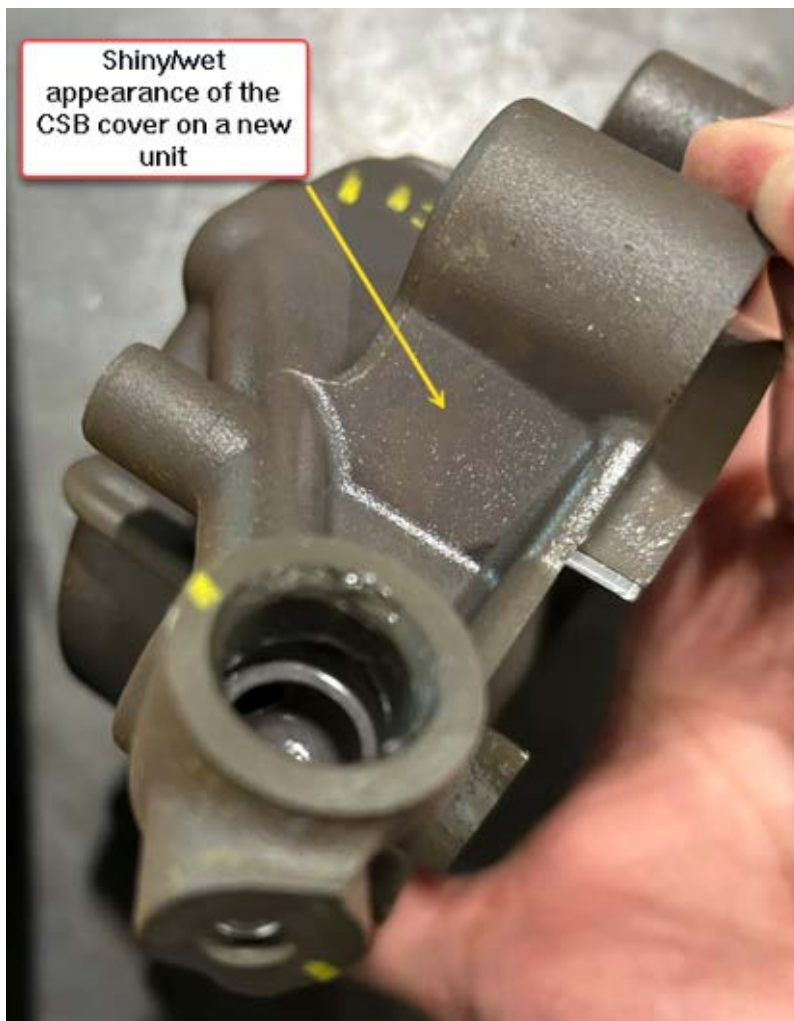
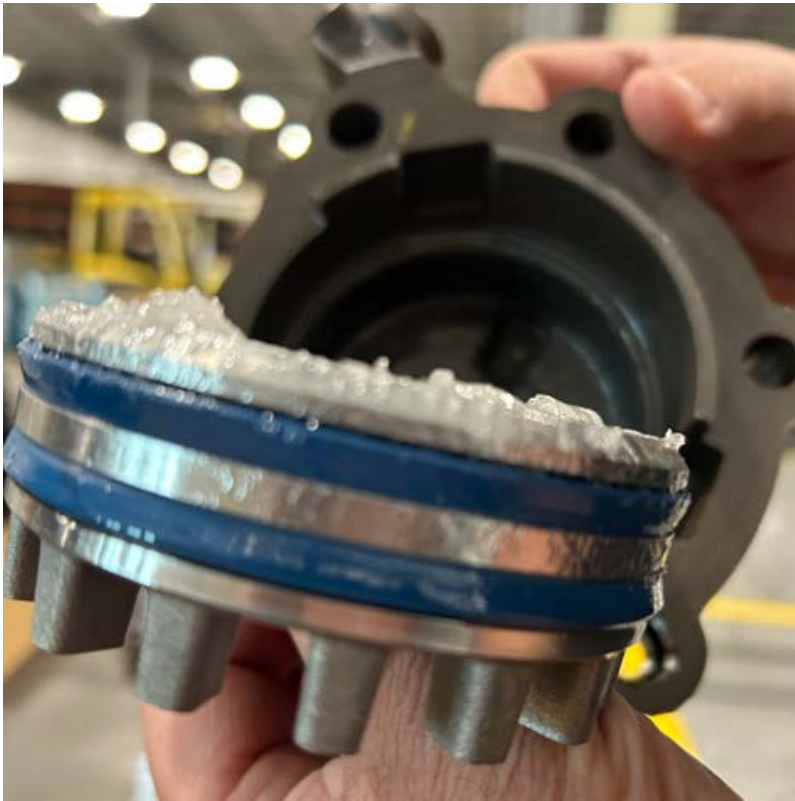
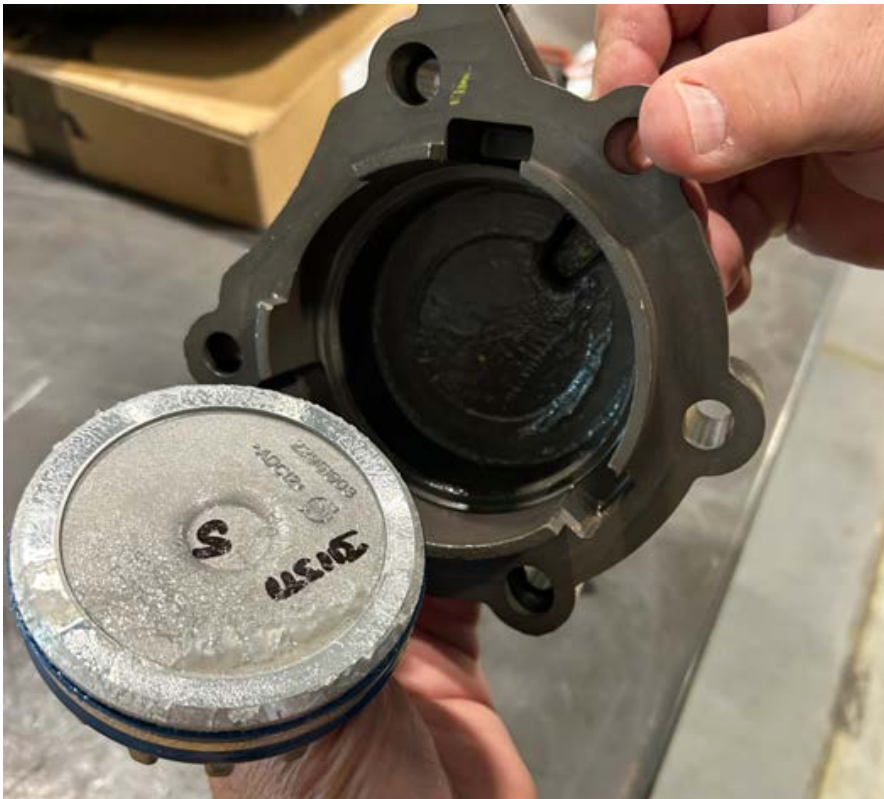
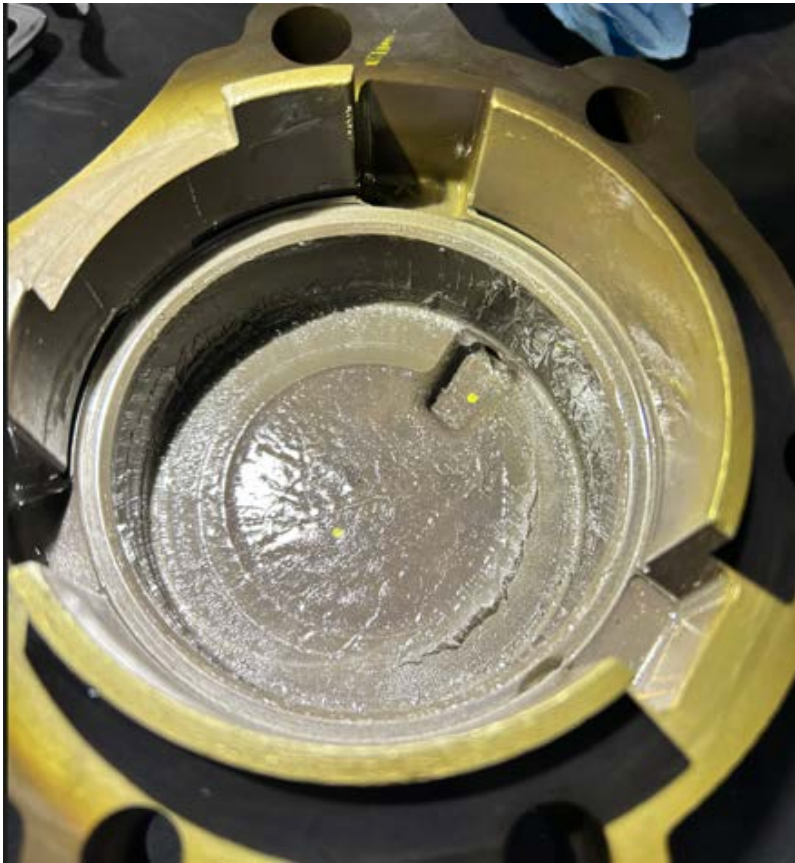
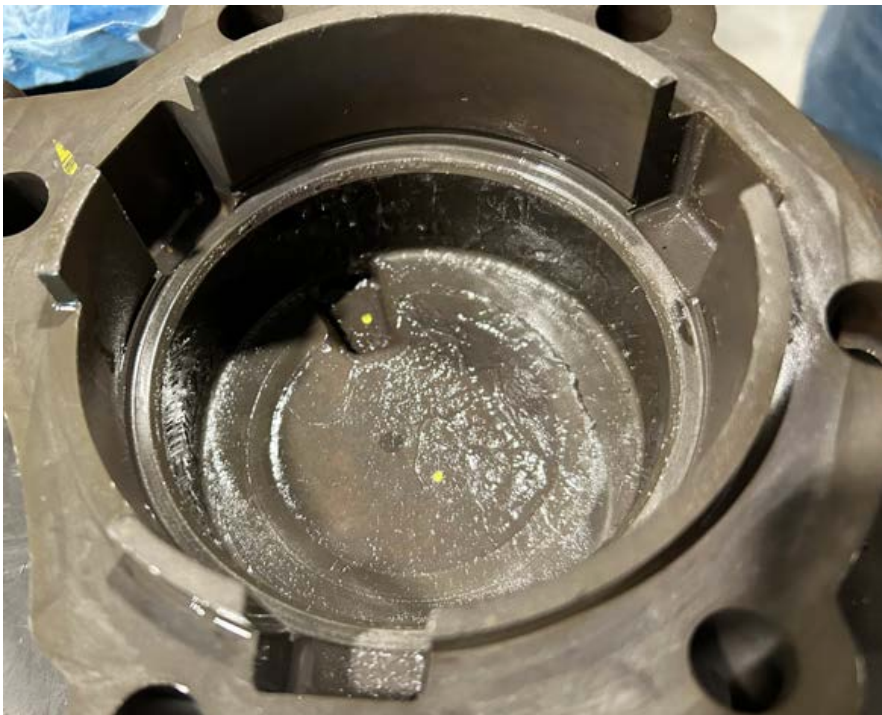
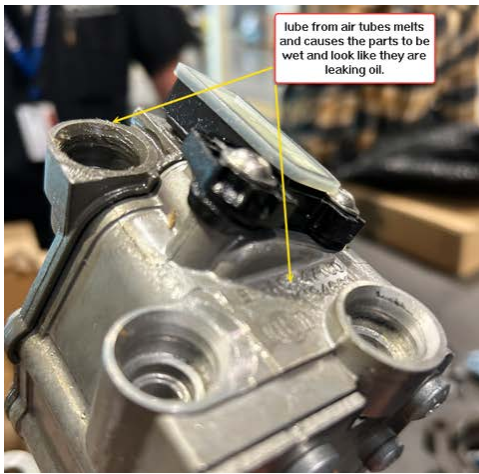
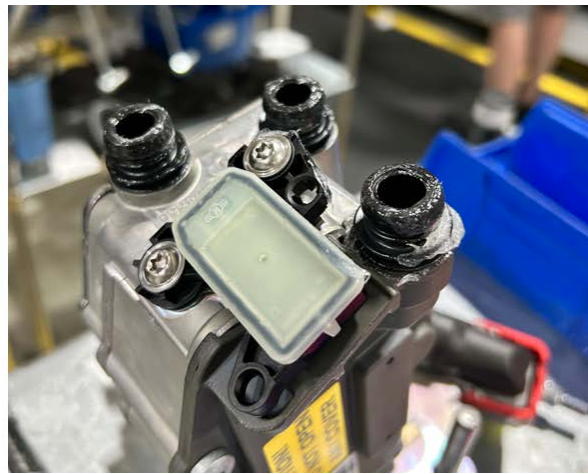
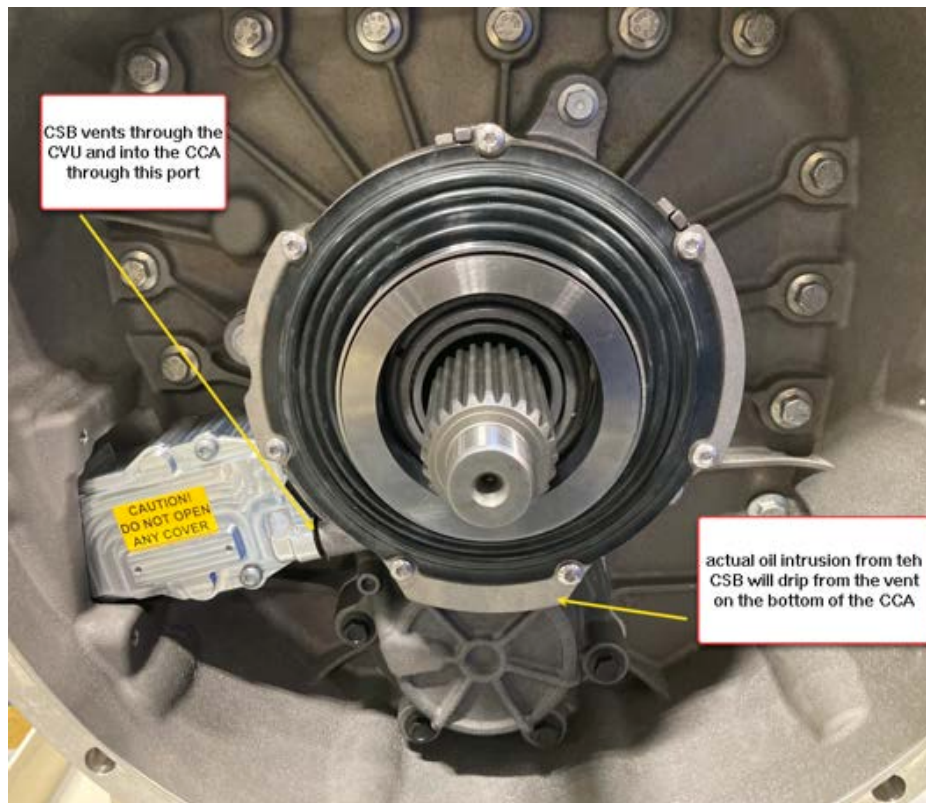
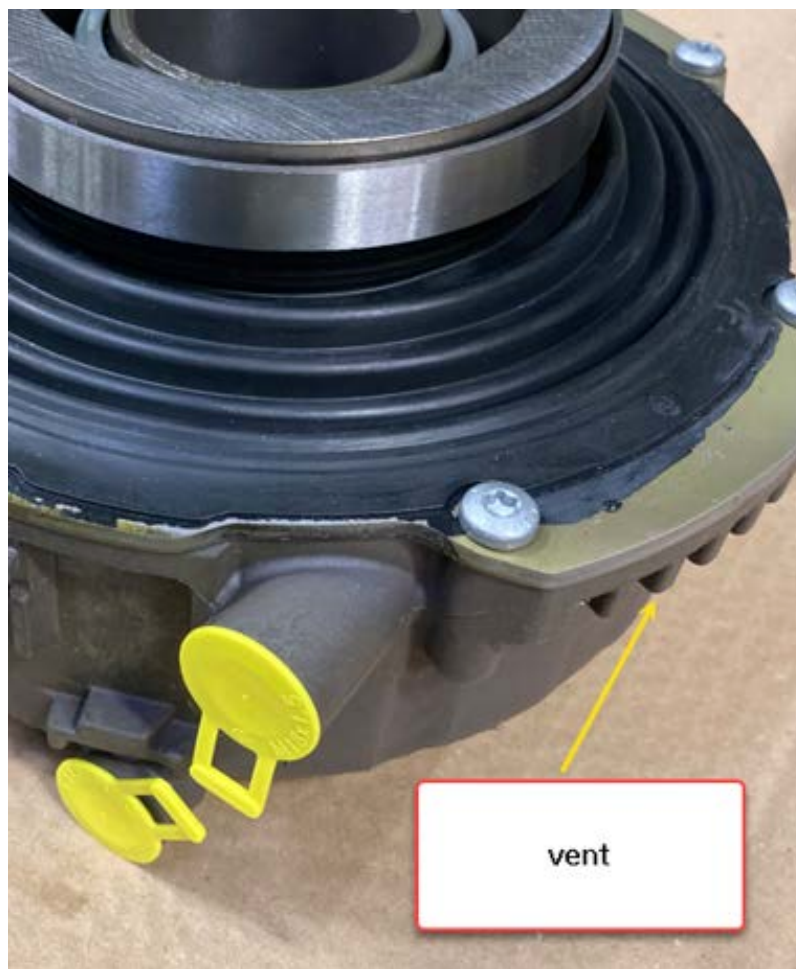
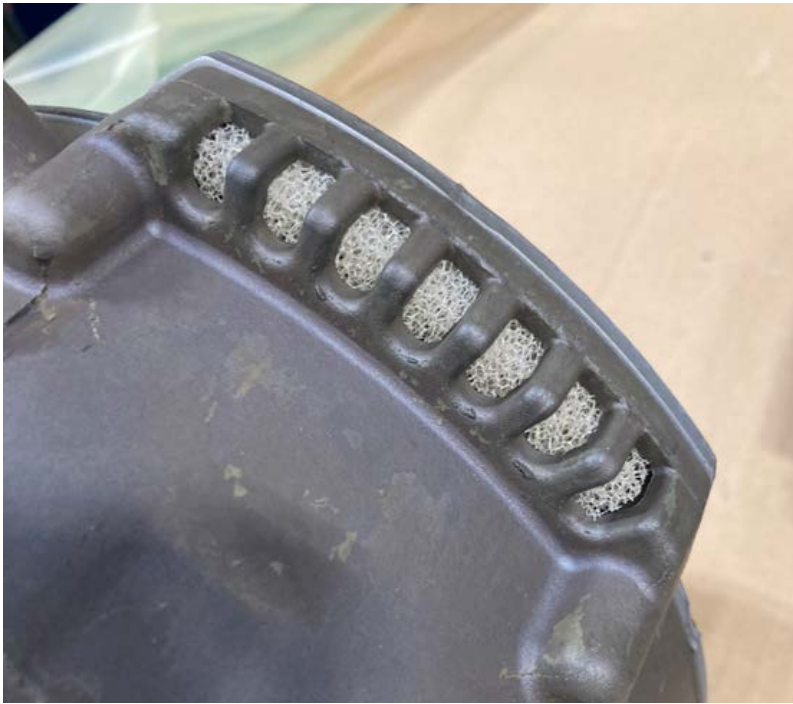
Some new AMT-G units may be misdiagnosed due to:

- Shiny or oily appearance inside the CVU or CCA air passages
- Excessive lubricant applied to air tubes or internal parts, giving the false appearance of a leak

These conditions can lead to incorrect replacement of non-faulty components.

If inspection shows no actual intrusion and parts appear over-lubricated:

- **Clean all affected components thoroughly**
- **Reassemble using a light, even coating of lubricant**
- **Investigate alternative sources** for the apparent leak
