Check engine light active - Fault P3007F1, P3007F2, P300CA8, or P300CA9 present in CDI control unit

Topic number	LI14.30-N-075882
Version	6
Function group	14.30 - Secondary air injection
Date	6/20/25
Validity	Model 907 with engine 654
Reason for change	Remedy update

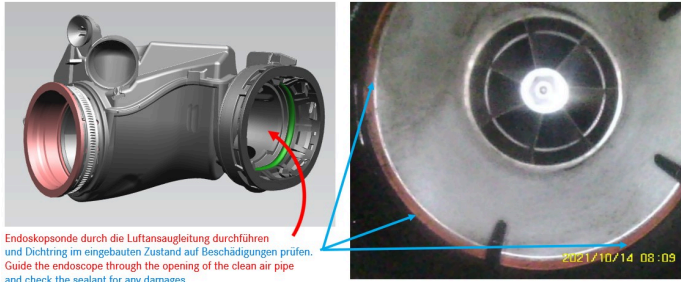
Attachments	
File	Description
<p>Dichtring_Sealant.jpg</p>

- If there is a leakage upstream of the exhaust gas turbocharger (see "Dichtring_Sealant.jpg").
- If the housing intermediate flange at the high-pressure EGR valve (where the exhaust back pressure sensor connects) is carbonized or clogged, or if there is carbonization/incomplete sealing of the high-pressure or low-pressure EGR valves. (See "Gehaeusezwischenflansch_intermediate_flange.jpg" and "verstopfter_Gehaeusezwischenflansch_clogged_Intermediate_Flange.jpg".)

<p>Endoskopspeende durch die Luftansaugleitung durchführen und Dichtring im eingebauten Zustand auf Beschädigungen prüfen. Guide the endoscope through the opening of the clean air pipe and check the sealant for any damages</p>	
<p>Gehaeusezwischenflansch_Intermedidate_Flange.jpg</p>

- Inspect the clean air line between the air filter housing and the exhaust gas turbocharger for proper assembly.
- Reference WIS documents: AR09.10-S-8130EA, AR09.40-S-0500EA (dual-stage turbo), AR09.20-S-0010EA, and/or AR09.41-S-6817EA.
- Confirm correct assembly and all connections:
- Ensure proper seating and locking of all quick-release couplings (see provided images and WIS refs).
- For dual-stage turbochargers, confirm the cast lug aligns with the tab. (See picture 1c.)
- Note: Always replace the red sealing ring (see annex "Dichtring_Sealant_nok") during assembly/repairs.

- Inspect the sealing ring between the exhaust gas turbocharger and the clean air line for damage with an endoscope (see annex "Dichtring_Sealant_nok").
- Repair/replace as needed.

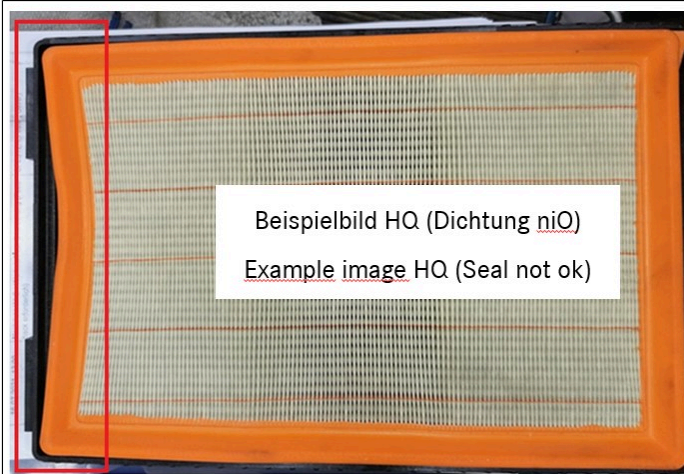
<p>Luffilter_air_filter.jpg</p>

- If engine timing is misadjusted.
- There is a defective hot film mass air flow sensor or a hot film mass air flow sensor that is affected by incorrect airflow (this can be due to a clogged or deformed air filter). Refer to the attached file "Luftfilter_air_filter."

- There is a defective hot film mass air flow sensor, or it is affected by incorrect airflow due to a clogged or deformed air filter (see "Luftfilter_air_filter").

- Visually inspect the air filter for blockages, severe soiling, deformation, or damage (see "Lufffilter_air_filter").
- The fault may be set if the hot film mass air flow sensor (MAF) element is oiled.
- Replace air filter/MAF as needed.

- Visually inspect the air filter for blockages, severe soiling, deformation, or damage (see "Luftfilter_air_filter").
- The fault may be set if the hot film mass air flow sensor (MAF) element is oiled.
- Replace air filter/MAF as needed.

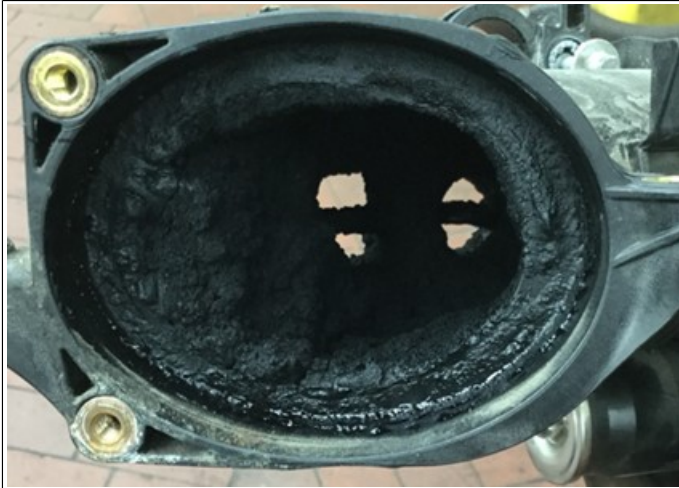
[Saugrohr_Intake_manifold_II.jpg](#)

- Note: Only relevant if correction value in load range 1 is less than -8%.
- If the intake manifold (charge air distribution line) or charge air cooler is carbonized (see "Saugrohr_intake_manifold.jpg").

- There is a leak downstream of the exhaust gas turbocharger.
- The charge air distribution line (intake manifold) is heavily carbonized (see "Saugrohr_intake_manifold.jpg").
- There is carbonization or incomplete closure of the high-pressure exhaust gas recirculation valve, especially in the housing intermediate flange at the EGR valve (linked to the exhaust back pressure sensor).

- Inspect the following for severe carbon build-up or other inconsistencies:
- Intake manifold (charge air distribution line) – see "Saugrohr_intake_manifold.jpg."
- Housing intermediate flange at the high-pressure EGR valve (exhaust back pressure sensor connection, use a flashlight).
- Only necessary if the air intake correction value in load range 1 is less than -8%.
- Charge air cooler.
- Initiate repairs/cleaning as needed.
- If issues are found in the intake manifold, also check the cylinder head intake ports.
