## HV battery is not charging to its full capacity with restricted maximum SoC

Topic number	LI47.70-N-079422
Version	1
Function group	47.70 - Powertrain energy supply
Date	6/12/25
Validity	Applies to models 907, 910, and 447 with engine 780
Reason for change

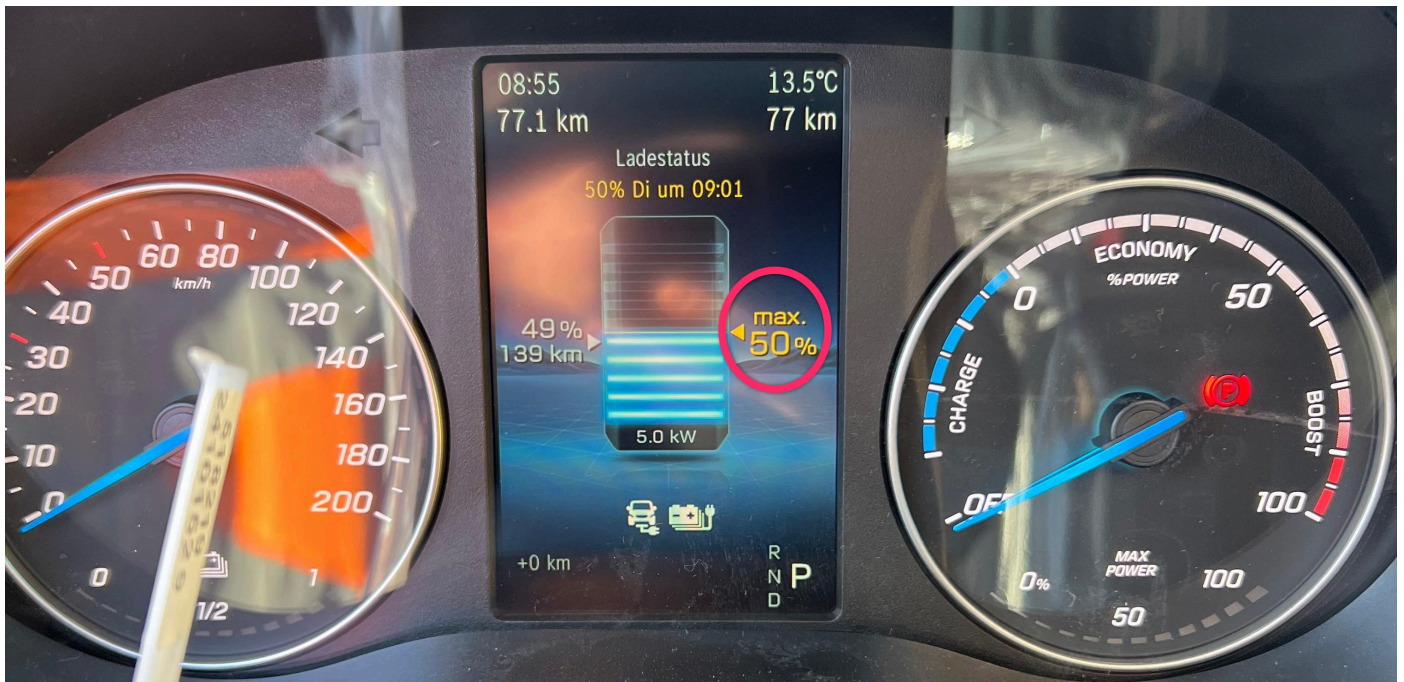
The vehicle's HV battery is not charging to its full capacity, with the maximum State of Charge (SoC) being restricted to a specific percentage (e.g., 50% as illustrated in the picture).

The State of Charge (SoC) percentage limitation might be influenced by the Onboard Logic Unit (OLU), MBUX Headunit, or the Powertrain Control Unit (PTCU).

If the Onboard Logic Unit (OLU) and MBUX Headunit do not impose a SoC percentage limitation, then proceed with the SCN coding of the Powertrain Control Unit (PTCU).

Note: During the SCN coding, the Energy Management System in the PTCU will be initialized, followed by a Soft Reset of PTCU.
