Field campaign

Topic	OBC Charging Efficiency MIL HW/SW Update (NAR Only) Bentayga (Hybrid) 24MY
Market area	United States E05 Bentley USA and rest America (6E05)
Brand	Bentley
Transaction No.	2077790/1
Campaign number	ED44
Note	
Type	
US code

Hybrid (PHEV) Bentayga 24 Model Year

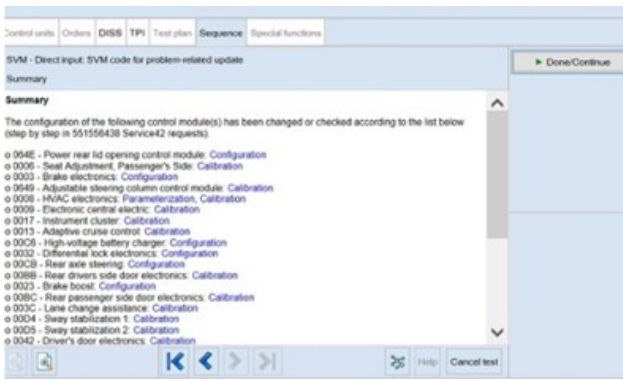
8. If the SVM code completes successfully, ODIS should display as per the image above.

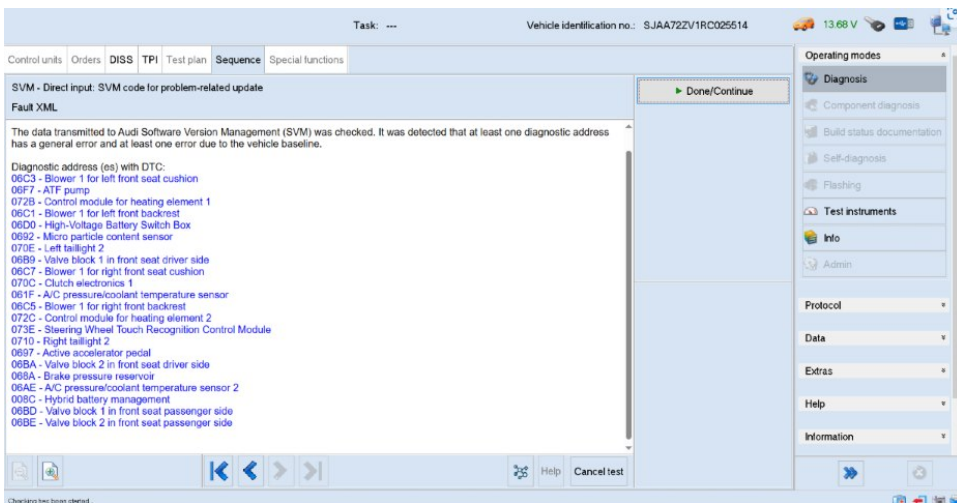
b. If you receive the error '8058' or the screen shown in the image above, please do the following:

c. Locate 00C6 in control unit list

d. Select -> Guided Functions -> Read Identification Data

e. If the software version of 00C6 is now at SW3322 then proceed to step 2.

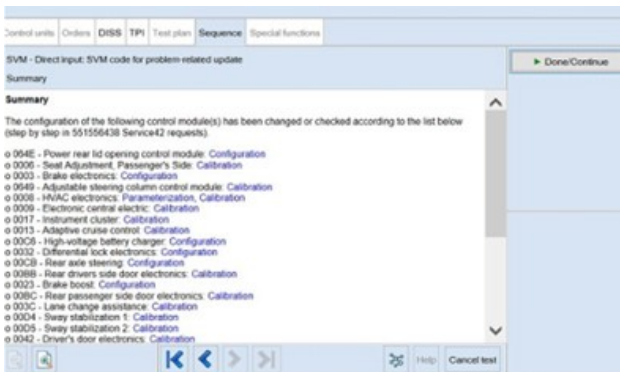
8. If the SVM code completes successfully, ODIS should display as per the image above.

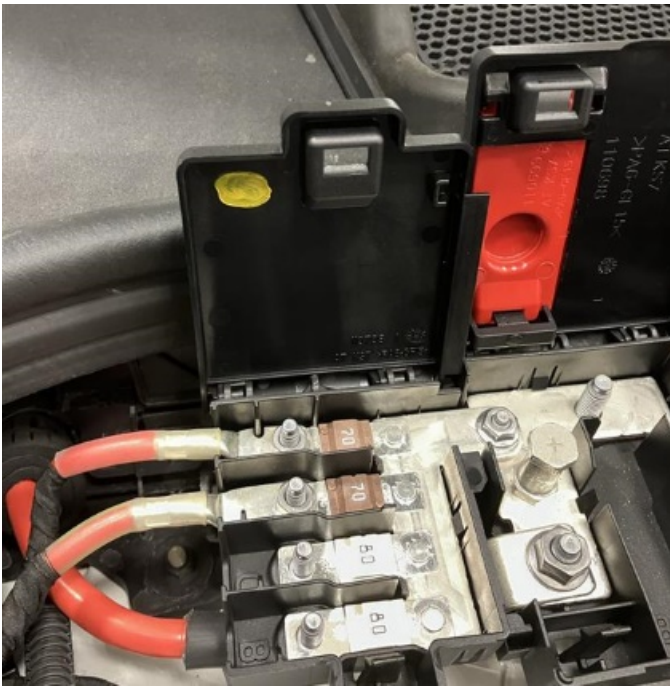
You must also add a paint mark as per the picture below.
