Field campaign

Topic	OBC Charging Efficiency MIL SW Update (NAR Only) Bentayga (Hybrid) 24MY
Market area	United States E05 Bentley USA and rest America (6E05)
Brand	Bentley
Transaction No.	2077846/1
Campaign number	ED45
Note	
Type	
US code

Hybrid (PHEV) Bentayga 24 Model Year

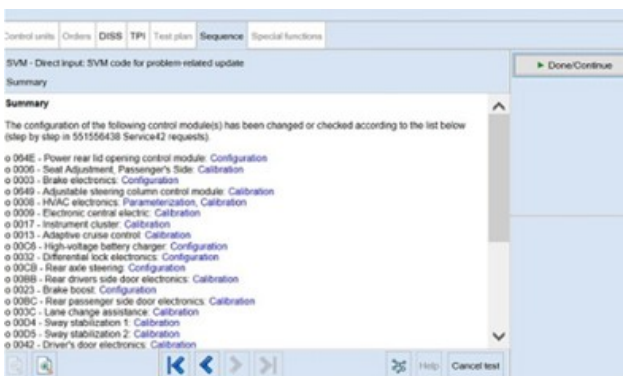
8. If the SVM code completes successfully, ODIS should display as per the image above.

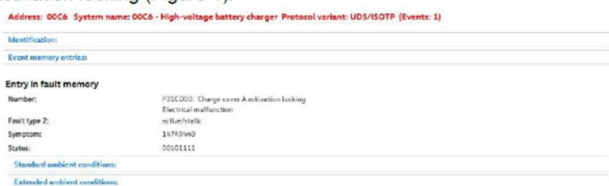
Figure 1

The diagnostic address for the on board charger, 00C6, is storing DTC P31CD00 – Charge cover A activation locking (Figure 1).

The symptom code shown is 14749440.

This DTC is a static fault that can be ignored if the charge flap is functioning normally and there are no warning lights displayed on the driver's instrument panel.

5. If the DTC shown above is present in 00C6, this can be ignored as per TPI 2076739/-

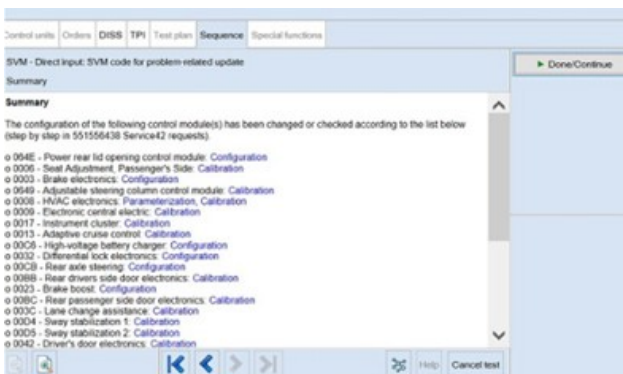
8. If the SVM code completes successfully, ODIS should display as per the image above.
9. After successful completion of the update, perform the following.
 - a. Turn off the ignition.
 - b. Remove all equipment from the car (Diagnostic tester/dongle, battery charger, keys).
 - c. Remove the VCI.
 - d. Close all doors, windows, bonnet and boot lid.

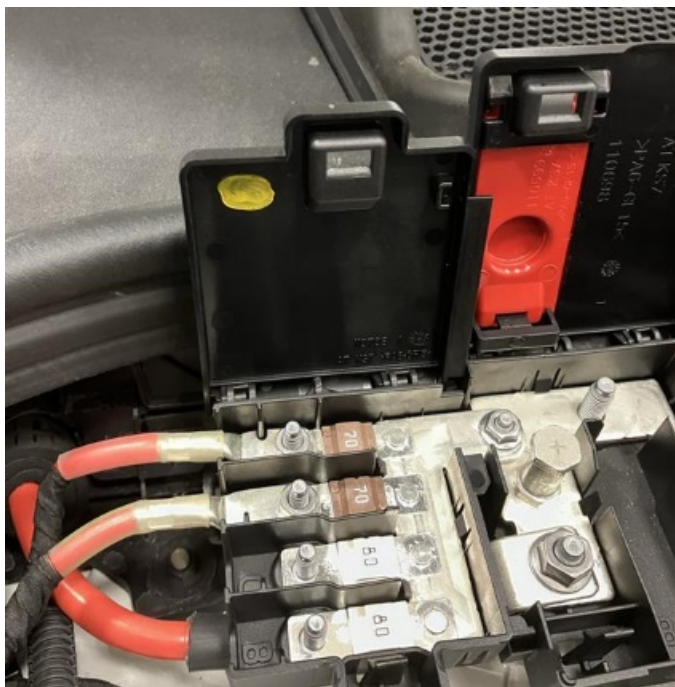
You must also add a paint mark as per the picture below.
