Field campaign

Topic	OBC Charging Efficiency MIL SW Update (NAR Only) Bentayga (Hybrid) 25MY
Market area	United States E05 Bentley USA and rest America (6E05)
Brand	Bentley
Transaction No.	2077847/1
Campaign number	ED46
Note	
Type	
US code

Hybrid (PHEV) Bentayga 25 Model Year

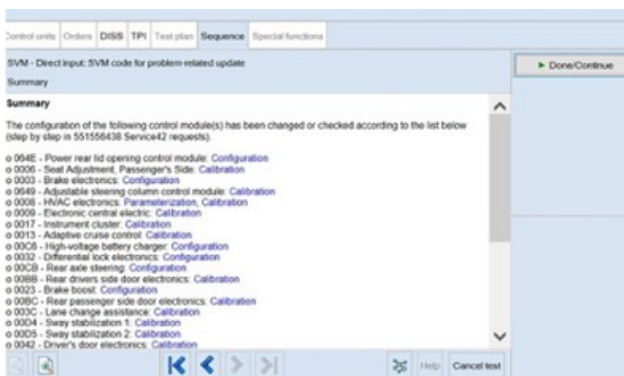
9. If the SVM code completes successfully, ODIS should display as per the image above.
