# Technical Service Bulletin

<b>Topic</b>	Engine Overheating - Coolant Pump Leaking and Low Coolant Warning   W12
<b>Market area</b>	Bentley: worldwide (2WBE)
<b>Brand</b>	Bentley
<b>Transaction No.</b>	2071239/3
<b>Level</b>	EH
<b>Status</b>	Released for publishing
<b>Release date</b>	Jun 5, 2025

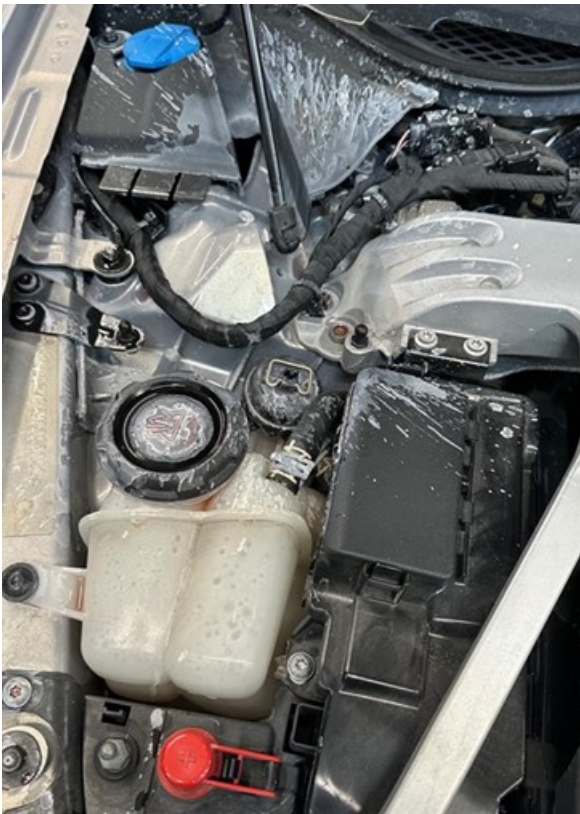
Figure 1

1) On receipt of the vehicle - Take a photograph of the coolant level within the coolant reservoir and inspect the engine bay for any coolant residue (figure 1).

If coolant residue is found in the engine bay, please raise a full technical DISS query and attach a photograph of the coolant residue and a photograph of the coolant level.

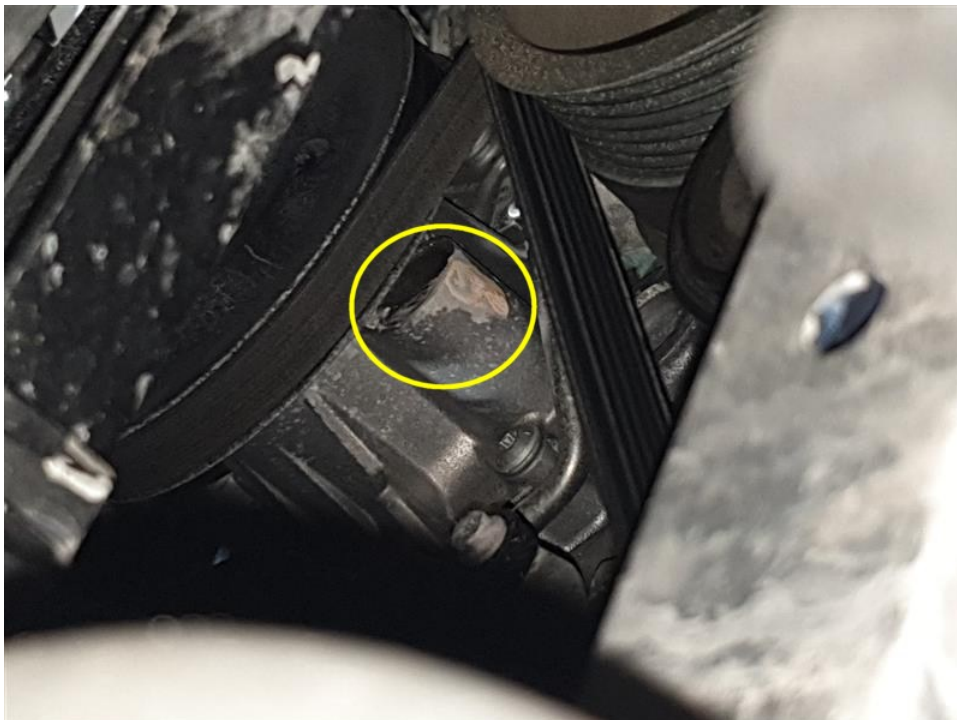
Figure 2

The video shows an example of a coolant pump with no leak, although a small coolant witness mark is evident (Figure 2). In this scenario the coolant witness mark should be cleaned off (using a suitable cleaning agent) to the condition shown in Figure 3

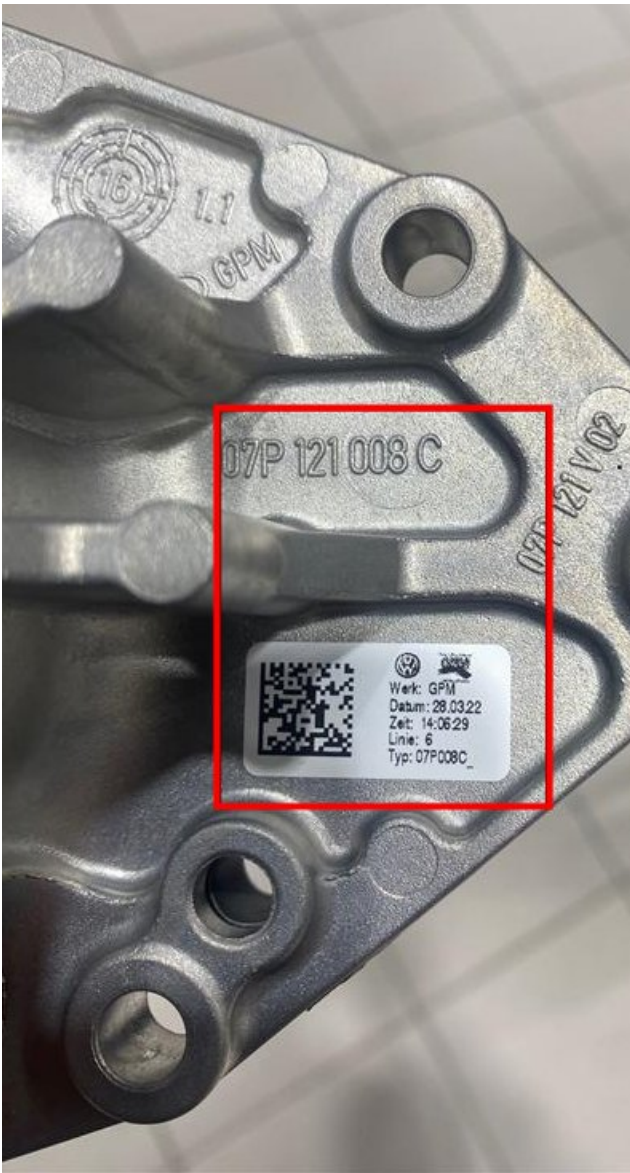
- Clear photo of the coolant level
- Clear photo of the original mechanical coolant pump part number **07P 121 008C** (Figure 5)
- Video of the coolant leak whilst carrying out the pressure test
- Current ODIS log
- Await feedback via DISS before replacing any parts

*NOTE: The photo shown in Figure 5 is a C level coolant pump (shown removed from the vehicle for photographic purposes) a borescope may have to be used for photographs of the coolant pump when fitted*

- Mechanical coolant pump - Rep.Gr 19
- Solenoid for coolant circuit N492 assembly - Rep.Gr 19
