Technical Service Bulletin

Topic	Engine Overheating - Warning in the DIP V8 Kovomo
Market area	Bentley: worldwide (2WBE),China 723 Volkswagen (Anhui) Automotive CO (6723),China 796 VW Import Comp. Ltd (Vico), Beijing (6796)
Brand	Bentley
Transaction No.	2061369/10
Level	EH
Status	Released for publishing
Release date	Jun 5, 2025

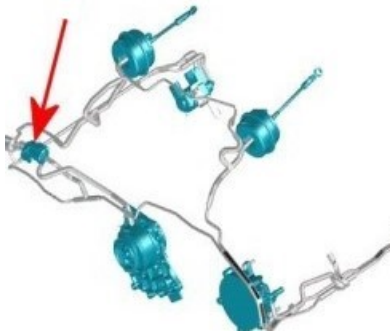
To allow the engine coolant to heat as quickly as possible (from cold start) coolant delivery from the mechanical coolant pump is interrupted by switch valve N649

Figure 1 - Bentayga

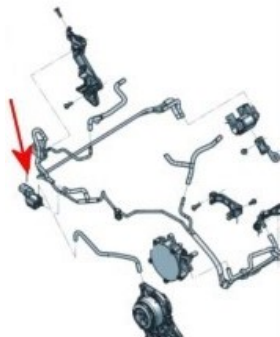
Figure 2 - New Continental GT/ GTC and Flying Spur

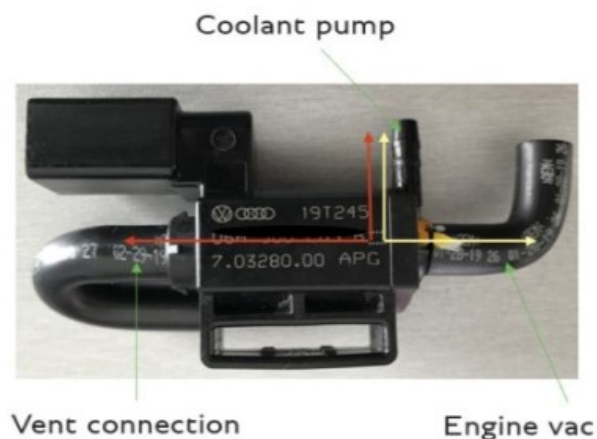
Figure 3

NOTICE
 The correct operation of N649 (Figure 3) is as follows

Un-energised state (Ignition off) - Coolant pump connected to vent connection (red arrows)

Energised state (Ignition on) - Engine vacuum connection to coolant pump (yellow arrows)

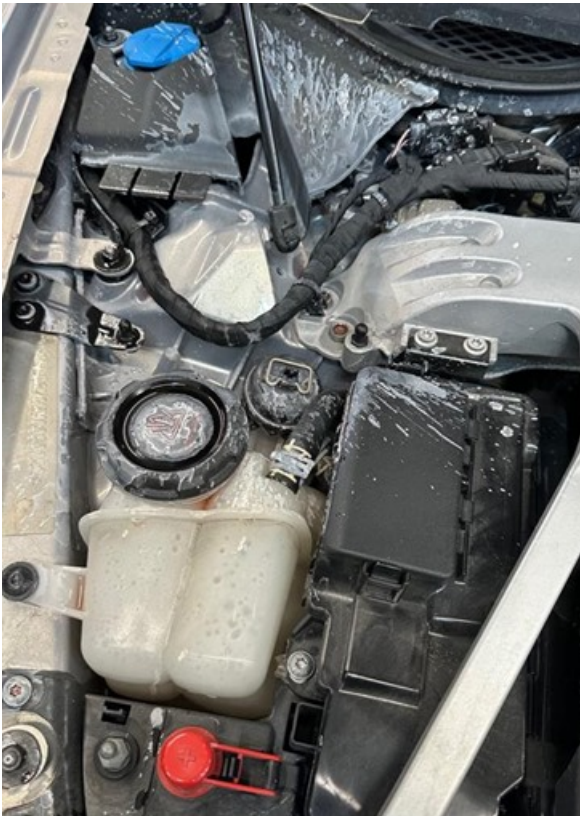
Figure 4

When inspecting the engine bay coolant residue can sometimes be seen around the reservoir when the engine has overheated (figure 4).

If this condition is found, the coolant may also be below the minimum level.

If coolant residue is found in the engine bay, please raise a full technical DISS query and attach a photograph of the coolant residue. If the coolant level is below the minimum level please also attach photographic evidence of this.
