REFERENCE:	TSB: 08-199-25 GROUP: 08 - Electrical	Date:	June 25, 2025	REVISION:	–
VEHICLES AFFECTED:	2025 (WS) Jeep Wagoneer/ Grand Wagoneer This bulletin applies to vehicles built on or after October 14, 2024 (MDH 1014XX) and on or before May 13, 2025 (MDH 0513XX) equipped with: <ul style="list-style-type: none"> • Uconnect 5 Nav w/10.1" Display (USA) (Sales Code UBN). • Uconnect 5 Nav w/10.1" Display (CAN) (Sales Code UEN). • Uconnect 5 Nav w 12.0" Display (USA) (Sales Code UBQ). • Uconnect 5 Nav w 12.0" Display (CAN) (Sales Code UEQ). • Uconnect 5 Nav w 10.1" Display (MEX) (Sales Code UFN). • Uconnect 5 Nav w 8.4" Display (MEX) (Sales Code UFL). 			MARKET APPLICABILITY: <input checked="" type="checkbox"/> NA <input type="checkbox"/> MEA <input type="checkbox"/> SA <input type="checkbox"/> IAP <input type="checkbox"/> EE <input type="checkbox"/> CH NOTE: This bulletin applies to the North America market

This bulletin involves inspecting the software level and updating the software to U35.18.

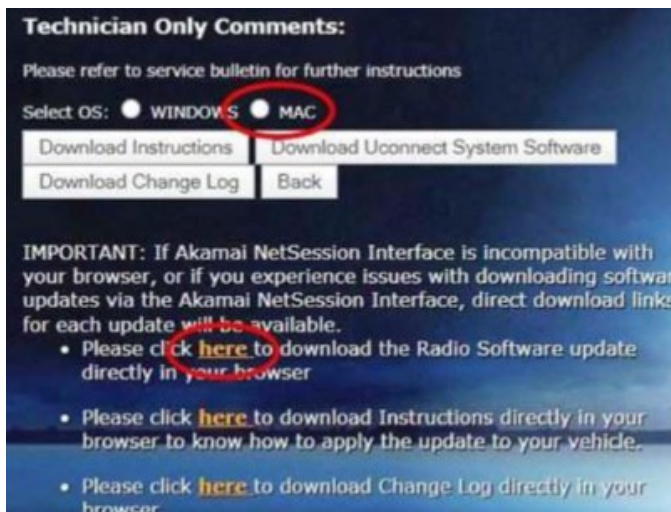
Fig. 1

MAC Download Steps

6. Download the software update file to your local PC's desktop. Make sure to select the "MAC" radial button for all downloads [Fig. 1](#).

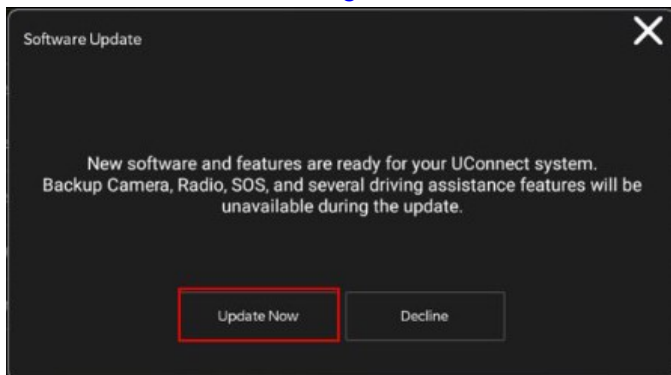
Fig. 2

Software Update Is Available

12. Once the system has verified there is an available update, press the "Update Now" button. Make sure the vehicle is in park. Do NOT turn the ignition off until the two minute timer has expired. The ignition doesn't have to be turned off to update the radio's software [Fig. 2](#).

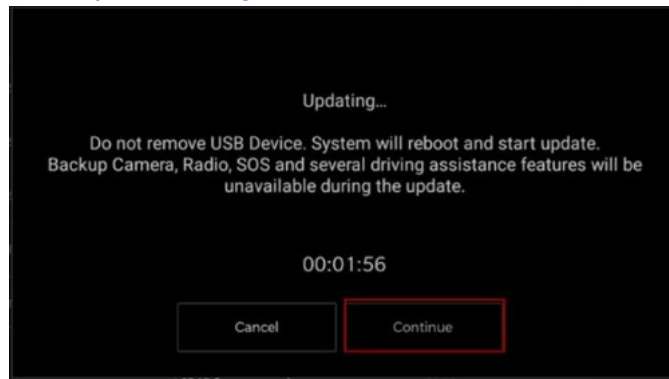
Fig. 3

Continue Display Screen

13. Press the “Continue” on the display screen [Fig. 3](#).

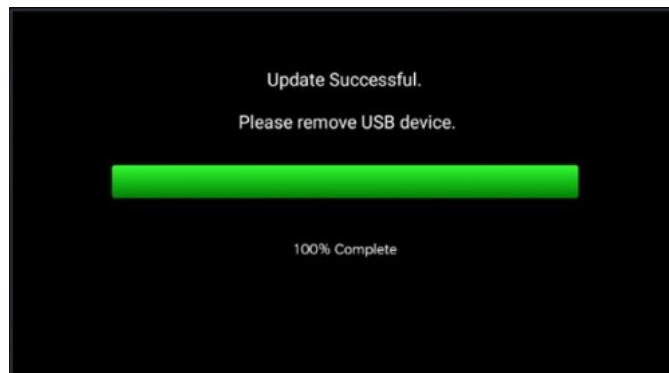
Fig. 4

Software Update Completed

14. The radio will reboot and the update will begin. The update should only take 30 minutes [Fig. 4](#).

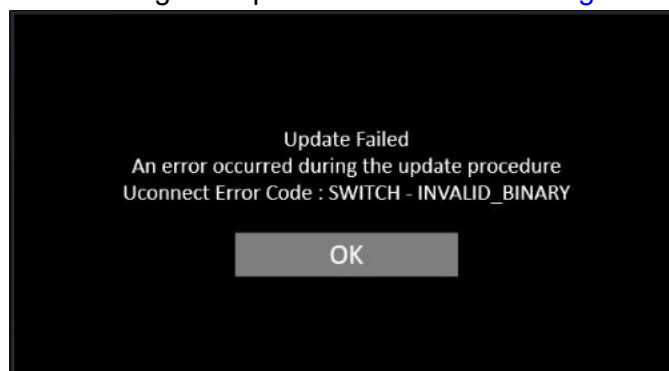
Fig. 5

Error Message

16. Sometimes the radio will display an error pop up “SWITCH- INVALID_BINARY “ after successful radio update. Please ignore this error message and press “OK” to continue [Fig. 5](#).

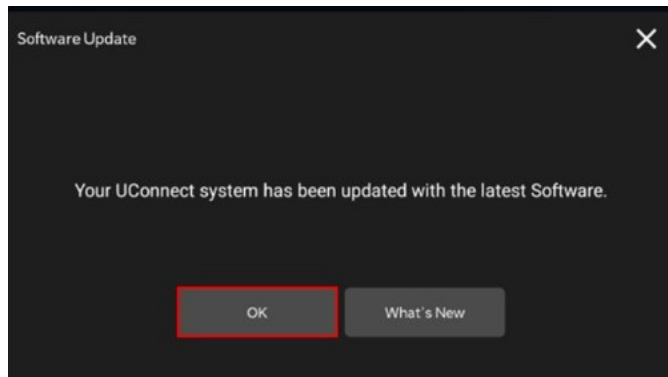
Fig. 6

Radio Software Has Been Updated

17. Press “OK” to continue [Fig. 6](#).
