Technical Service Bulletin

Topic	Exhaust Flap Control Unit - Various DTCs Bentayga Series 17-25MY
Market area	Bentley: worldwide (2WBE), China 796 VW Import Comp. Ltd (Vico), Beijing (6796)
Brand	Bentley
Transaction No.	2077982/1
Level	EH
Status	Released for publishing
Release date	Jun 5, 2025

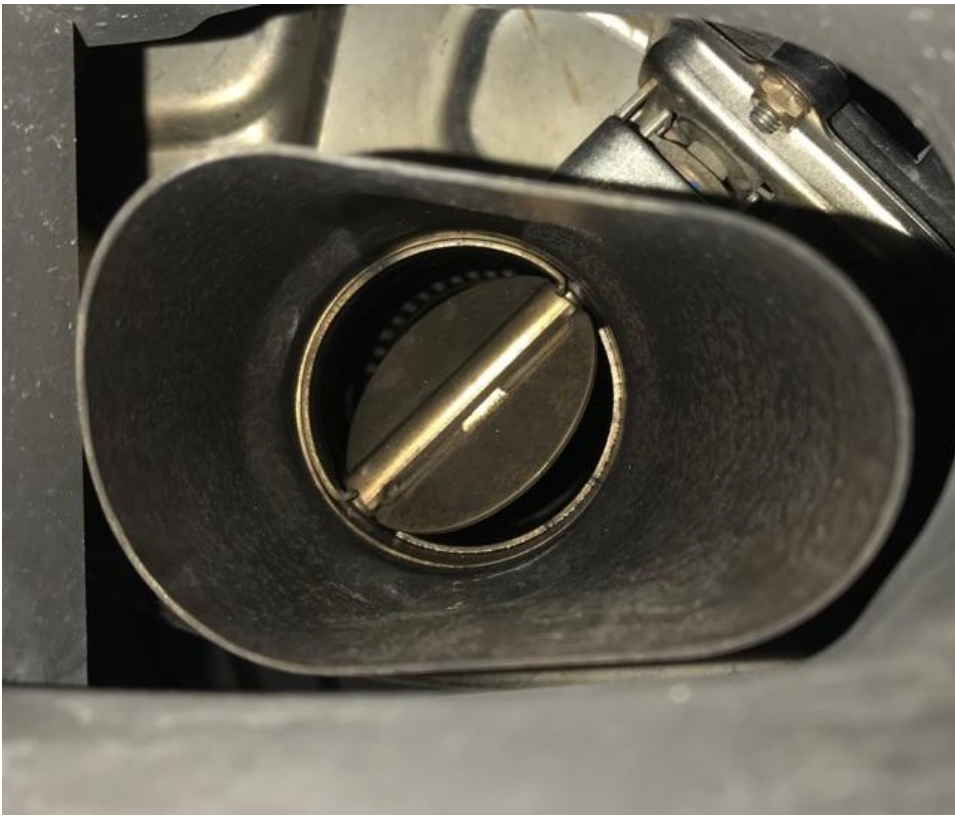
The root cause of Exhaust Flap Control Unit malfunction is electrical 'shorting' of the commutator segments, this is caused by an accumulation of "Sludge" within the exhaust flap control unit

DTC's are stored when the respective Control Unit does not move through its full range of motion

If an Exhaust Flap is stuck in an open, closed, partially closed position or does not achieve a full range of motion continue to follow the instructions within this Technical Product Information (TPI) document - Figure 2

Remove the suspected Exhaust Flap Control Unit – Refer to **Repair Group. 26 Exhaust system – Exhaust flap control unit – To remove and fit**

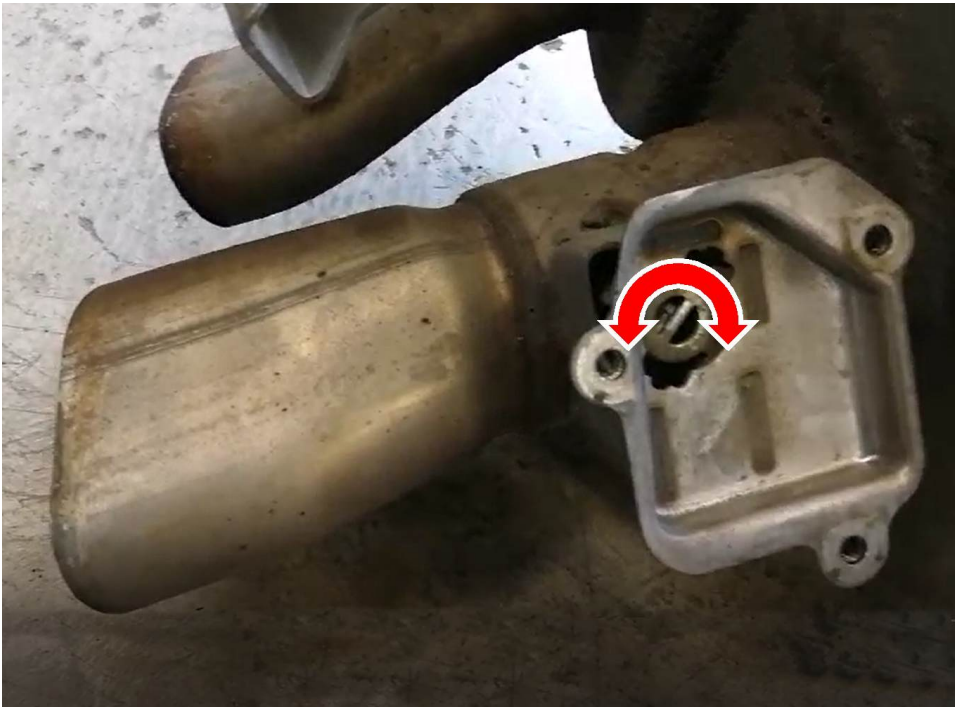
Check and confirm the Exhaust Flap spindle is free to open and close by hand - Figure 3

If no issue is evident and the Exhaust Flap oscillates freely by hand - replace the defective Exhaust Flap Control Unit, refer to **Repair Group. 26 Exhaust system - Exhaust flap control unit - To remove and fit**

If the Exhaust Flap does not oscillate freely by hand – replace the exhaust system. Refer to **Repair Group. 26 Exhaust system – Rear silencer and pipes – To remove and fit**
