Technical Service Bulletin

Topic	Headlamp Control Unit Replacement Bentayga and Flying Spur 20,21,22,24MY
Market area	Australia E04 Bentley rest Asia and Australia (6E04),China 723 Volkswagen (Anhui) Automotive CO (6723),China 796 VW Import Comp. Ltd (Vico), Beijing (6796),Germany E02 Bentley rest Europe (6E02),Japan E03 Bentley Japan (6E03),Korea, (South) E08 Bentley South Korea (6E08),United Arab Emirates E06 Bentley Middle East and Africa (6E06),United Kingdom E01 Bentley UK (6E01),United States E05 Bentley USA and rest America (6E05)
Brand	Bentley
Transaction No.	2071933/2
Level	EH
Status	Released for publishing
Release date	Jun 5, 2025

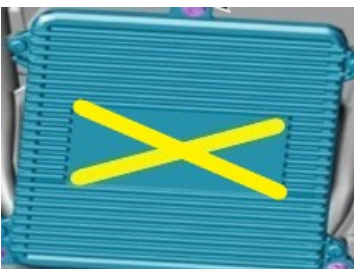
Figure 1

NOTICE
 The headlamp control unit can only be replaced a **MAXIMUM** of **TWO** times (per headlamp) If there are two yellow paint marks on the control units (Figure 1) or the vehicles repair history shows the control units have been replaced **TWICE**, a new headlamp assembly is required
