To: After Sales Official Network
Subject: Front bonnet latch replacement
Date: 06/06/2025
Pages: 3

L74X-A.16.25

Front bonnet latch replacement

Revuelto

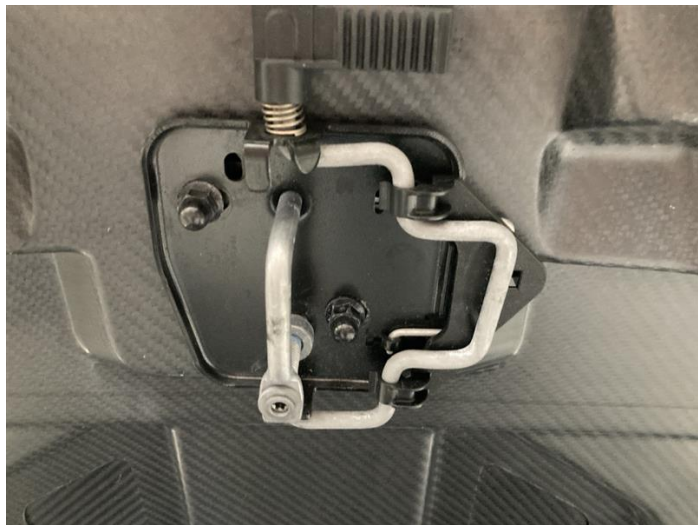
Before replacing the latch, mark the position of the old component to not lost the alignment

Follow the instructions given in the Workshop Manual at the following path:

1. *Body and chassis > Exterior > Front lid, Lock and Opener > Luggage compartment lid lock hook - Replacement procedure*
