REAR DRIVELINE 'CLUNK' TYPE NOISE

SSM 76324

Range Rover

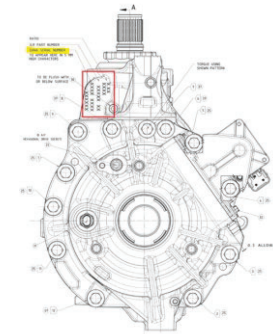
- Do not renew any components for this concern.
- Take a photo of rear drive unit serial number. (top picture)
- Take a photo of the rear driveshaft production date. (middle picture)
- Remove the rear driveshaft from the rear drive unit following the TOPIx Workshop Manual.
- Clean away any grease from both the rear drive unit pinion splines, and driveshaft rear joint internal splines.
- Apply Loctite™ 658 retaining compound, to the first 15mm section of each RDU spline in the area pictured. (Loctite™ Application , bottom picture)
- Reassemble the rear driveshaft onto the rear drive unit, following TOPIx Workshop Manual.
- Allow the Loctite™ 658 to cure for 6 hours before driving the vehicle.
- Please raise an Electronic Product Quality Report (EPQR) with reference to this SSM and include the pictures taken.
