# Technical Service Bulletin

<b>Topic</b>	Headlamp Control Unit Replacement   Bentayga and Flying Spur   20,21,22,24MY
<b>Market area</b>	Australia E04 Bentley rest Asia and Australia (6E04),China 723 Volkswagen (Anhui) Automotive CO (6723),China 796 VW Import Comp. Ltd (Vico), Beijing (6796),Germany E02 Bentley rest Europe (6E02),Japan E03 Bentley Japan (6E03),Korea, (South) E08 Bentley South Korea (6E08),United Arab Emirates E06 Bentley Middle East and Africa (6E06),United Kingdom E01 Bentley UK (6E01),United States E05 Bentley USA and rest America (6E05)
<b>Brand</b>	Bentley
<b>Transaction No.</b>	2071933/3
<b>Level</b>	EH
<b>Status</b>	Released for publishing
<b>Release date</b>	Jun 13, 2025

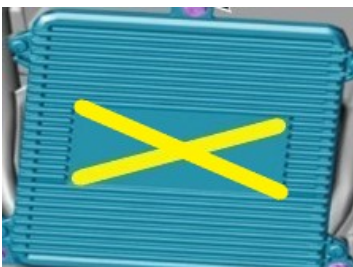
Figure 1

The headlamp control unit can only be replaced a **MAXIMUM** of **TWO** times (per headlamp) If there are two yellow paint marks on the control units (Figure 1) or the vehicles repair history shows the control units have been replaced **TWICE**, a new headlamp assembly is required
