Service Bulletin

Bulletin No.: 24-NA-029

Subject: HUMMER EV Water Leak Diagnostic Tips

Brand:	Model:	Model Year:		VIN:		Engine:	Transmission:
		from	to	from	to		
GMC	HUMMER EV Pickup	2022	2025	-	-	All	All
	HUMMER EV SUV	2024	2025

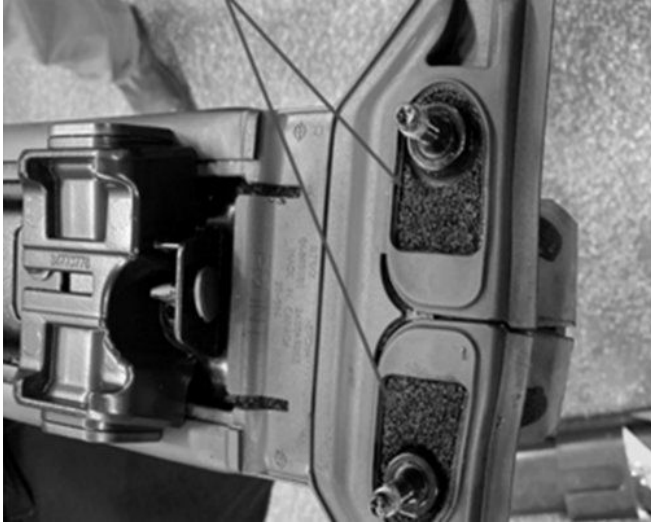
6541873

This design is from 2022 ONLY. If the open cell foam is discovered, check the vehicle for open field action and replace the I-Bar per Service Update Bulletin N222378440.

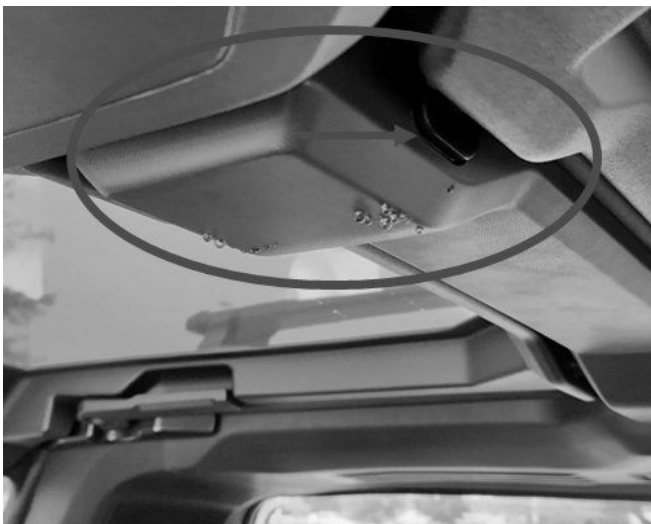
6542034

Condition	Water pours out of the lower I Bar trim cover as it collects in the sump created by the contour of the trim, especially when turning a corner.
------------------	--

Easiest way to diagnose this complaint is to remove the lower trim panel, water test, and watch for the leak.

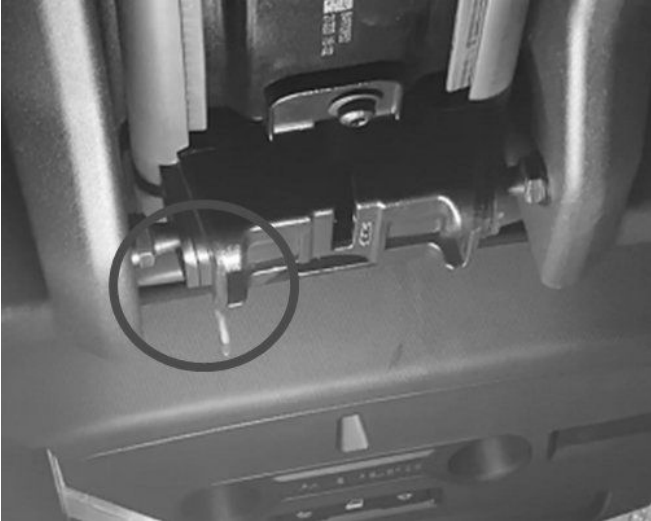
6542118

With trim panel removed, if water is leaking through the I-Bar as shown, replace the I bar.

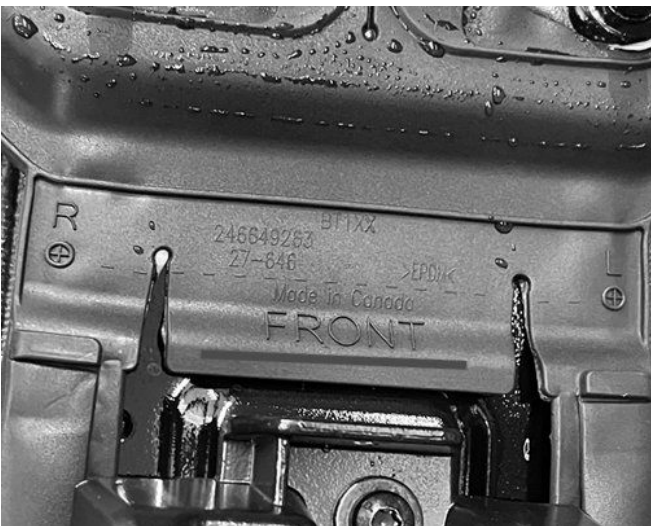
6542125

The front I Bar is designed to be removed by the customer. If the front I bar is installed backward it will leak. When removing the I Bar, inspect the orientation of the I Bar to ensure the “front” is in fact pointing towards the front of the vehicle. Inform the customer on proper installation if this condition is found.

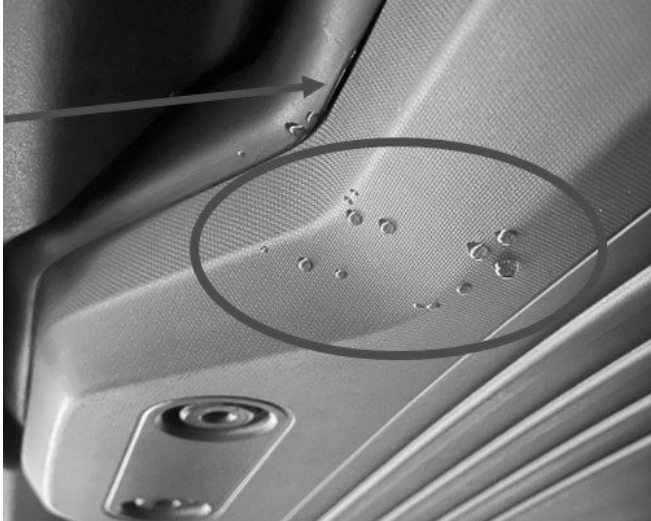
6542146

Water leaking near the front or rear of the I Bar in this zone is usually not caused by the I Bar. Water droplets coming past the weather strip and roof headliner panel are due to excessive water building up in the drain system. If any sky panel is out of alignment, excessive water can get past the sealing surfaces and allow too much water to enter into the drain system, thus allowing water to exist in unwanted locations. Inspect the sky panels for proper alignment and adjust as necessary. Refer to SI DOC ID 6339878 (pickup) or 6341146 (SUV).

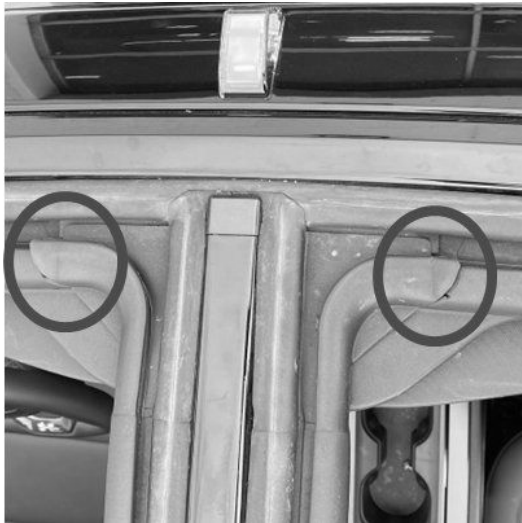
6542173

Another possible cause of water droplets in this area can be caused by creased I Bar weather strips.

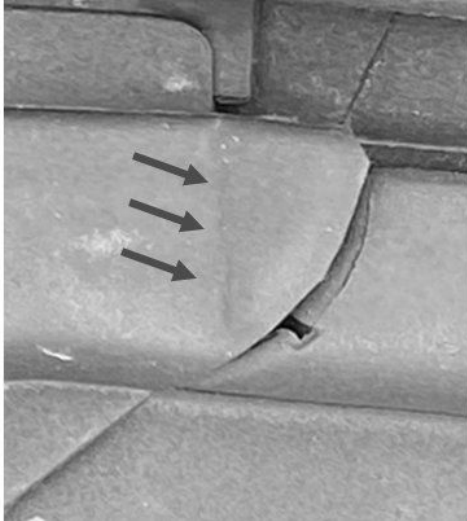
6542199

<p>Cause</p>	<p>Folded over weather strips on the I-Bar due to improper sky panel installation. Pay close attention to these areas when first removing the sky panel. If the outboard weather strip ends are folded over this will cause the sky panel to raise up preventing a good seal. If the crease is permanently set as shown below, this will also prevent the weather strip laying flat even with the sky panel installed pushing the sky panel upwards causing a gap and leak.</p>
<p>Correction</p>	<p>Replace the I-Bar – educate customer on proper sky panel installation.</p>

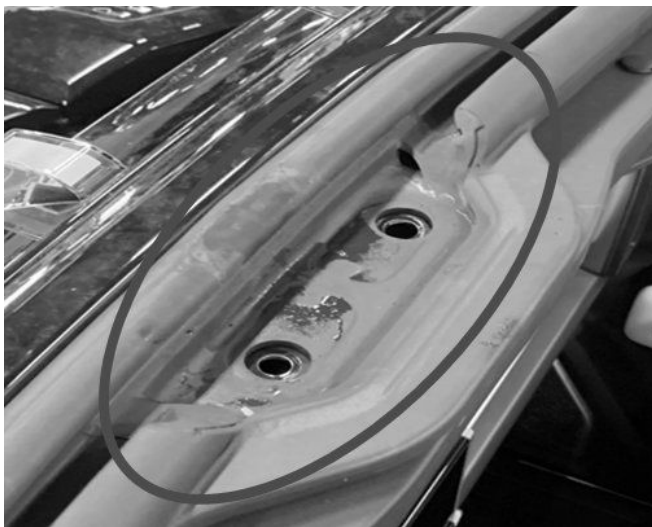
6543780

The recessed areas where the I Bar mounts to the roof are part of the water management system and designed to be wet.

It is normal to have presence of water as shown.

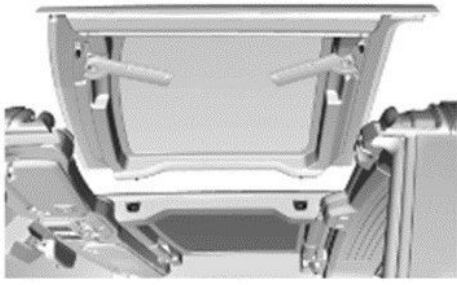
6542230

Correct Assembly

Incorrect Assembly

Carefully place the roof panel into its designated location. Position the inboard edge of the roof panel next to the weatherstrip on the I-Bar, then align and fit the horizontal pins into the receivers on the I-Bar.

When aligning the pins and receivers, make sure the inboard edge of the roof panel does not come in contact with the roof seals. Ensure that the inboard edge is far enough in that it clears the I-Bar weatherstrip. Ensure that the I-Bar weatherstrip is lying flush with the adjacent roof seals before fully engaging the pins into the receivers. Failure to do so may damage the weatherstrip or lead to an improper seal.

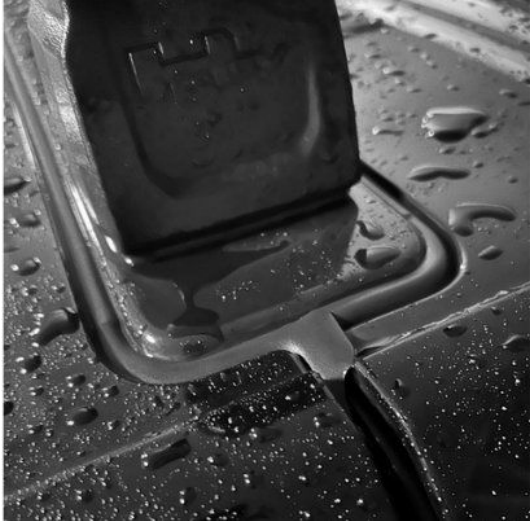
6908309

Condition	Leaks near the top of any of the side windows, weather strips, or sky panel weather strip.
Cause	If any sky panel is out of alignment such as being shifted too far forward or rearward, or too high, this will causing excessive water to enter into the water management system in the weather strips. This causes water to back up over the sealing surfaces creating a leak inside the cabin near the corners of weather strips near the weather strip drain holes.
Correction	Perform top down, side to side, visual inspection of all 4 sky panels installed, with the I-bar installed. If any sky panel appears to be not square in the opening or sitting high – verify the dimensions and adjust as necessary following SI DOC ID 6339878 (pickup) or 6341146 (SUV)

Example of a sky panel weatherstripping flap up that would allow water to intrude. This is something that can be overlooked if the top is removed and the customer or dealer doesn't pay attention when reinstalling the removable top.

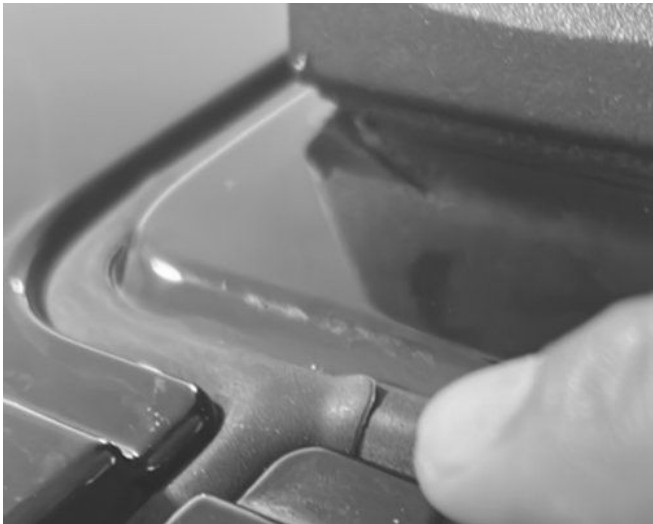
6908313

Example of the correct way the roof flap should be tucked in to prevent water intrusion.

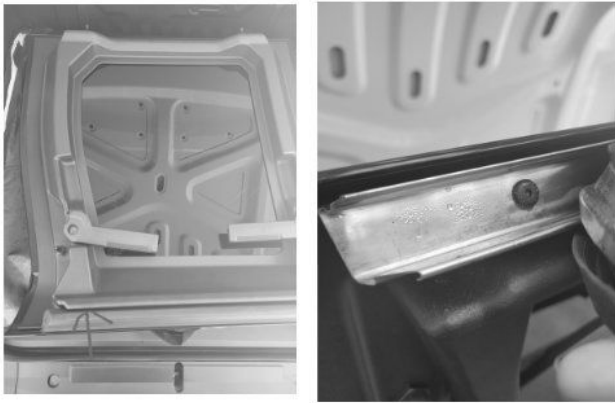
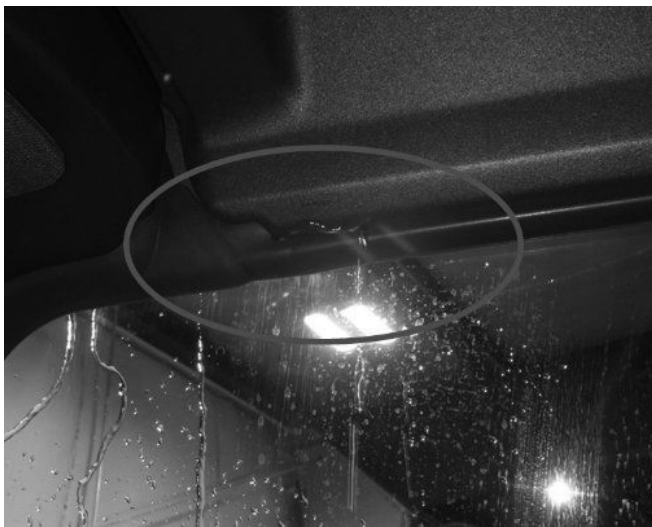
6542346

Condition	Water dripping into the cabin from between the sky panel and its seal (front corner of the LR panel pictured), especially when stopping.
Cause/Correction	This was due to the left rear sky panel being too far rearward allowing poor seal along the front edge of the left rear sky panel to weather strip. Essentially overwhelming the water drain management system. To adjust the sky panel, refer to SI DOC ID 6339878 (pickup) or 6341146 (SUV).

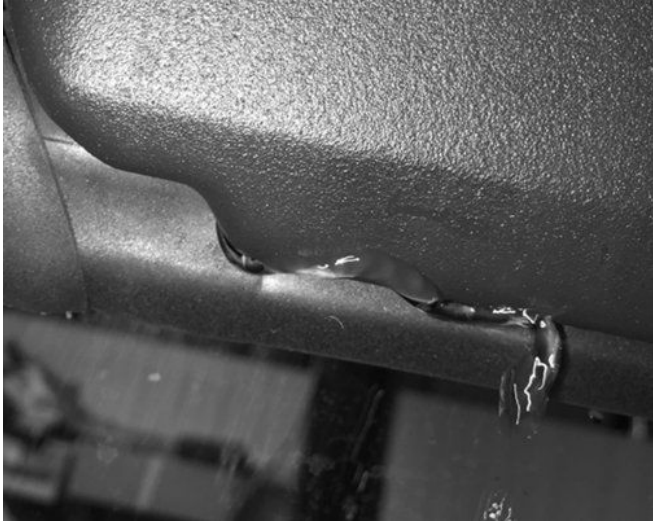
6542378

Condition	Water drains into the cabin from between the sky panel and its seal (front corner of the RF panel pictured).
Cause/Correction	Adjusting the sky panel strikers down resolved the leak. To adjust the sky panel strikers, refer to SI DOC ID 6339878 (pickup) or 6341146 (SUV).

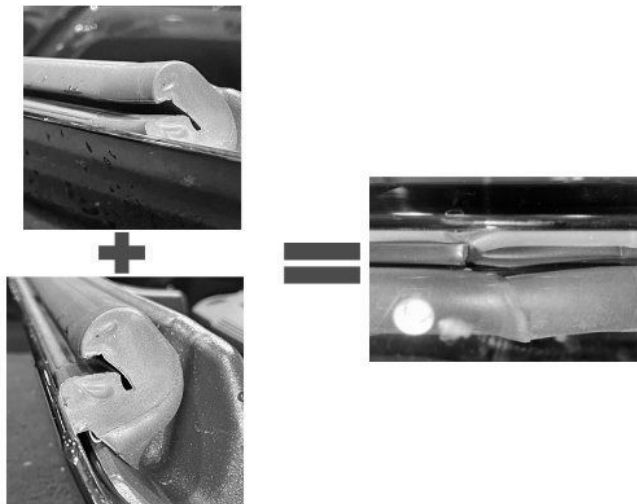
6542379

Condition	Water leaking past the top of the window, and onto the door trim panel.
Cause	Sky panel weather strip was not properly seated to the metal u-channel. The weather strip will have an uneven appearance on the end. Further inspection should reveal the weather strip is not properly seated onto and under the metal u-channel. Water will leak at the overlap joint between the sky panel weather strip and roof bow weather strip.
Correction	Inspect the sky panel weather strip to ensure it's properly seated onto the metal u-channel retainer. If necessary, pull the weather strip up and away, then gently re-seat the weather strip over the u-channel. Verify the weather strip lays flat on the ends.

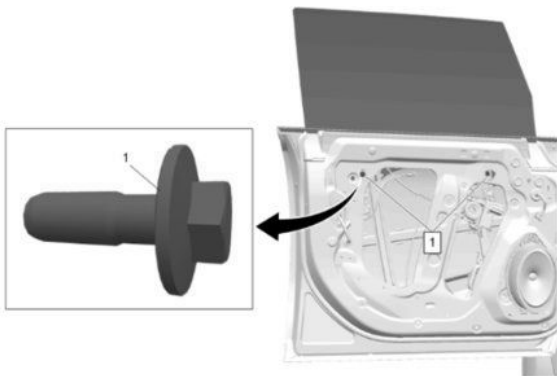
6542380

Condition	Water leaks between the side windows and weather strips.
Cause	Side glass is out of position, including being too low or tilted at an angle, the glass will not seal properly to the door opening weather strips or the top weather strip on the sky panel.
Correction	<p>Inspect the side door glass ensuring it's square in the body opening and covering the weather strip evenly on both sides. Compare the height and orientation from side to side. Adjustments are made by loosening the window regulator to door glass clamps. Refer to applicable SI procedure for regulator replacement for proper steps to access these attachment points.</p> <p>Note: Side Glass out of adjustment can also cause wind noise.</p>

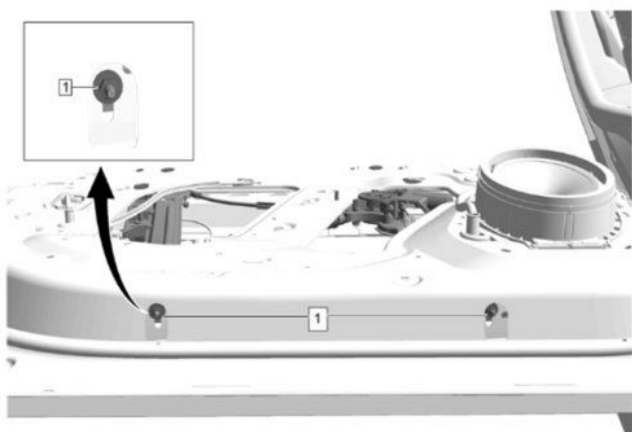
6542381

Condition	Water leaks between the side windows and weather strips.
Cause	Side glass out of position, including being tilted outboards causing a lack of pressure between the side glass and the weather strip.
Correction	Inspect the side door glass ensuring that it's compressing onto the door opening weather strips. Tilting the glass inwards will help push the glass onto the door opening weather strips making a tighter seal. Adjustments are made by loosening the window regulator to door bottom mounting bolt and tilting the entire window and regulator asm as needed. Refer to applicable SI procedure for regulator replacement for proper steps to access these attachment points.

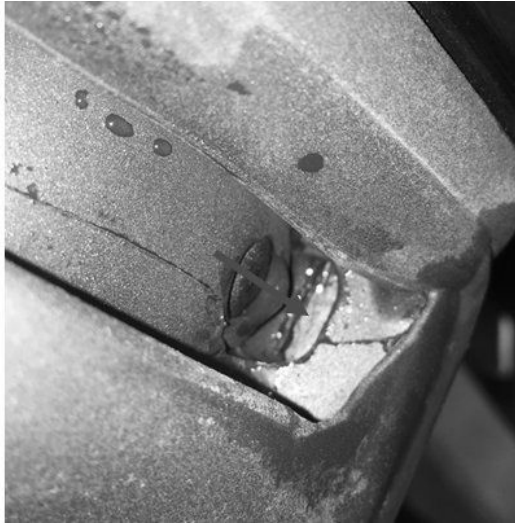
6542383

Condition	Water leaks between the side windows and weather strips
Cause	Plugged drain(s)
Correction	Inspect the drain hole closest to the location where the leak is occurring. Look for any rubber flashing that might be partially covering the drain hole(s). Remove debris or rubber flashing as required. Tip: With the top removed, close the door, fully raise the window check the drain hole to ensure it's not being pinched closed when the side window is all the way up.

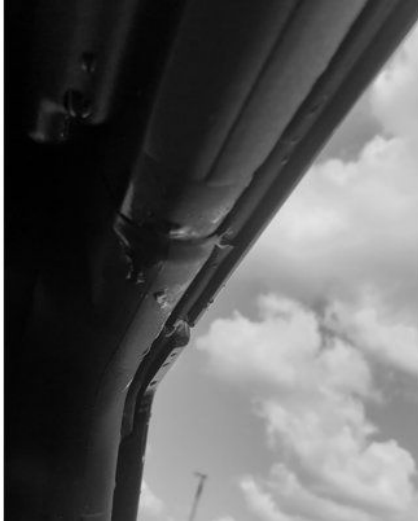
6542384

Condition	Water leaks between the side windows and weather strips
Cause	Plugged drain(s)
Correction	<p>Inspect the drain hole closest to the location where the leak is occurring. Look for any debris or rubber flashing that might be partially covering the drain hole(s). Remove flashing if required.</p> <p>Tip: With the top removed, close the door, fully raise the window check the drain hole to ensure it's not being pinched closed when the side window is all the way up.</p>
