Service Bulletin

Bulletin No.: 24-NA-138

Subject: Forward Collision Alert Unavailable DIC Message with U3000 SYM44 in Front Camera Module

Brand:	Model:	Model Year:		VIN:		Engine:	Transmission:
		from	to	from	to		
Chevrolet	Colorado	2024	2024				
	Corvette	2024	2024				
GMC	Canyon	2024	2024

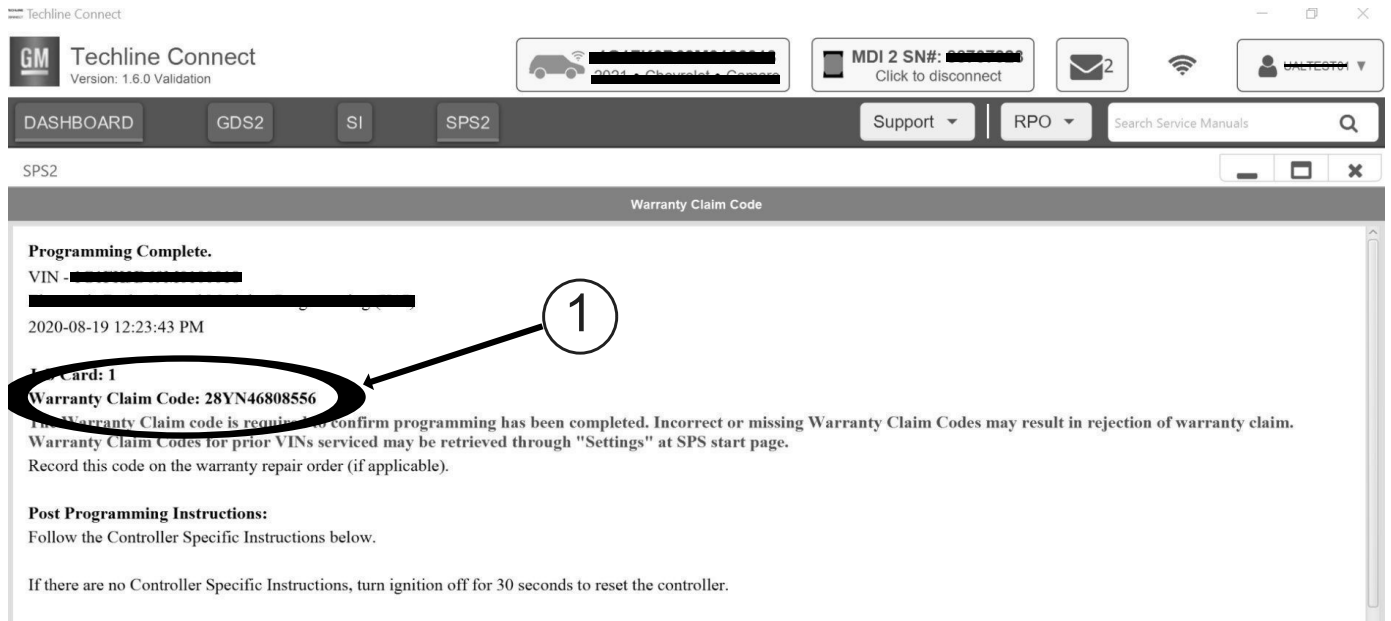
5644478

Note: The screenshot above is an example of module programming and may not be indicative of the specific module that is being programmed. Module selection and VIN information have been blacked out.

Important: To avoid warranty transaction rejections, you **MUST** record the warranty claim code provided on the Warranty Claim Code (WCC) screen shown above on the job card. Refer to callout 1 above for the location of the WCC on the screen.

2. Record the SPS Warranty Claim Code on the job card for warranty transaction submission.
