## 167 Air Conditioning System Leak

| Topic number | LI83.30-P-077763 |
| Function group | 83.30 - Air conditioning |
| Date | 7/3/25 |

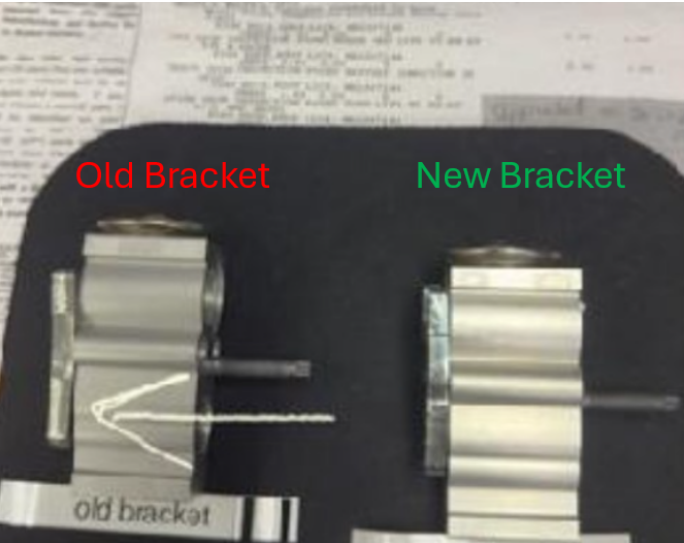
| Attachments | |
|---|---|
| <a href="#">Bracket Comparison Image.png</a> | Bracket Comparison Image required for warranty |

3. Attach pictures of new and old bracket so it can be seen if leaking to your warranty submission. (see attachment "Bracket Comparison Image required for warranty")
