THIS IS A TECH TIP, NOT A TECHNICAL BULLETIN.

Applicable Vehicles					
Model(s)	Year	Eng. Code	Trans. Code	VIN Range From	VIN Range To
Taos	2022 - 2024	1.5T (DNKA)	All	All	All
Taos	2025	1.5T (DYBA)	All	All	All
Jetta	2022 - 2025	1.5T (DNKA)	All	All	All

Revision Table			
Instance Number	Published Date	Version Number	Reason For Update
2078031/1	06/12/2025	13-25-01TT	Original Publication

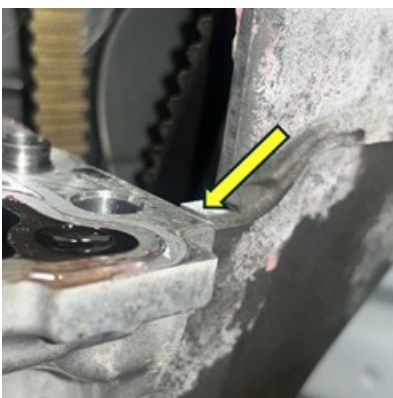
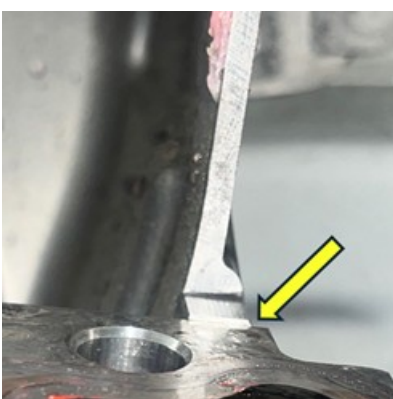
While removing the cylinder head, the technician may notice a difference in height between the engine support bracket and the engine block. (See examples below.)

No repairs or adjustments are necessary. The engine mount is installed after the cylinder head and engine block are assembled at the engine factory. This does not impede the clamping area between the cylinder head and engine block as the difference in height is made up in the thickness of the head gasket.
