Customer statement / workshop findings

Applicable Vehicles					
Model(s)	Year	Eng. Code	Trans. Code	VIN Range From	VIN Range To
Taos	2022 - 2024	1.5T (DNKA)	All	All	All
Jetta	2022 - 2024	1.5T (DNKA)	All	All	All

Revision Table			
Instance Number	Published Date	Version Number	Reason For Update
2078029/1	06/12/25	01-25-xx	Original publication.

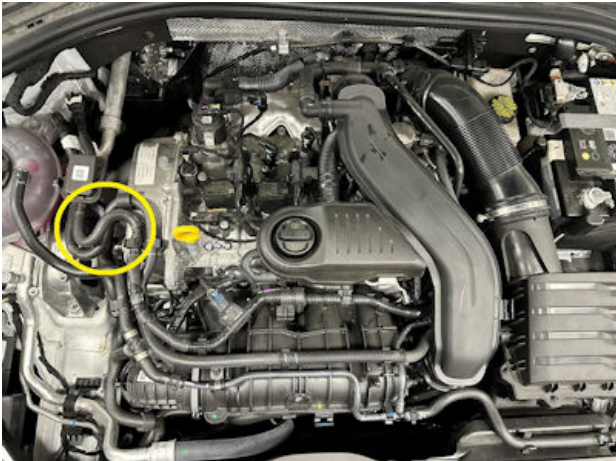
Figure 1:

Focus special attention to the area circled in Figure 1.

STEP 4: Inspect, and if necessary, replace purge line with -N80-

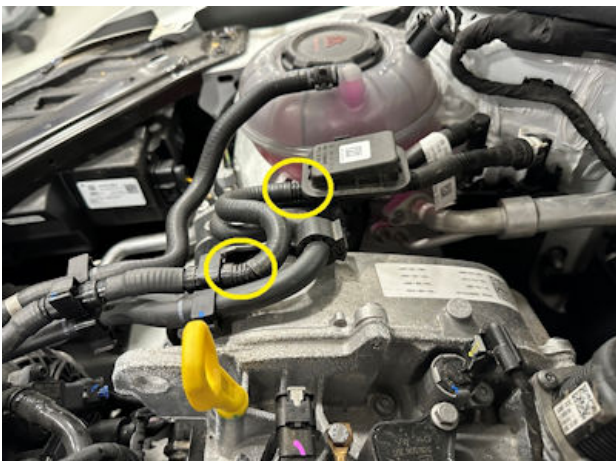
Figure 2:

Figure 2 highlights two sections of the purge line from figure 1 that are prone to cracking.

If a leak is found from the corrugated purge line (shown above) remove and replace the component.
