## Technical Service Bulletin

<b>Topic</b>	91 Charging target cannot be adjusted in MMI
<b>Market area</b>	United States 444 Volkswagen of America, Inc. (6444)
<b>Brand</b>	Audi
<b>Transaction No.</b>	2077780/2
<b>Level</b>	EH
<b>Status</b>	Released for publishing
<b>Release date</b>	Jun 2, 2025

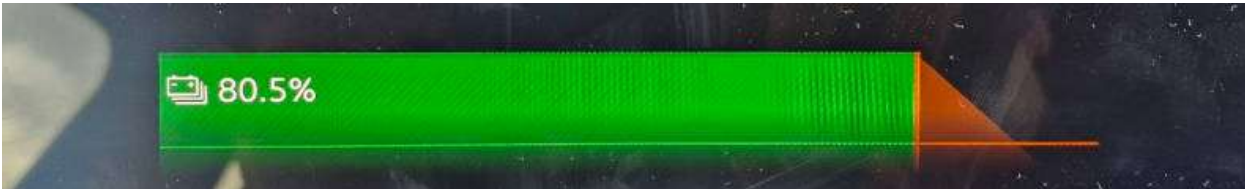
- The customer complains that the charging target setting cannot be adjusted (Figure 1).

**Figure 1.** Charge target setting in the MMI.

- The customer complaint can be reproduced; the charging target is set at 84% and cannot be adjusted.
- The adjustment options with a plus symbol / minus symbol / red dot are not displayed.

1. Perform the following steps:
2. Run SVM code **19A028**. (Ensure this step completes **BEFORE** proceeding)
3. Switch the ignition off and on again.
4. Run SVM code **19B028**.
5. Wait for the vehicle to enter bus sleep mode.
6. Reassess the complaint.

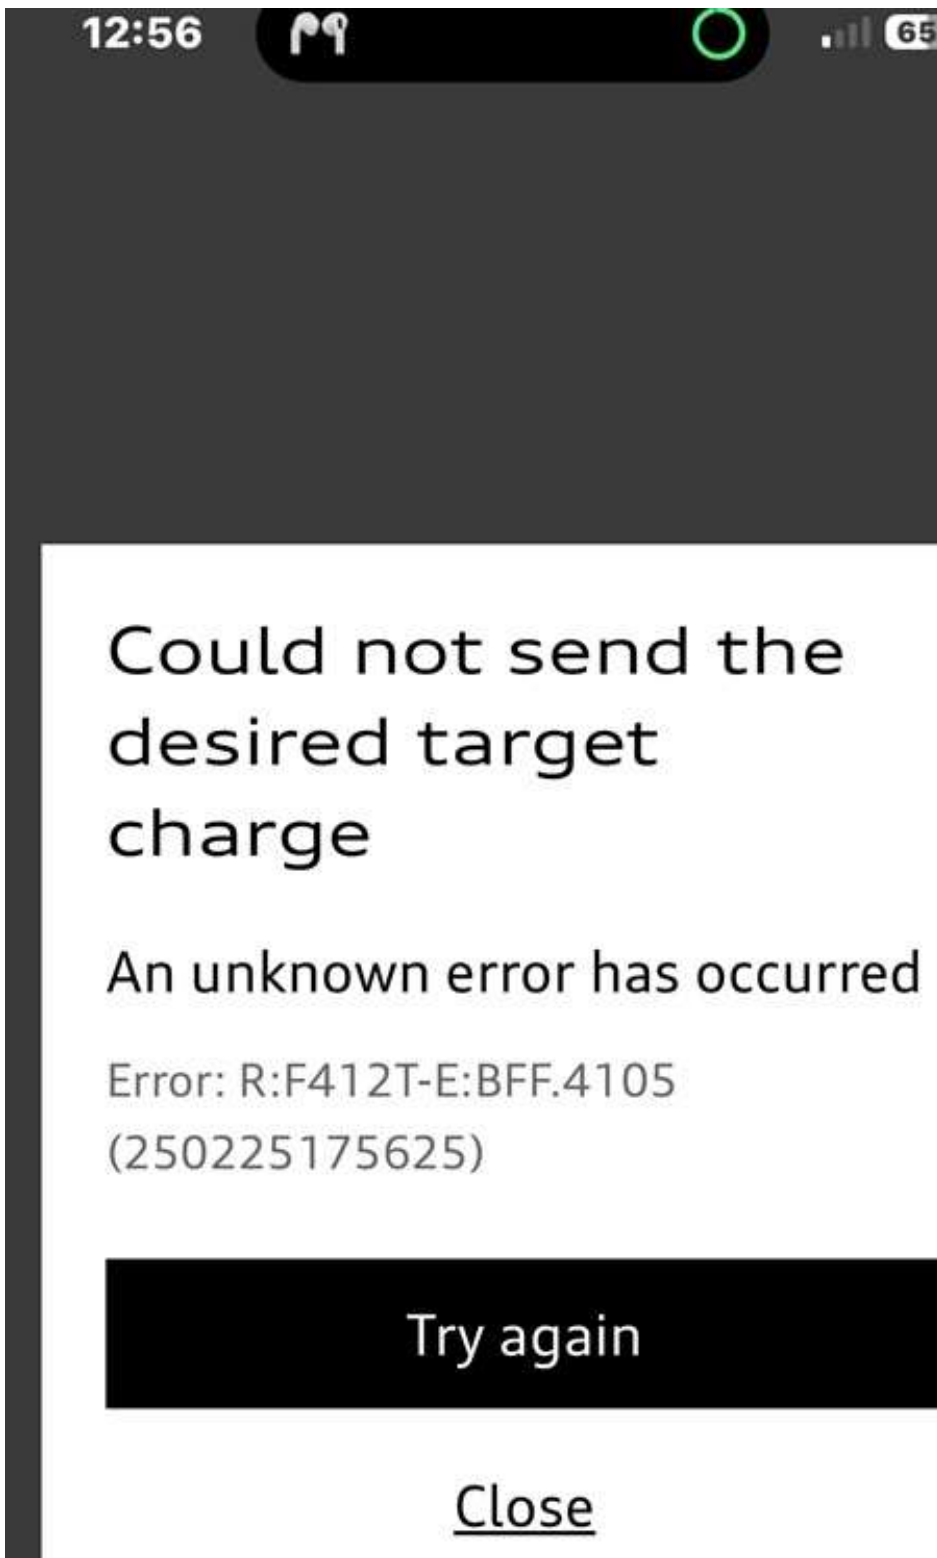
- In the context of the issue that the charging target cannot be set, an error message appears in the myAudi app (Figure 2) indicating that the set charging target cannot be sent.

**Figure 2.** Screenshot from app: “The desired charging target could not be sent. An unknown error has occurred.”

- An error message appears in the myAudi app indicating that the charging target cannot be sent.
- The charging timers cannot be set in the app or on the MMI.
