Technical Service Bulletin

Topic	93 Q4 power transmission: clacking noises during load changes/when changing direction (e.g. maneuvering/driving away)
Market area	United States 444 Volkswagen of America, Inc. (6444)
Brand	Audi
Transaction No.	2074899/3
Level	EH
Status	Released for publishing
Release date	Jun 30, 2025

Transaction No.: **2074899/3**

93 Q4 power transmission: clacking noises during load changes/when changing direction (e.g. maneuvering/driving away)

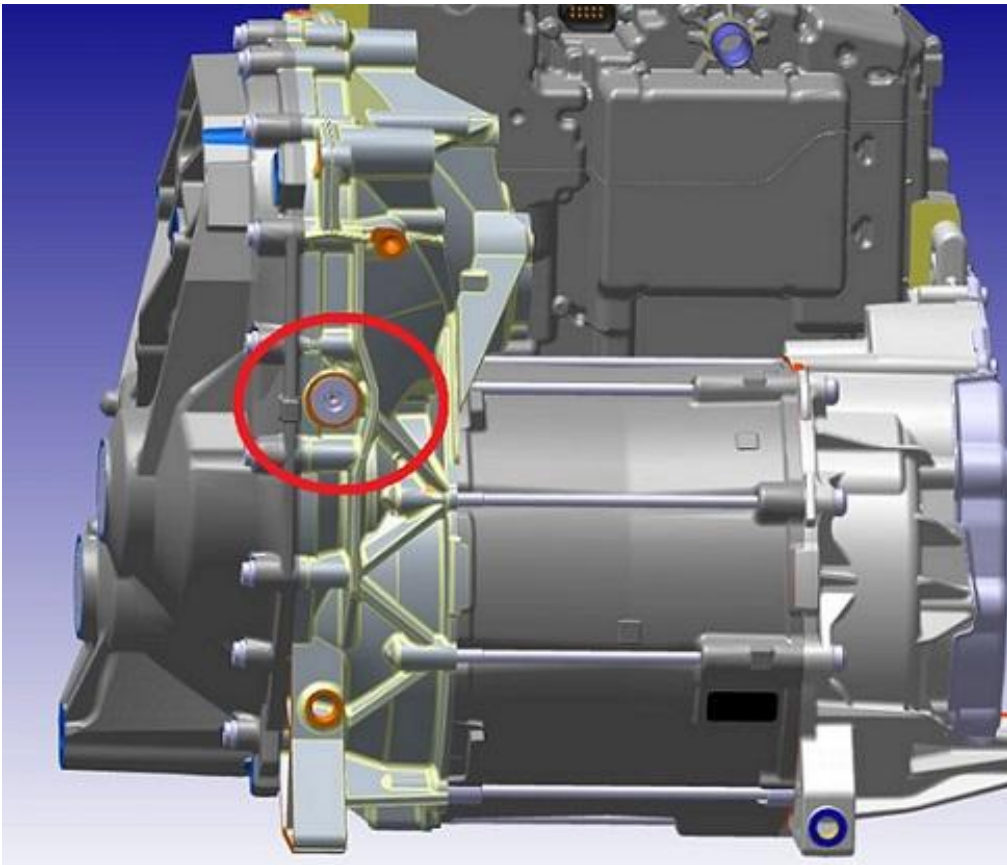
Figure 1. Filler cap for gear oil.

- Remove the gearbox as described in the ELSA Repair manual.
- Attach the gearbox to the engine and gearbox support -VAS6095A- as described in the ELSA Repair manual.
- Drain the gear oil via the filler cap (refer to Figure 1, red oval).

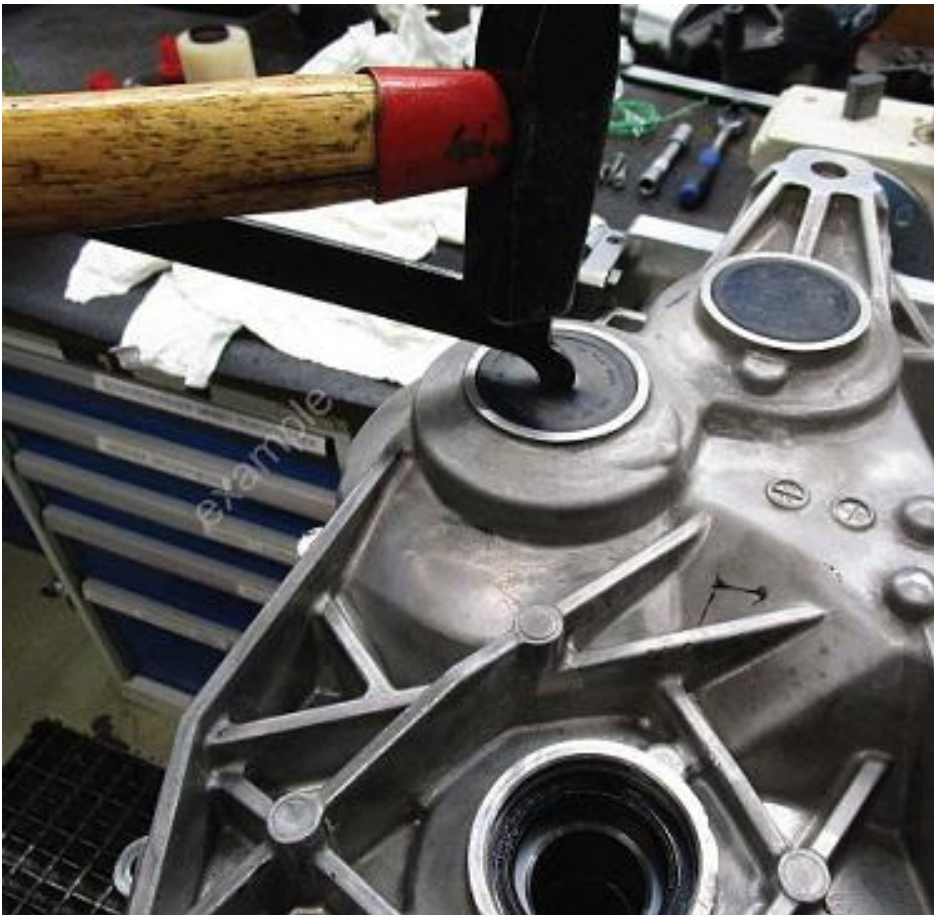
Figure 2. Removing the filler cap with the extractor lever -VW681- (example).

- Remove the center filler cap using the extractor lever -VW681- (refer to Figure 2).

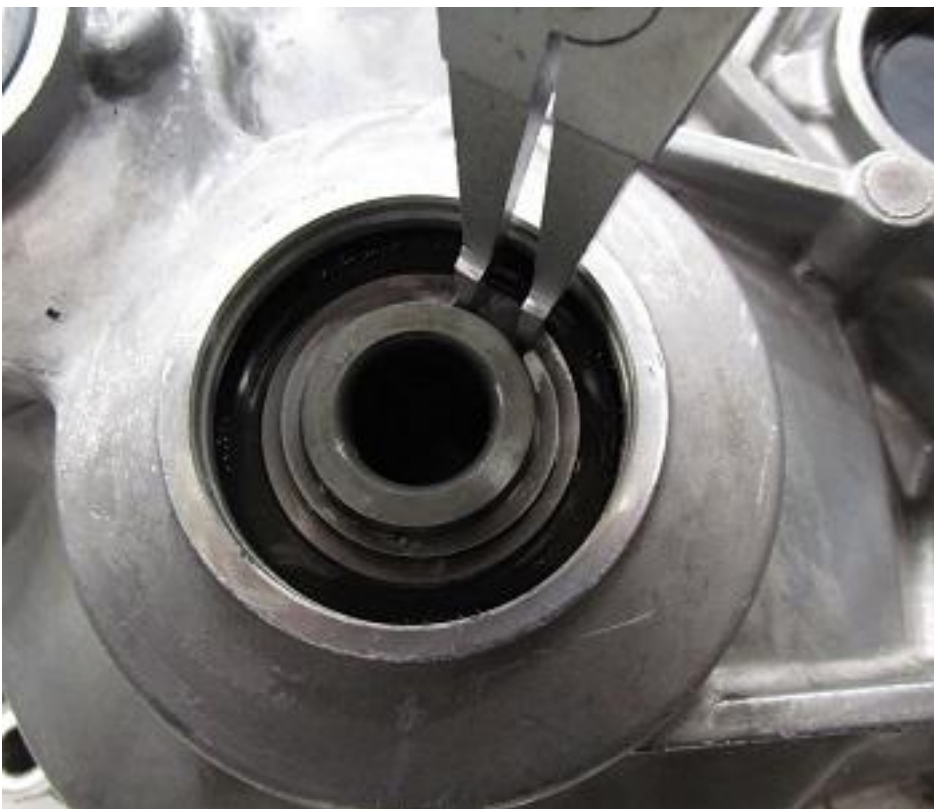
Figure 3. Removing the retaining ring for the inner ring of the intermediate shaft (example).

- Remove the retaining ring for the inner ring of the intermediate shaft (refer to Figure 3). The retaining ring must not be damaged and will need to be used again during the repair procedure.

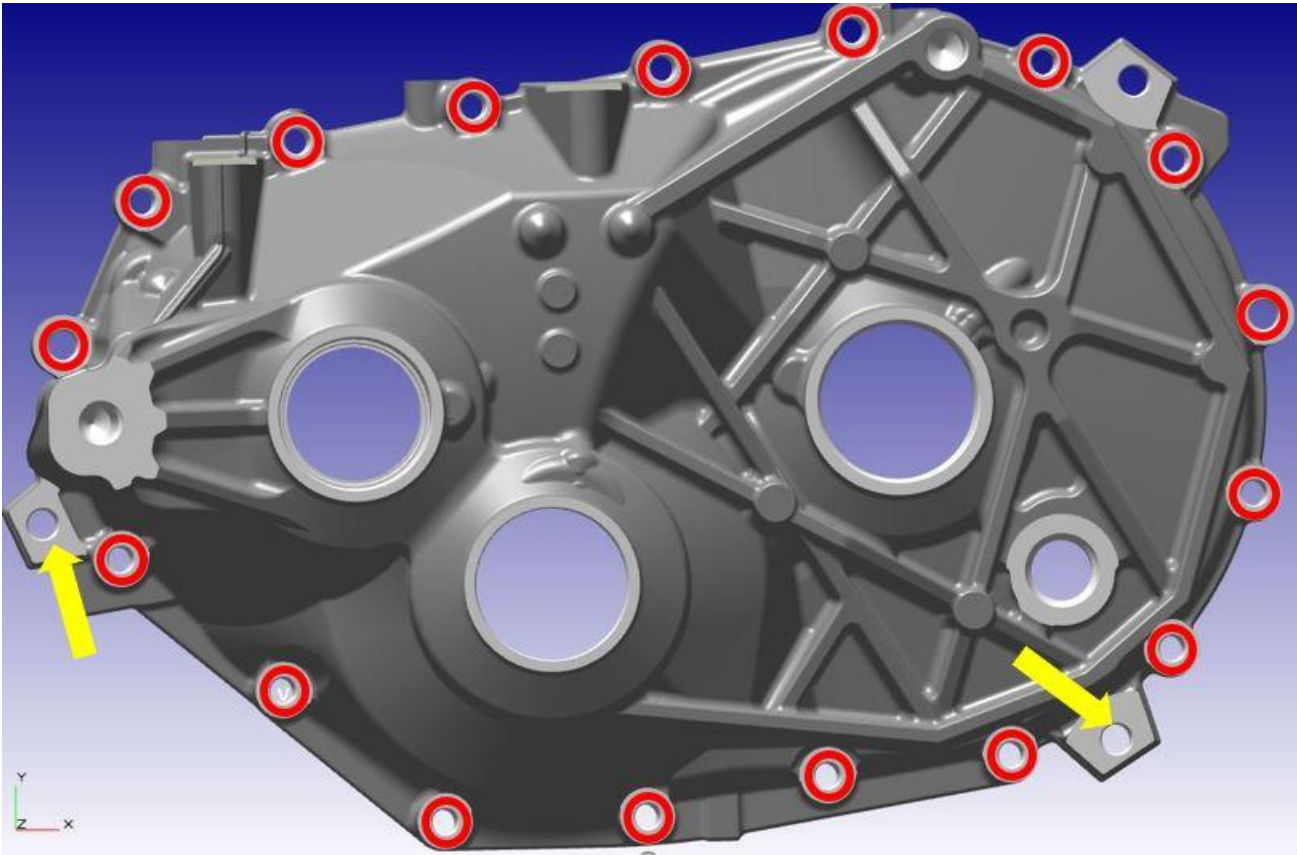
Figure 4. Positions of the housing bolts (red circles), and positions of contact points (yellow arrows).

- Remove 17 housing bolts (refer to Figure 4, red circles).

- Apply a commercially available assembly lever under the contact points (refer to Figure 4 (yellow arrows), Figure 5 and Figure 6), carefully separate the two sections of the gearbox housing from each other and detach the gearbox housing.

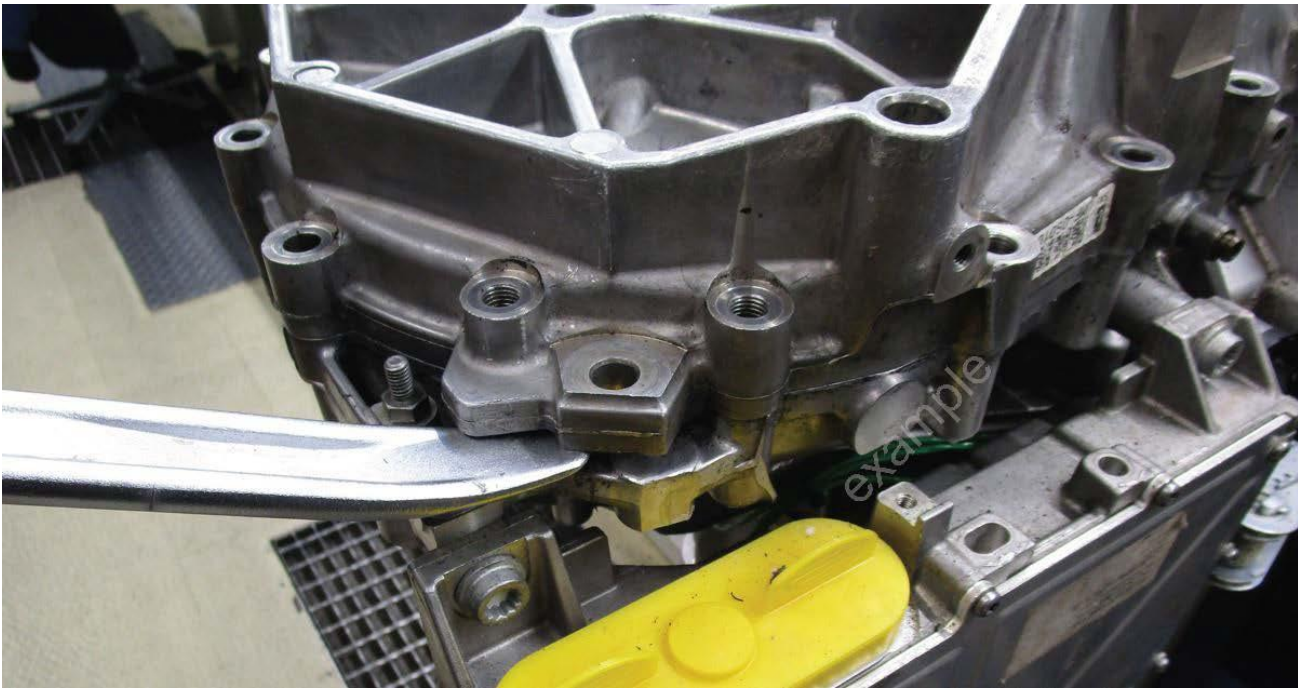
Figure 5. Separating sections of the gearbox housing from each other using the assembly lever.

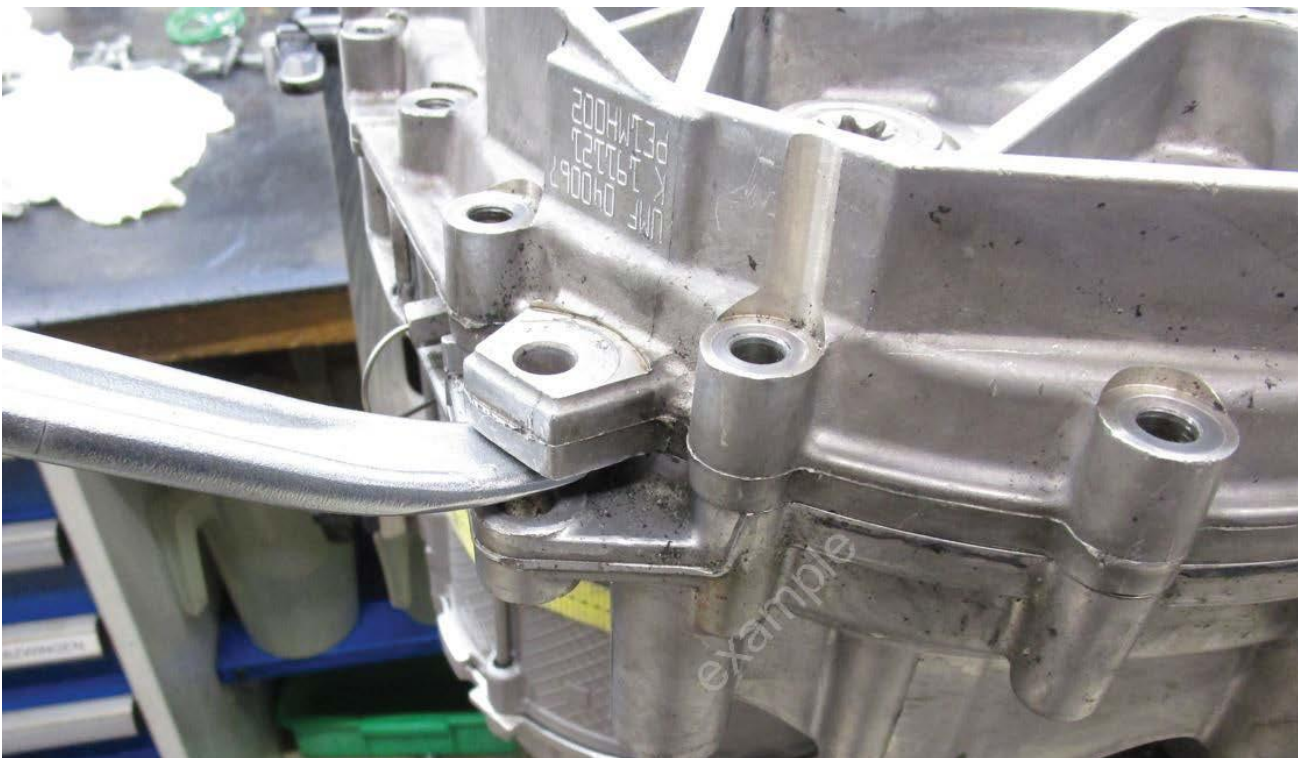
Figure 6. Separating sections of the gearbox housing from each other using the assembly lever.

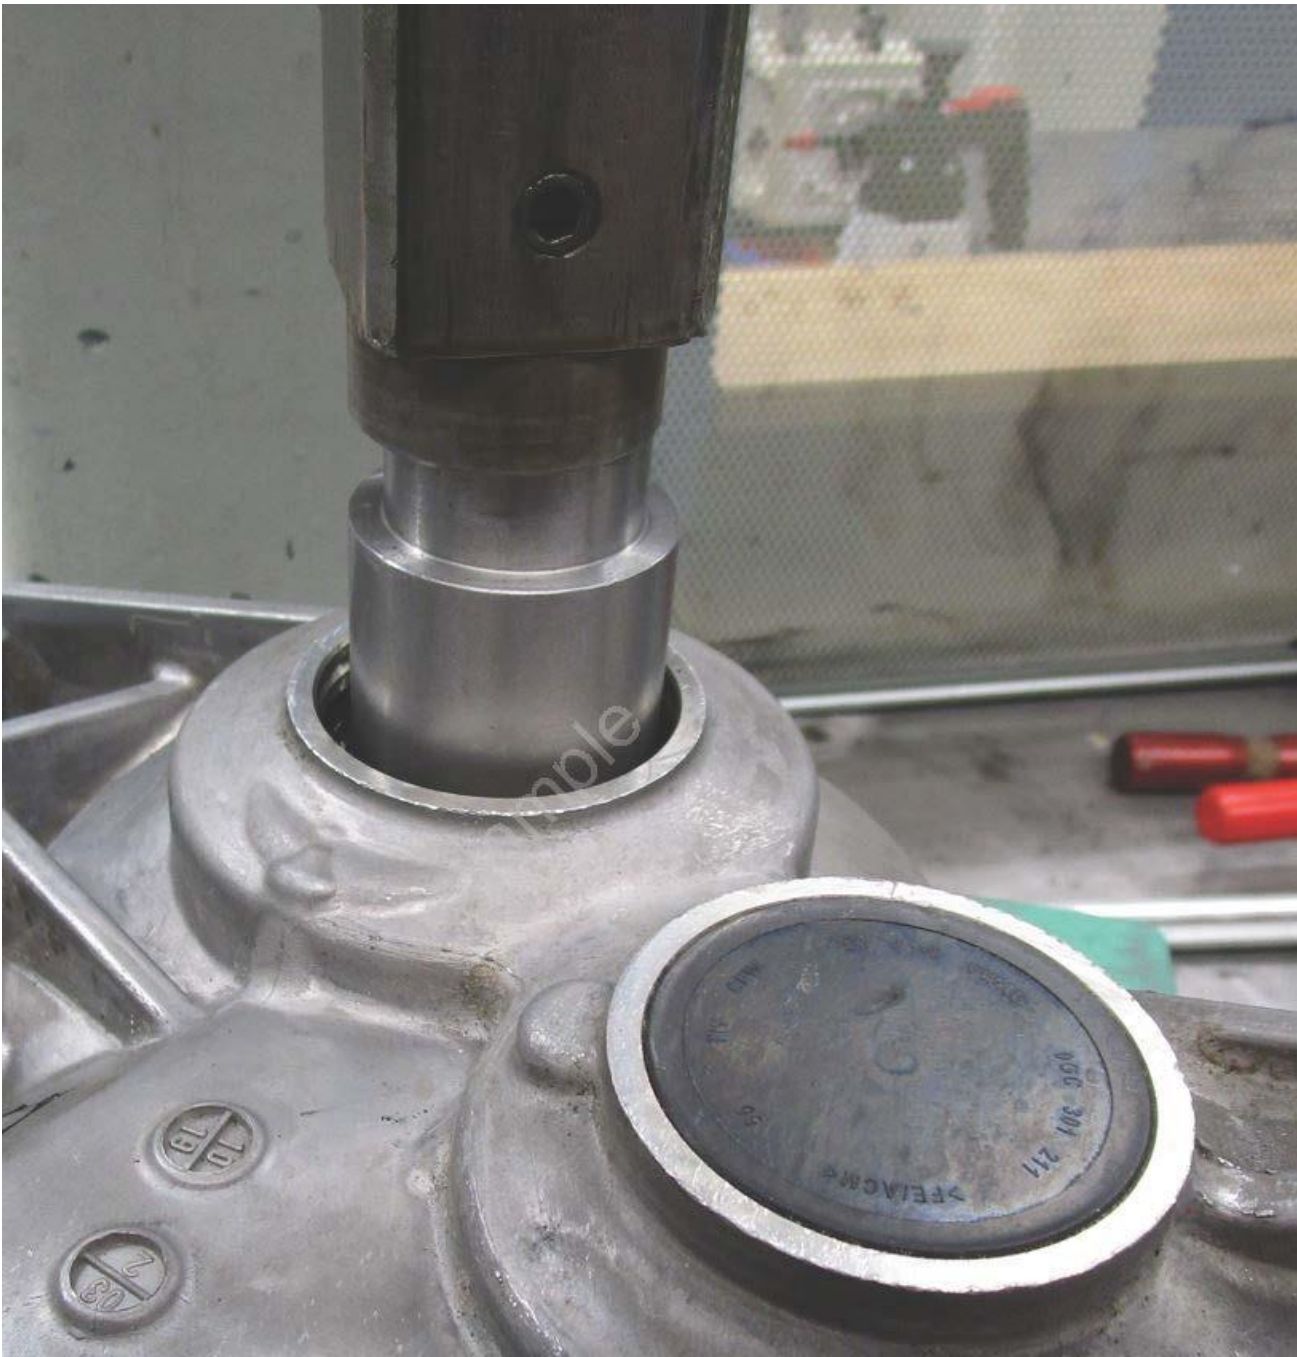
Figure 10. Pressing out the bearing for the intermediate shaft (example).

- Press the bearing for the intermediate shaft out, using the removing and installing tool -VW459/2- (refer to Figure 10).

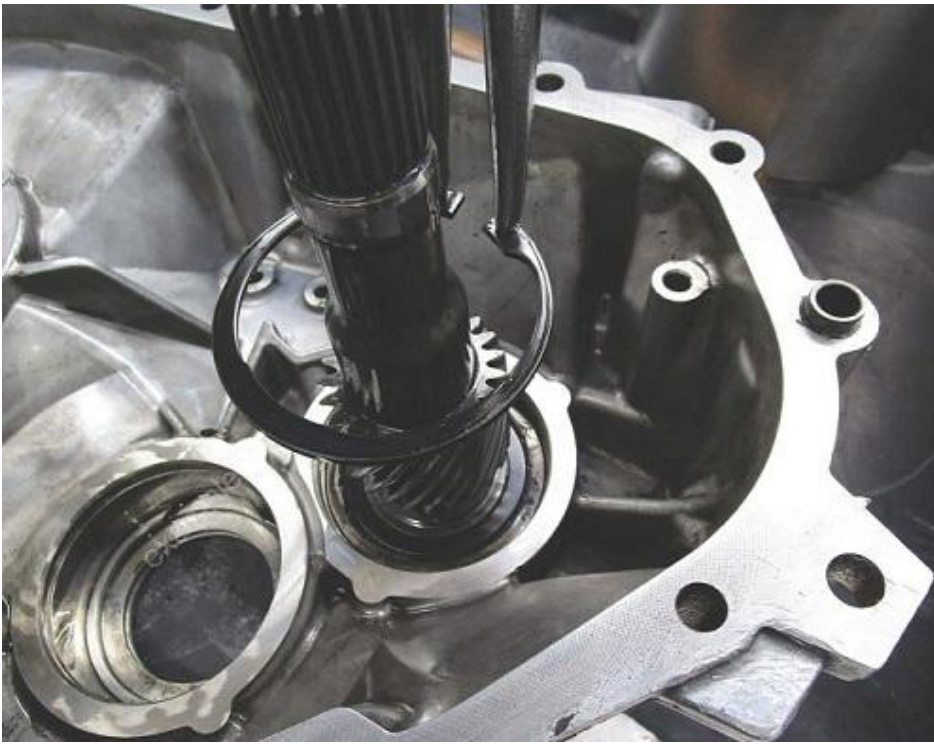
Figure 11. Removing the outer retaining ring for the drive shaft (example).

- Remove the outer retaining ring for the drive shaft (refer to Figure 11).

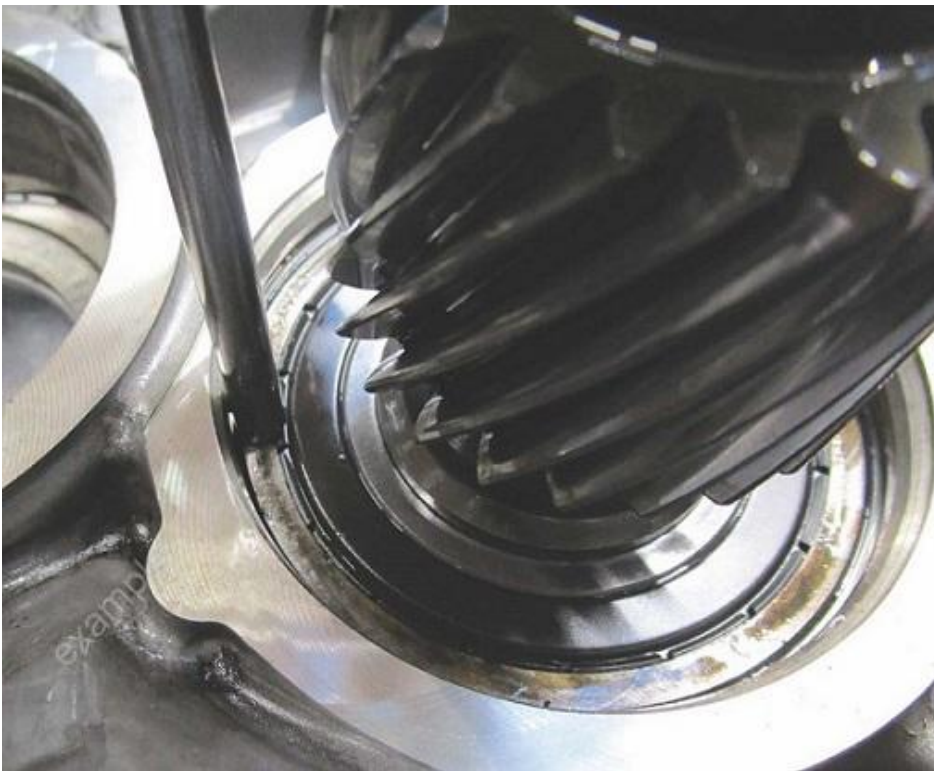
Figure 12. Driving the bearing for the drive shaft in deeper (example).

- Carefully drive the bearing for the drive shaft deeper into the gearbox housing using a commercially available drift and hammer at the outer ring of the bearing (refer to Figure 12).

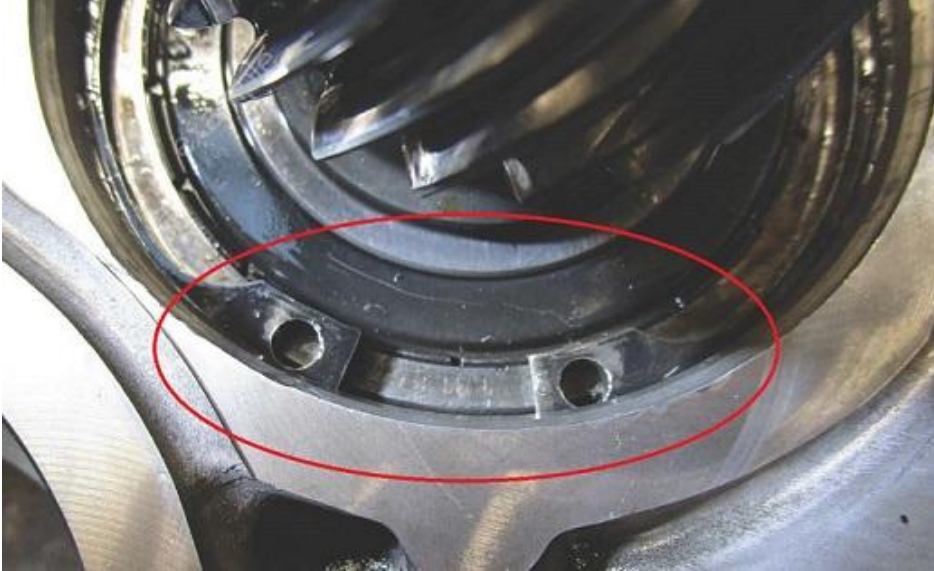
Figure 13. The retaining ring has snapped fully into the groove (example).

- Install the new retaining ring (with the maximum thickness/strength as described in parts information) as follows:

- Install the new retaining ring (starting with the maximum thickness/strength). If the retaining ring does not fit in the groove, try to insert the next thinnest retaining ring.
- Continue in this way as necessary until a retaining ring of the correct size can be installed.

The new retaining ring must snap fully into the groove (refer to Figure 13, red oval).

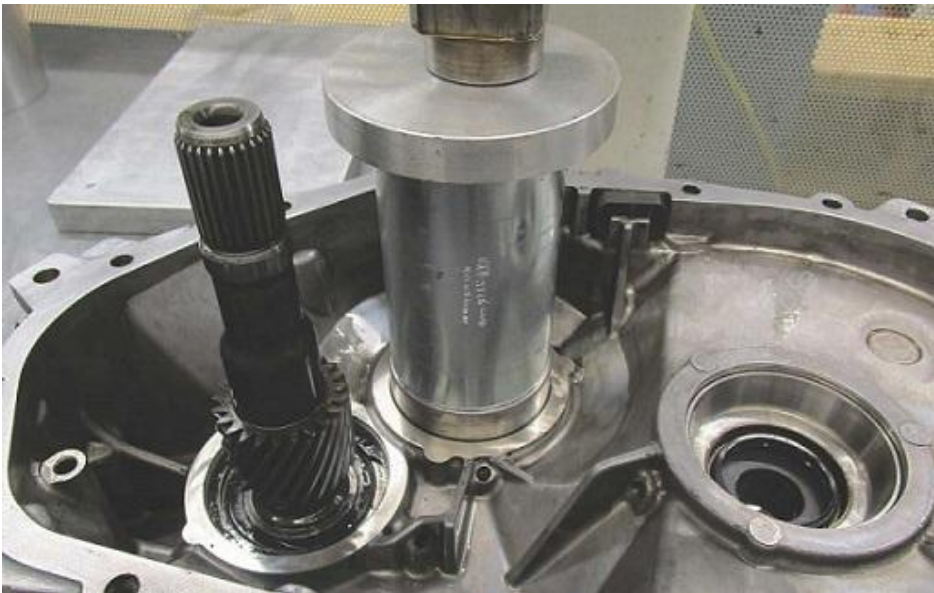
Figure 14. Pressing in the new bearing for the intermediate shaft with tube -3146-.

- Press the new bearing for the intermediate shaft (as described in parts information) into the gearbox housing with tube -3146- (refer to Figure 14).

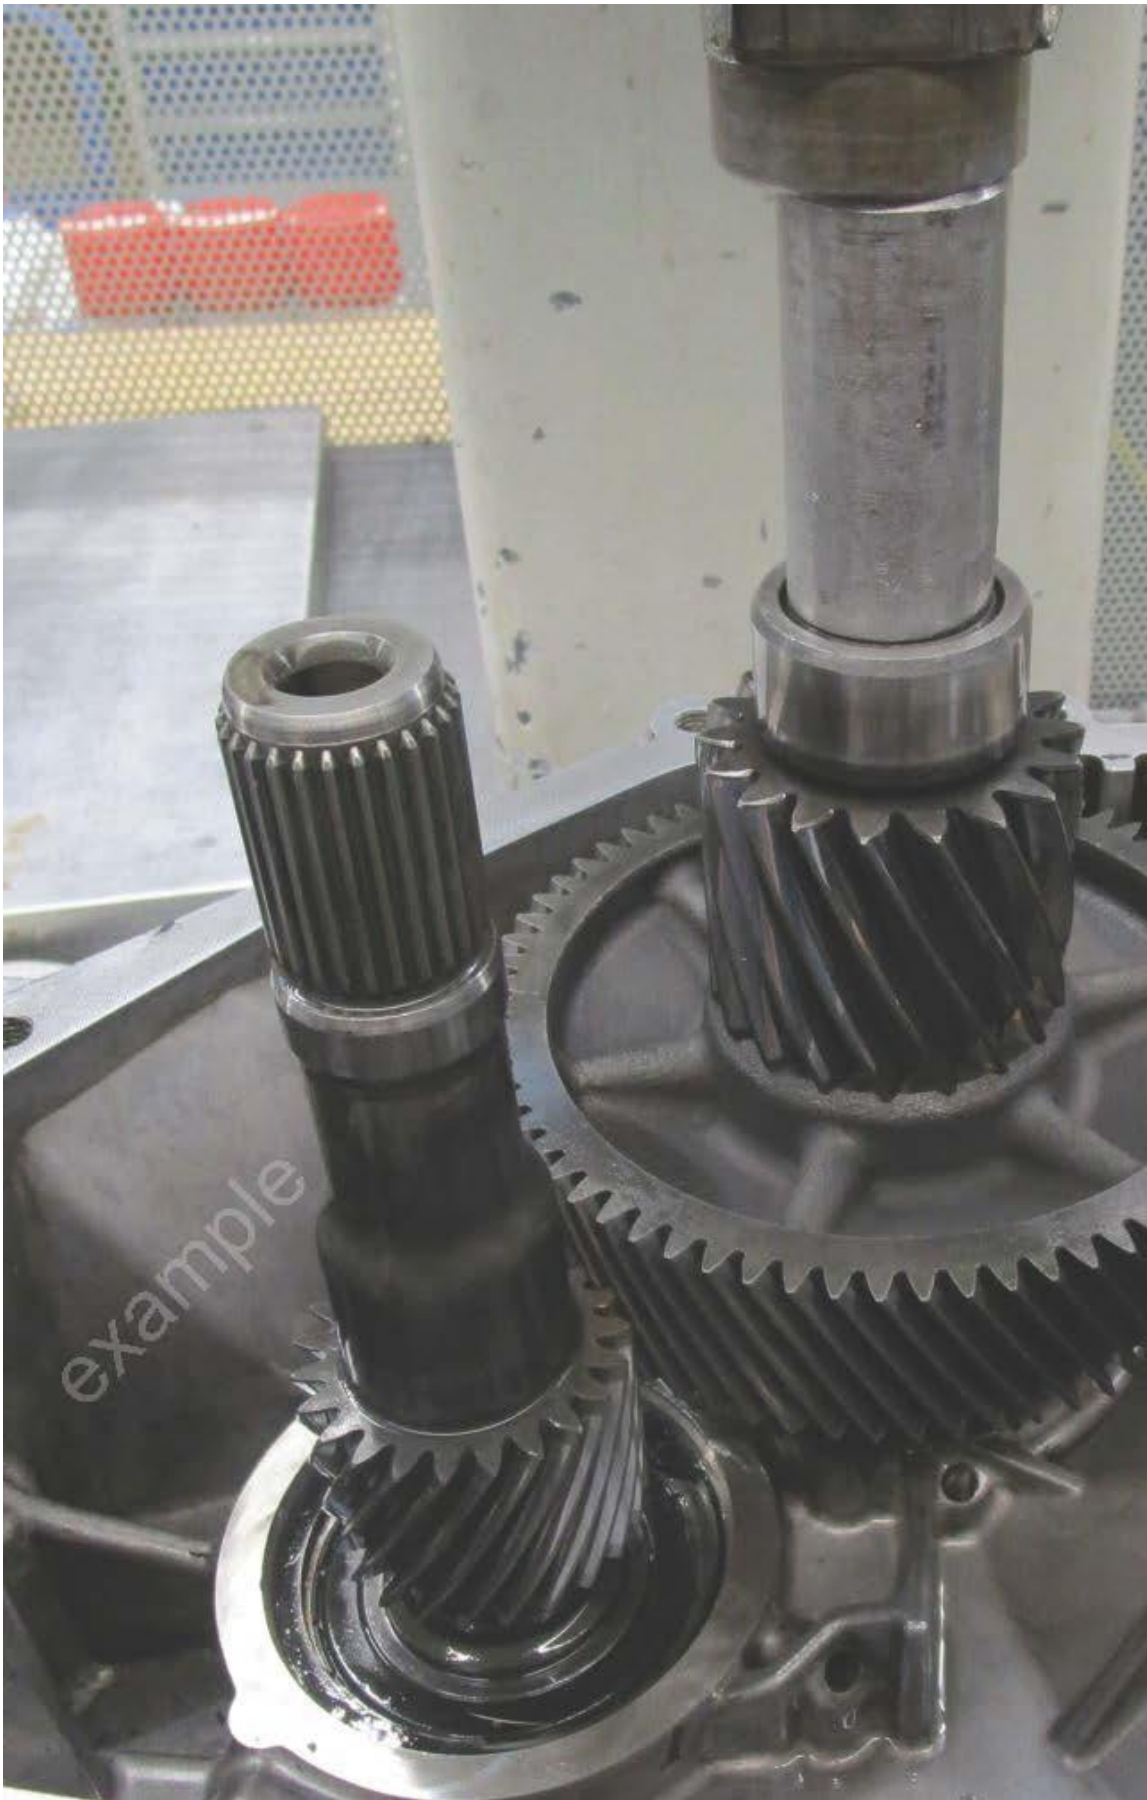
Figure 15. Pressing in the intermediate shaft with the removing and installing tool - VW459/2- (example).

- Re-install the retaining ring for the outer ring of the bearing for the intermediate shaft.
- Press the intermediate shaft in using the removing and installing tool -VW459/2- (refer to Figure 15); at the same time, support the inner ring with the thrust piece -VW454- (refer to Figure 16).

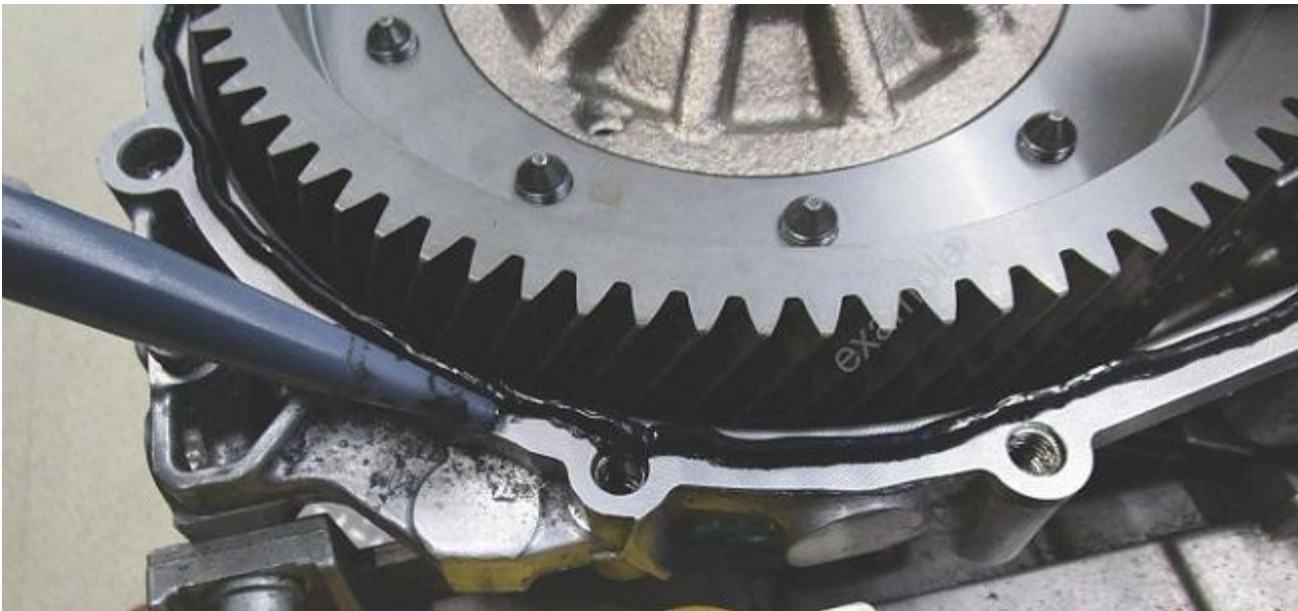
Figure 17. Applying silicone sealant all around the sealing surface of the intermediate housing (example).

- Allow flash-off time of 10 minutes for the sealing surfaces.
- Apply silicone sealant (part number: D 176 501 A1) all around the sealing surface of the intermediate housing (refer to Figure 17).

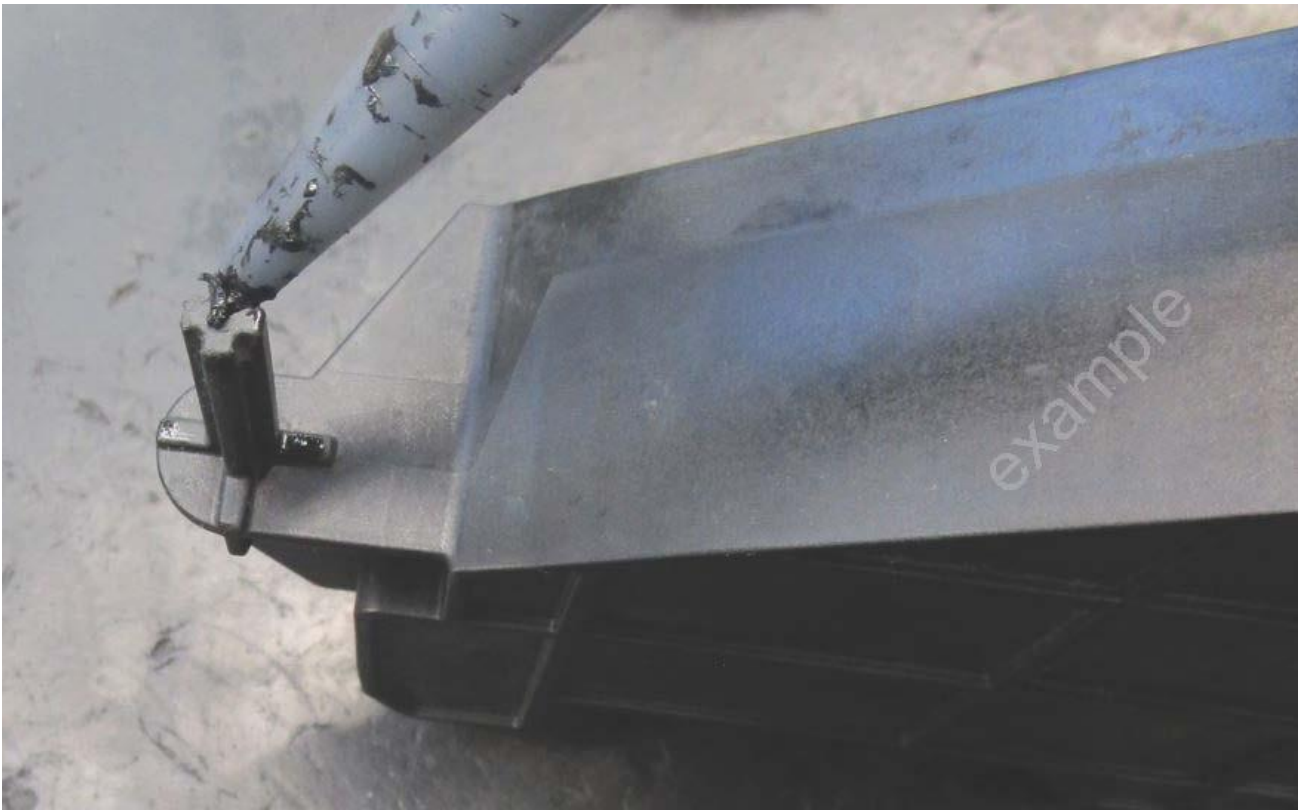
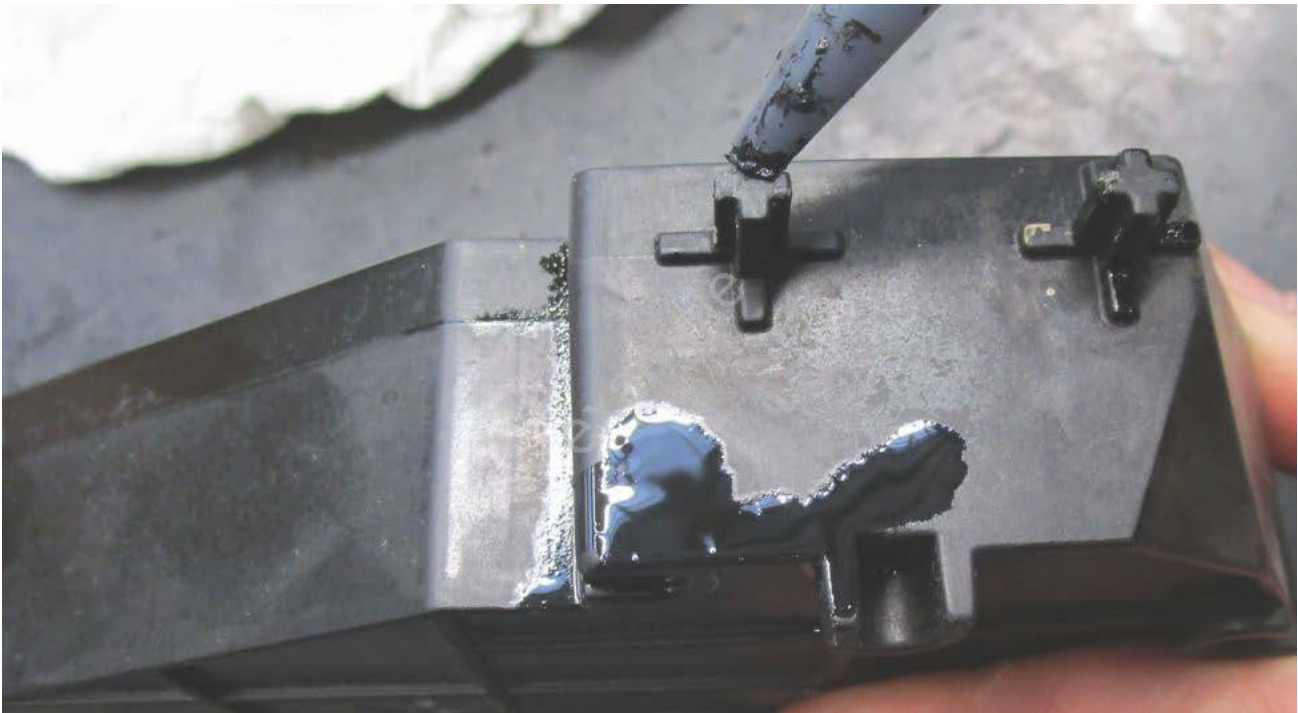
Figure 19. *Lightly applying silicone sealant to the attachment point (example).*

Figure 20. *Lightly applying silicone sealant to the attachment point (example).*

- Lightly apply silicone sealant (part number: D 176 501 A1) to the previously removed oil reservoir at 3 attachment points (refer to Figures 19 and 20) with.

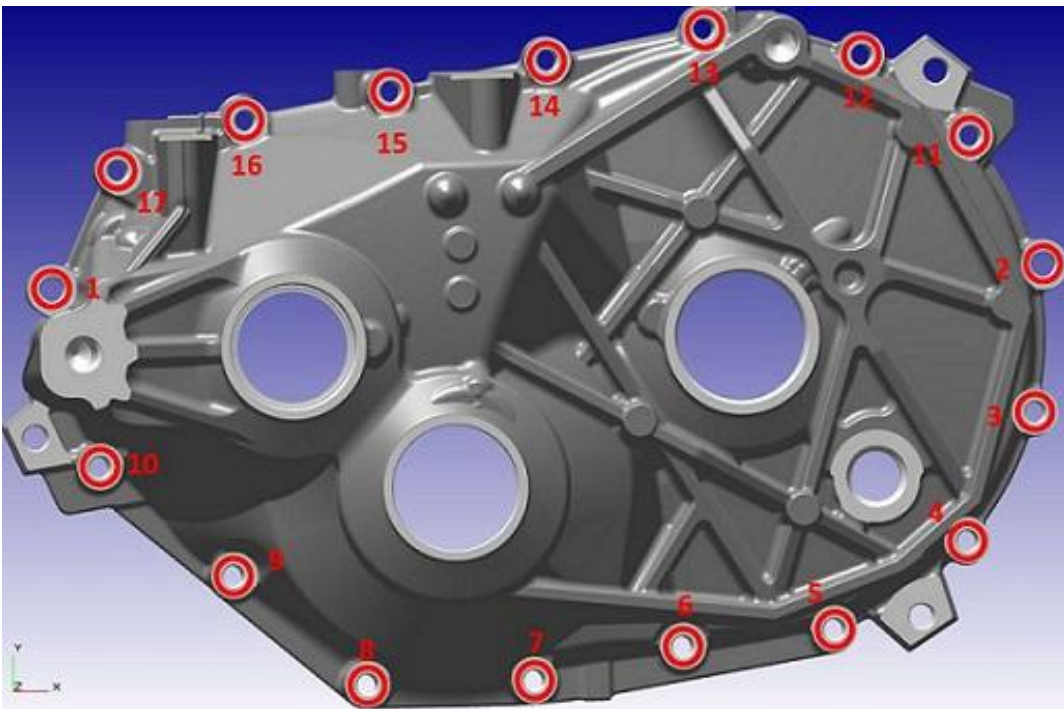
Figure 22. Installing the multi-point socket head bolts; tightening torque 20 Nm + 90°.

- Place the gearbox housing on the intermediate housing.
- Install the gearbox housing by screwing in the new multi-point socket head bolts in the sequence 1 to 17 (refer to Figure 22); **tightening torque: 20 Nm + 90°**.
