# Technical Service Bulletin

<b>Topic</b>	Rear Door Blind Defective Operation   Flying Spur   20-26MY
<b>Market area</b>	Bentley: worldwide (2WBE), China 796 VW Import Comp. Ltd (Vico), Beijing (6796)
<b>Brand</b>	Bentley
<b>Transaction No.</b>	2078338/1
<b>Level</b>	EH
<b>Status</b>	Released for publishing
<b>Release date</b>	Jun 26, 2025

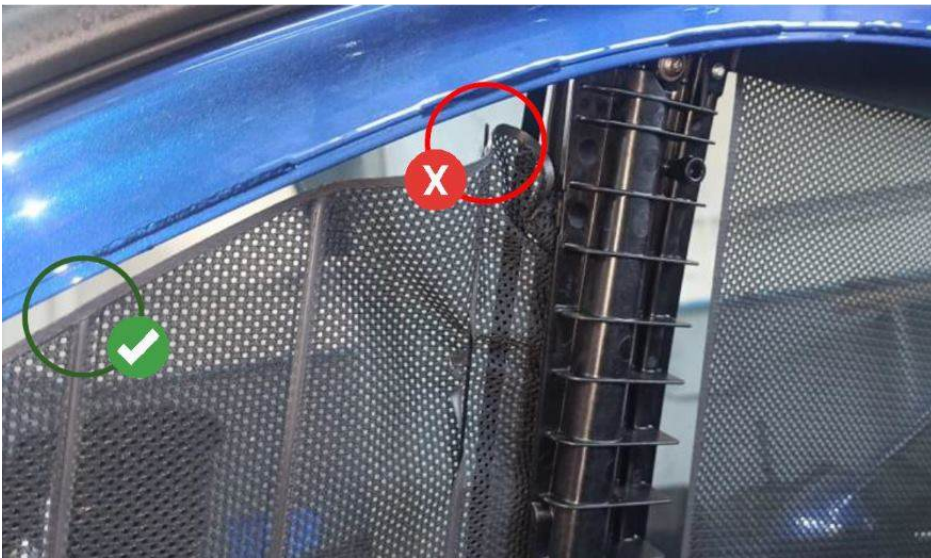
**Figure 1** Example of support rods protruding out of the fabric

1. Perform a visual inspection of the rear quarter sail/blind for support rods protruding out of the fabric.
2. Capture a video and image of the rear quarter blind defect/operation.

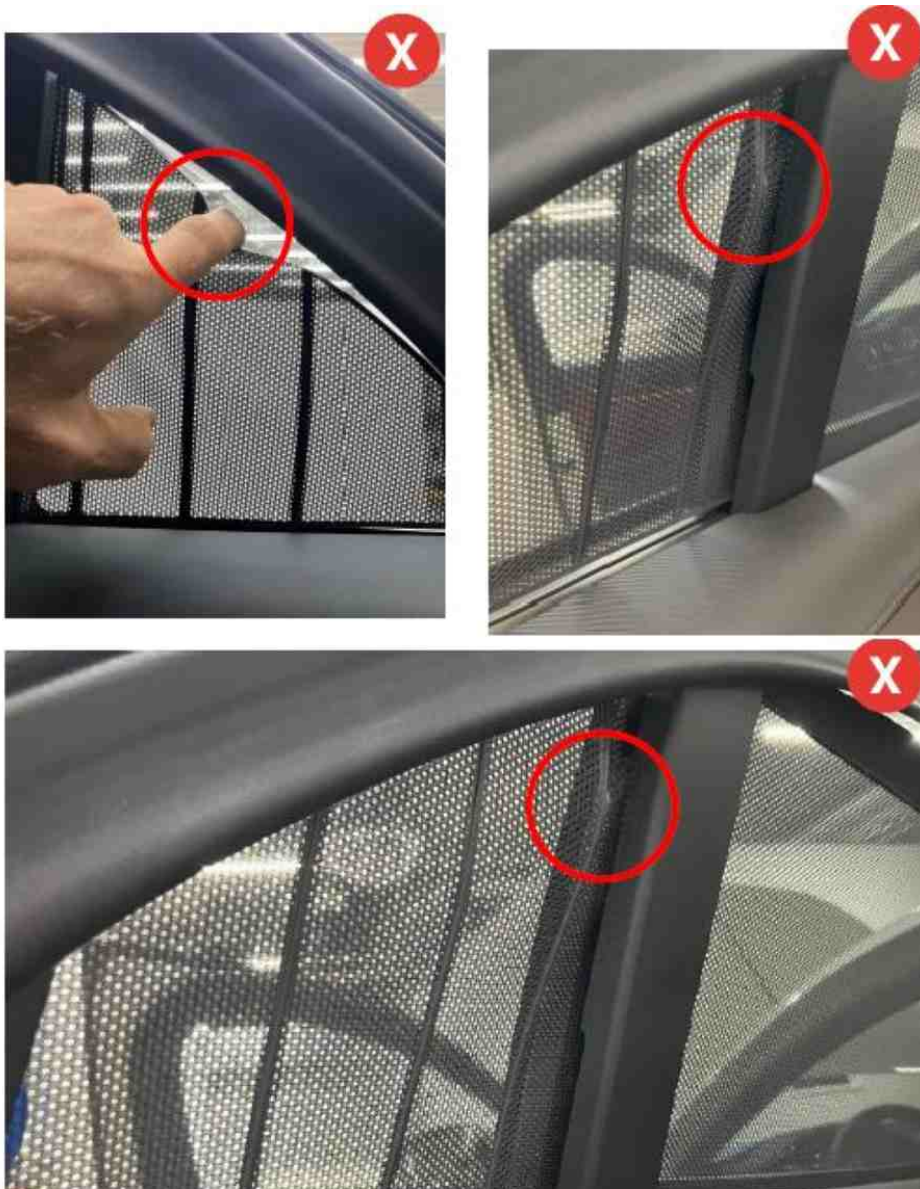
**Figure 2** Example of support rods bent / distorted

3. Check for signs of rear quarter blind misuse, support rods bent / distorted or rod protruding out of the fabric.

If the support rods are bent, this can lead to the blind 'rucking' and malfunction. Warranty claims for this will be rejected as Support rods CAN be straightened to recover normal operation.

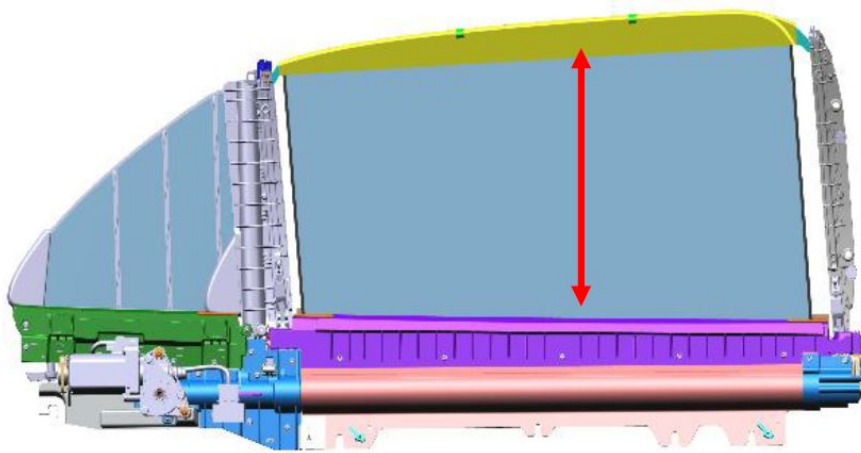
Figure 3 Main blind operation inspection

4. Capture a video and image of the main blind defect/operation.

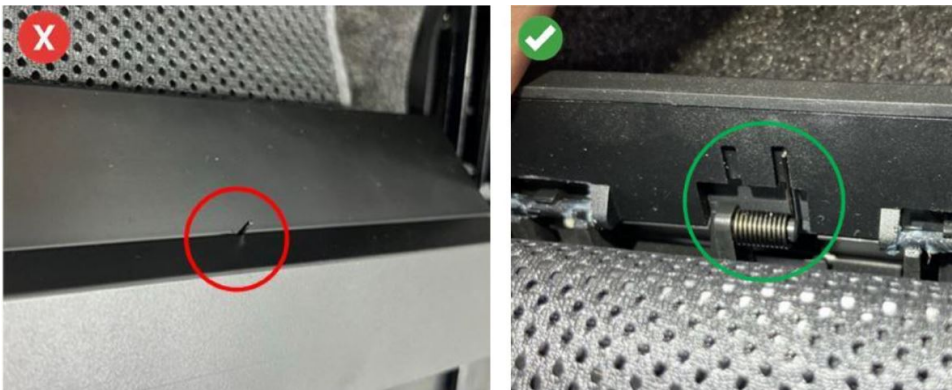
Figure 4 Letterbox flap spring inspection

5. Perform a visual inspection of the letterbox flap spring, check if it is misplaced or visible.

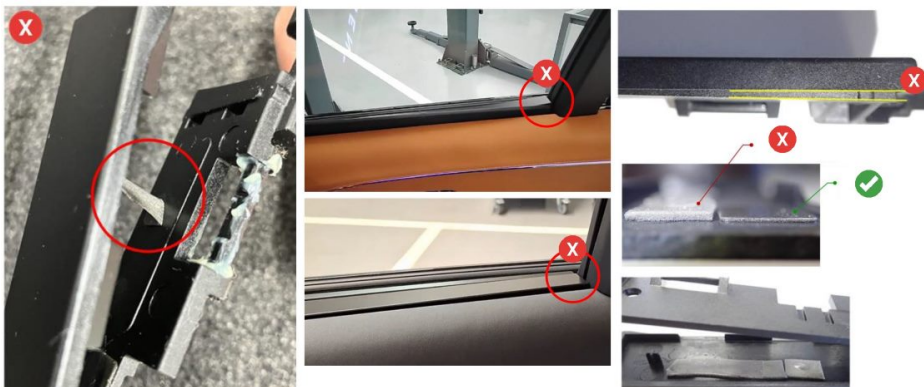
Figure 5 Letterbox flap cover inspection

6. Perform a visual inspection of the letterbox flap cover, check if it has become detached from the housing.

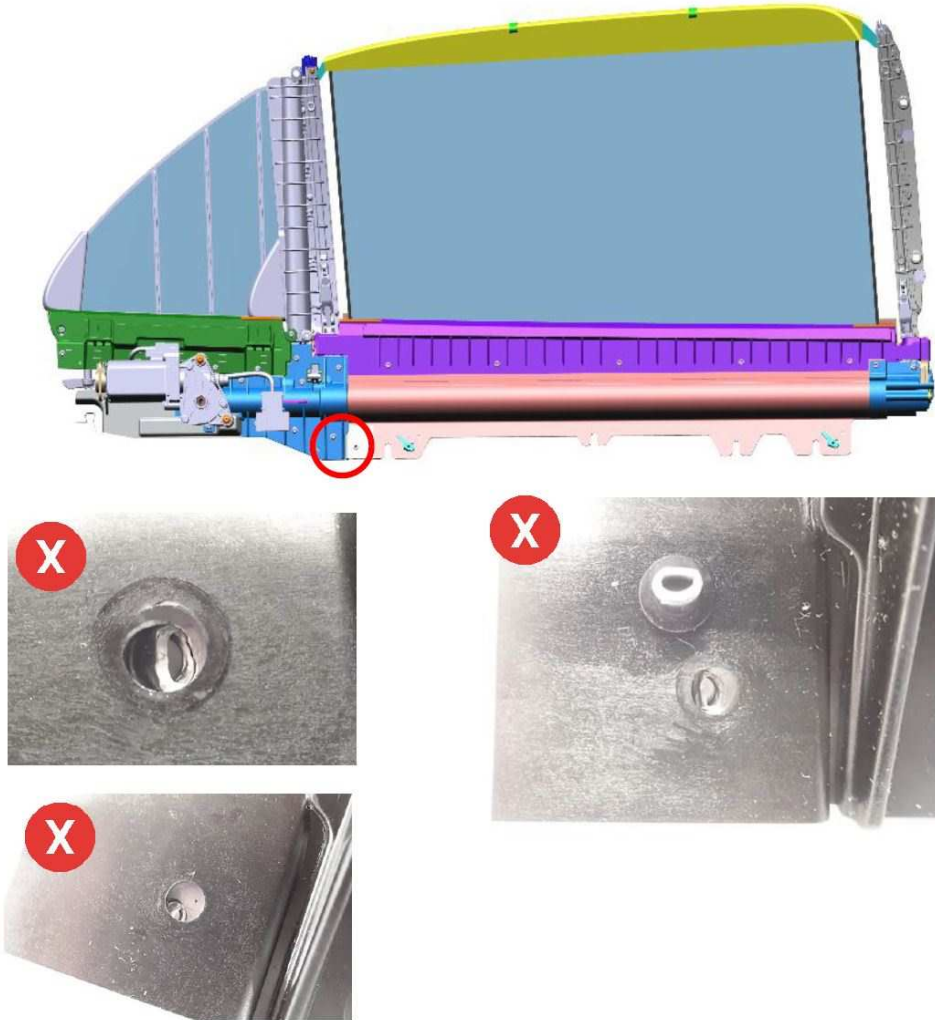
Figure 6 Connecting rivet location with Not OK condition

7. Perform a visual inspection of the rivet connection between the aluminium and plastic housing.

8. Check for any sheared connecting to rivets, see figure 5 for NOT OK rivet condition.
