WSE1- Rework Rear Inner Left and Right Side Section (Workshop Campaign)

Vehicle Type: **Taycan Turbo GT with Weissach package (Y1AFP1)**

Model Year: **2025**

Concerns: **Rear inner left and right side section**

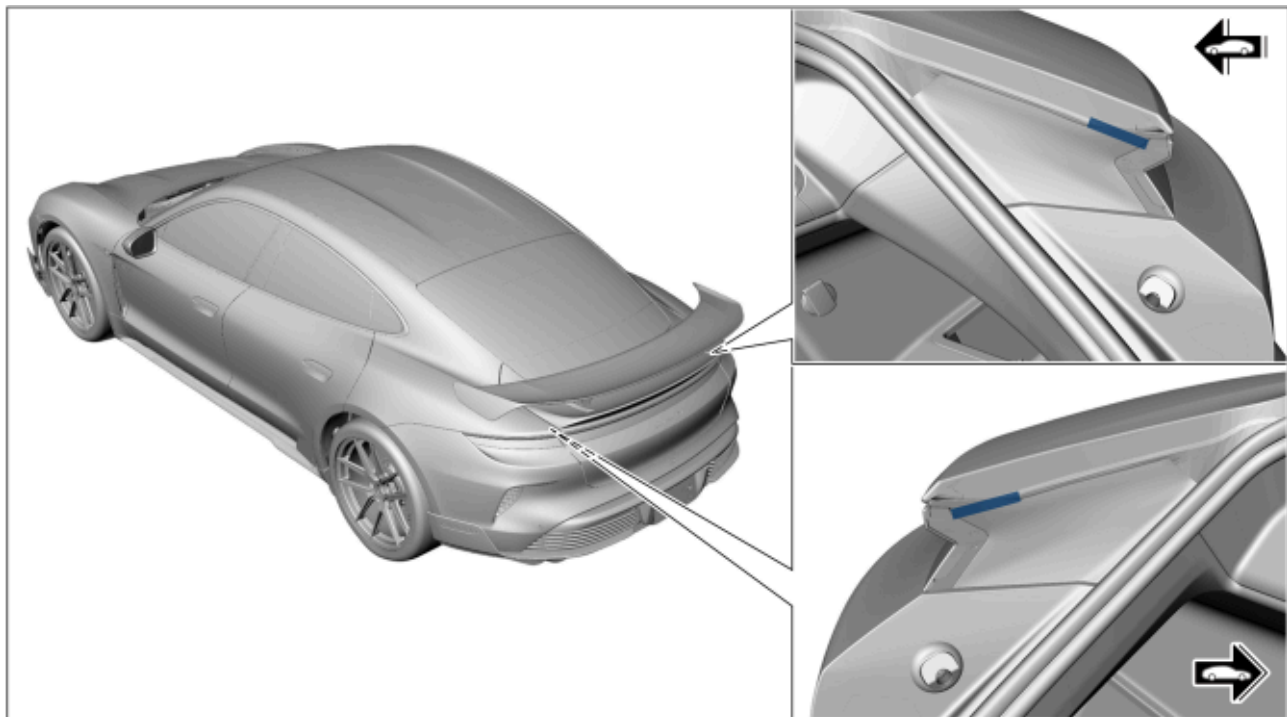
Installation position of seal weld

Cause: **The Taycan Turbo GT with Weissach package does not come with a rear lid closure as standard. In combination with the additional weight of the rear spoiler, increased force can therefore be exerted on the sealing seam in the area of the rear lid during manual closing. This could damage the sealing seam.**

Action: Rework rear inner left and right side sections.

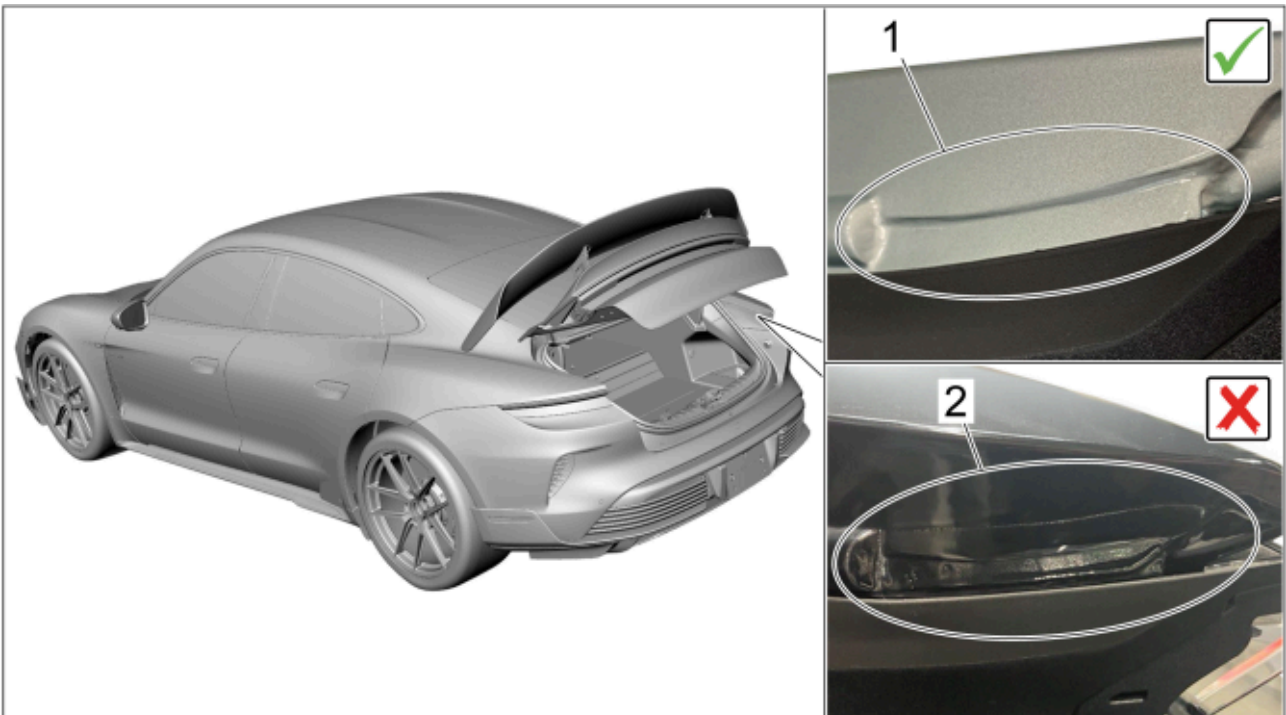
(✓)	The reworking area \Rightarrow Sealing seam on the rear side section on the inner right -1- is clean and there are no residues of the sealing seam; the rework is OK .
(x)	Sealing seam residues \Rightarrow Sealing seam on the rear side section on the inner right -2- are still visible in the rework area; rework is not OK here.

- 3 Remove residues from the sealing seam using the scraper or a foil eraser (plastic erasing disc).

Any residues of the sealing seam lead to visual defects and must therefore be avoided.
