Service Bulletin

Bulletin No.: 24-NA-166

Subject: DTC C1171 C1172 C1173 C1174 Tire Pressure Monitor Sensor Unable to Relearn Ethernet Cable Overlay for TCP OnStar Module

Brand:	Model:	Model Year:		VIN:		Engine:	Transmission :
		from	to	from	to		
Buick	Enclave	2025	2025				
Chevrolet	Traverse	2024	2025			LK0	
GMC	Acadia	2024	2025

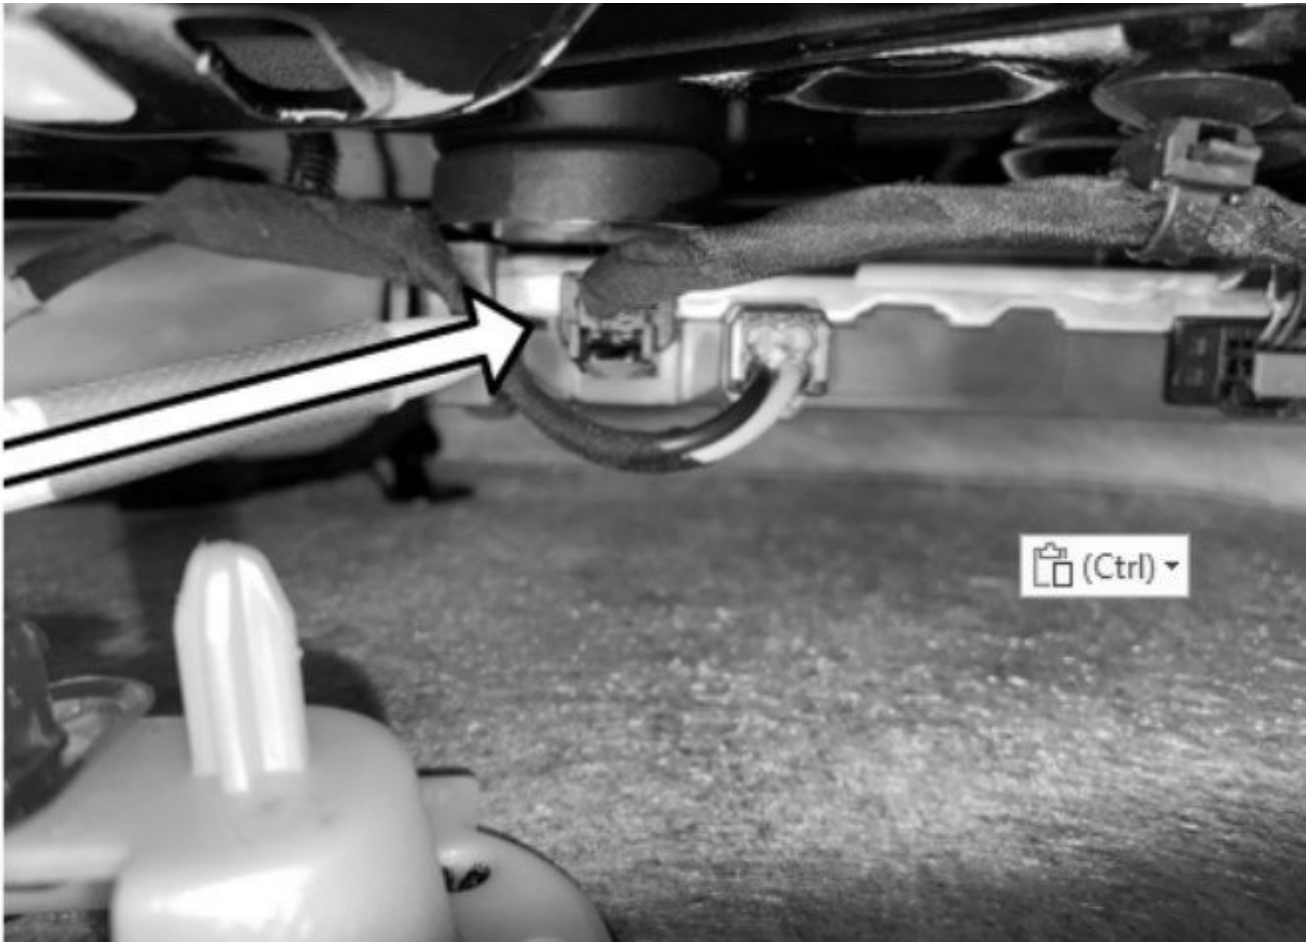
6720400

Involved Region or Country	North America, Middle East
Condition	<p>Some customers may comment on a Tire Pressure lamp illuminated and/or message on the dash. The dealer may also not be able to perform the tire pressure learn for one or both front tires.</p> <p>Note: If only the rear Tire Pressure Monitors are setting, then it is not related to this issue.</p> <p>Technician may find one or more of the following DTCs: DTCs C1171, C1172, C1172, and/or C1174.</p> <p>Important: This can cause fob related issues when accompanied by one or more of the DTCs listed above. If the customer is having intermittent fob issues and setting TPM codes, it is possible the new overlay in this procedure will resolve the fob concerns too.</p>
Cause	The causes of the condition may be interference from OnStar module due to an issue grounding from the X7 connector on the Ethernet cable. This issue can also be intermittent.

1. Once confirmed the TPM sensors cannot be learned, gain access to the rear headlining trim panel. DO NOT remove the headlining trim panel, only lower it to gain access Refer to Headlining Trim Panel Replacement in SI. Disconnect the X7 connector and attempt to learn the TPM sensors.

If the TPM sensors are able to learn, continue with Ethernet Cable replacement. Otherwise follow SI.
