Technical Service Bulletin

Topic	Unusual Suspension Behaviour whilst static Continental GT/GTC/Flying Spur 18-24MY
Market area	Australia E04 Bentley rest Asia and Australia (6E04),China 723 Volkswagen (Anhui) Automotive CO (6723),China 796 VW Import Comp. Ltd (Vico), Beijing (6796),Germany E02 Bentley rest Europe (6E02),Japan E03 Bentley Japan (6E03),Korea, (South) E08 Bentley South Korea (6E08),Russian Federation 935 Volkswagen Group RUS (6935),United Arab Emirates E06 Bentley Middle East and Africa (6E06),United Kingdom E01 Bentley UK (6E01),United States E05 Bentley USA and rest America (6E05)
Brand	Bentley
Transaction No.	2064555/3
Level	EH
Status	Released for publishing
Release date	Jun 26, 2025

Continental GT/GTC and Flying Spur

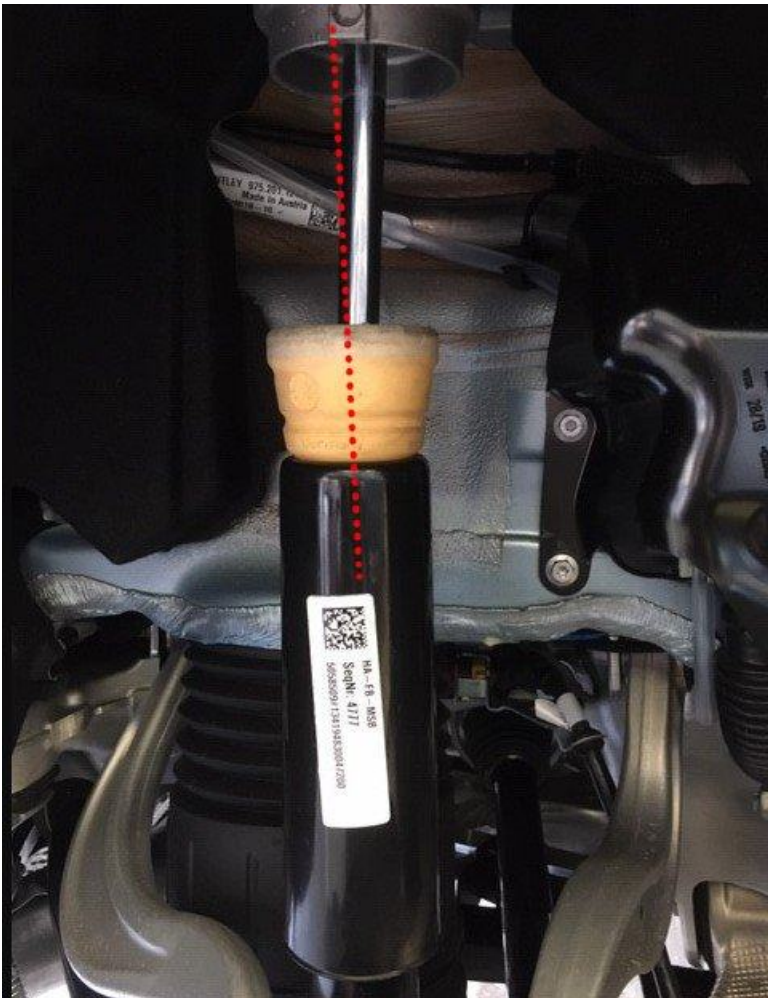
Figure 1

- 1) Carry out an inspection the left and right hand rear shock absorbers, checking for damage, leaks and/or misalignment as shown in Figures 1,2 and 3

2) In the event that one or both of the rear shock absorbers are as shown/described - Replace the affected shock absorber. Refer to ElsaPro, Repair Group 42 'Shock absorber – remove + install'

- Both shock absorbers should be replaced if there is an old version of the damper on the vehicle and only if the new version is available for ordering in ETKA. This is to avoid different versions of shock absorber fitted to the same vehicle.
- Both of the shock absorbers should be replaced on the vehicle if it has completed over 10000+km of mileage.
- If fitted, inform the customer that the new shock absorber is going to settle down and perform optimally after 1000km of vehicle running.
