TSIB 25-05 Rev A		Jun 24, 2025
TO:	All Operators	
TITLE:	Adjusting the Lower Mount of the HVAC Idler Pulley Bracket	
APPLICABILITY:	MCI coaches equipped with Isolated (rubber mounted) idler pulleys bracket

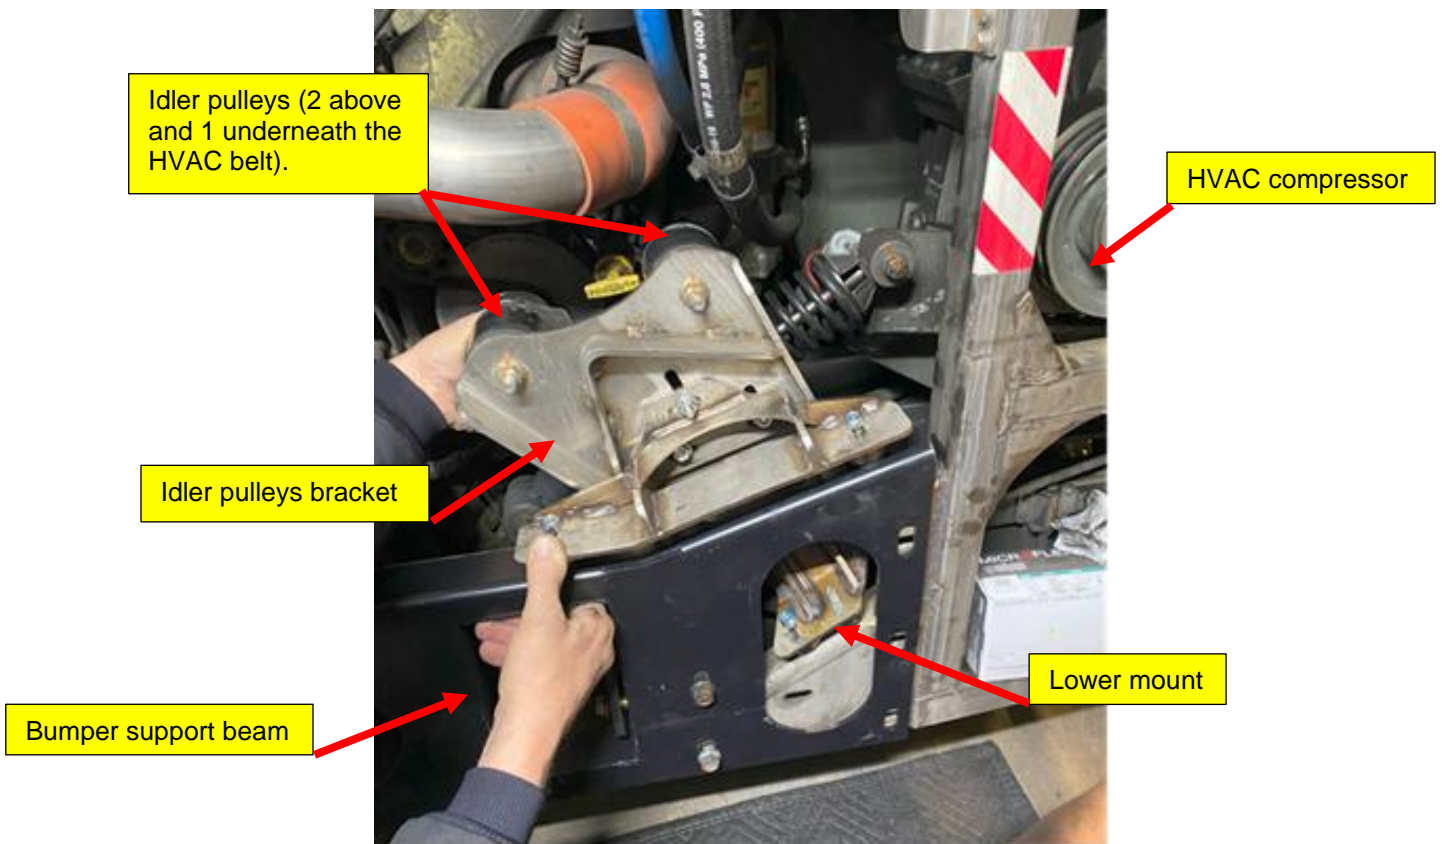
Figure 1: Idler pulley bracket and related components

This TSIB is to remind MCI coach operators that when servicing the HVAC belts, idler pulleys or the lower mount of the idler pulley bracket, ensure that the lower mount is adjusted so it is not contacting the bumper support beam nor the bumper itself. **Ensure that there is at least ¼” gap between the lower mount and the bumper support beam.** Refer to Figures 1 and 2. The idler pulley bracket is mounted with rubber isolators. If the lower mounting bracket is touching the rear bumper support beam, then the vibration from the belts will bypass the rubber isolators and may transfer belt vibration to the coach frame causing noise inside the passenger compartment.

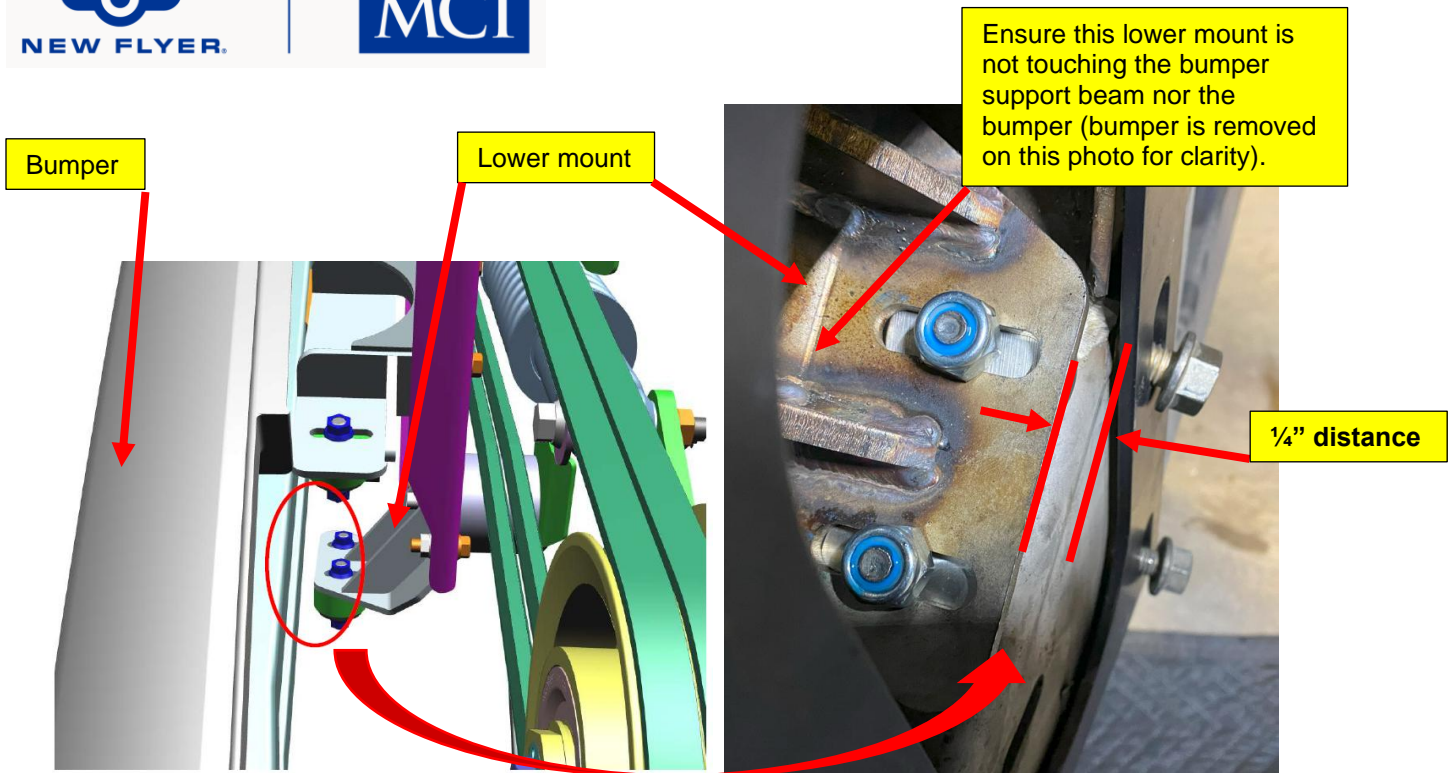
Figure 2: Idler pulley bracket lower mount
