### Porsche Mobile Charger Plus Supply Cable Initialization Failure

The Porsche Mobile Charger Plus (PMC+) and Porsche Mobile Charger Connect (PMCC) can fail to read a new temperature-sensing NEMA supply cable after updating to PMC+ SW level 3000 or PMCC SW 4501.

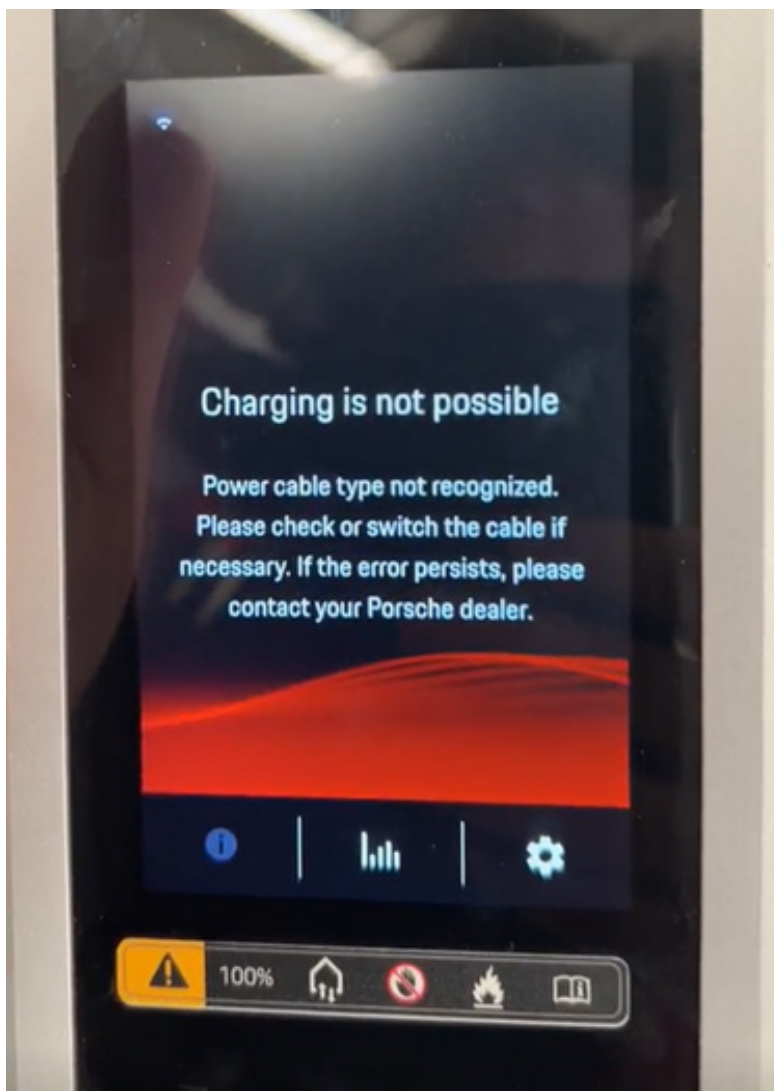
A similar fault occurrence can present in the PMCC variants on start-up. The lights will illuminate red after plugging into the power outlet, with the message in Figure 3 shown on screen.

While the Operating Instructions recommend removing and reinserting the power plug, this does not always remedy the condition. There is currently no known correlation of this condition to supply cable production date. If a charger exhibits the described behavior with a particular supply cable, normal operation cannot be guaranteed with a power supply cable of later production date. Each cable must be physically tested with the customer's charger at the Porsche Center to confirm functionality before returning the updated charger and new supply cable to the customer.

This condition is not directly a fault of the temperature-sensing supply cable. New cables that do not work on the affected PMC+/PMCC devices demonstrating this condition can work normally on PMC Basic part number variants with updated software. If the customer PMC+/PMCC continues to display this behavior with at least 5 replacement supply cables after multiple outlet plug-in cycles, it should be replaced.

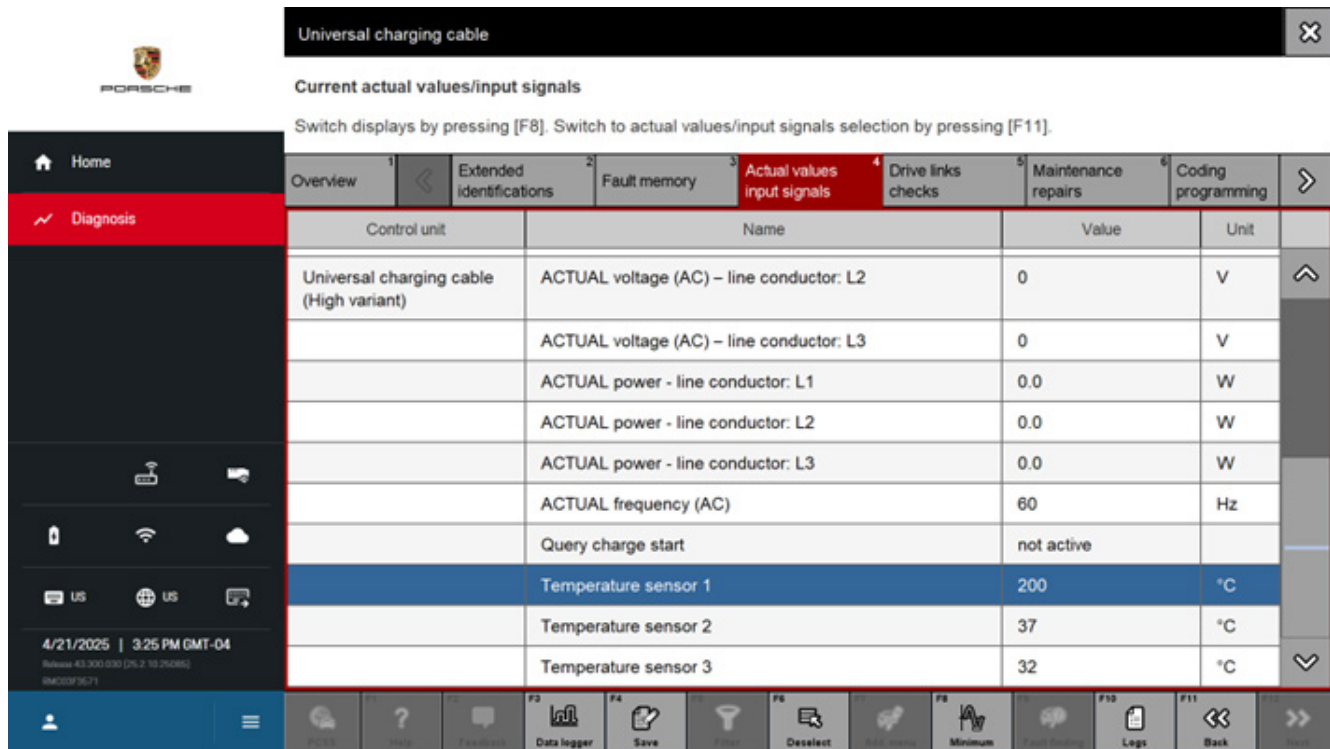
Figure 5

When connecting a Porsche Mobile Charger to the PIWIS tester for diagnostics, one of the temperature sensors in the Actual Values menu is always shown implausible at 200 °C as in Figure 5, regardless of which infrastructure cable is connected. This should NOT be used to diagnose a faulty infrastructure cable without the condition previously described in this case.
