Technical Journal

Technical Journal Title Subwoofer Poor Sound		Ref. No. TJ 37333.1.1	
Issuer (Dept.) Technical Service		Issue Date 3/31/25	Status Date 4/15/25
Car Market United States and Canada	Partner 3 US 7510 Volvo Car USA	Function Group 3956	
Function Description Power amplifier; high-power cables		Page Page 1 of 6

TJ Instruction VCC-531549-1

Title	Subwoofer	Page	1 (4)
Action	Adjustment	Operation number:	98782-2

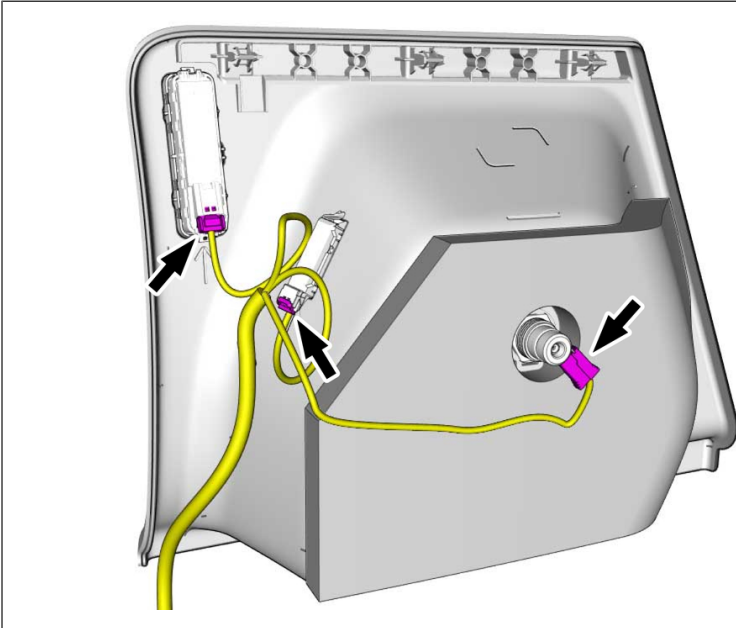
Note! The number of connectors may vary depending on the vehicle's equipment level.

Disconnect the connectors.
Remove the panel.

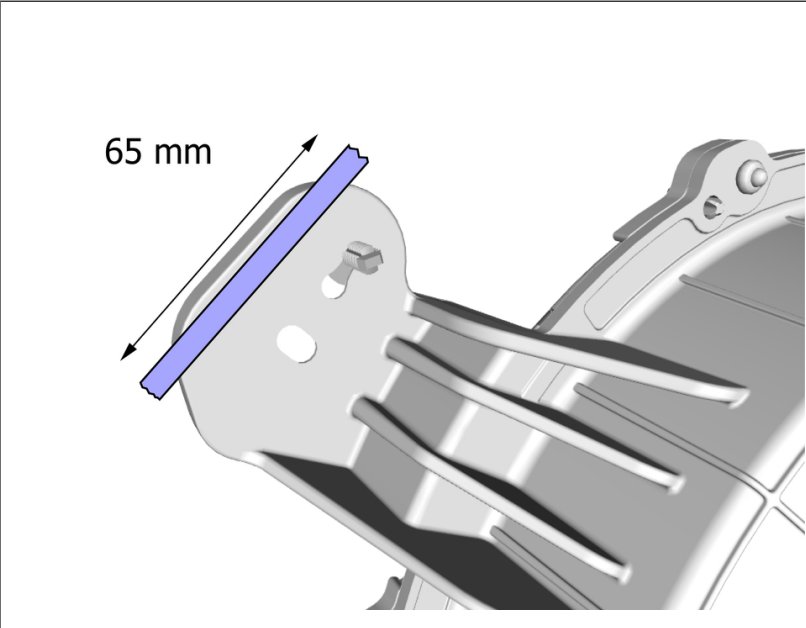
Note! Fold the marked component properly around the edge.

Apply tape.

Use: Tape , 31424536
