**Volvo Car USA LLC**
**Technical Journal**

Technical Journal Title <b>Rumbling Noise From ERAD / TVDC</b>		Ref. No. <b>TJ 37140.4.0</b>	
Issuer (Dept.) <b>Technical Service</b>		Issue Date <b>4/4/25</b>	Status Date <b>4/17/25</b>
Car Market <b>United States and Canada</b>	Partner <b>3 US 7510 Volvo Car USA</b>	Function Group <b>4601</b>	
Function Description <b>Rear axle, complete</b>		Page <b>Page 1 of 3</b>

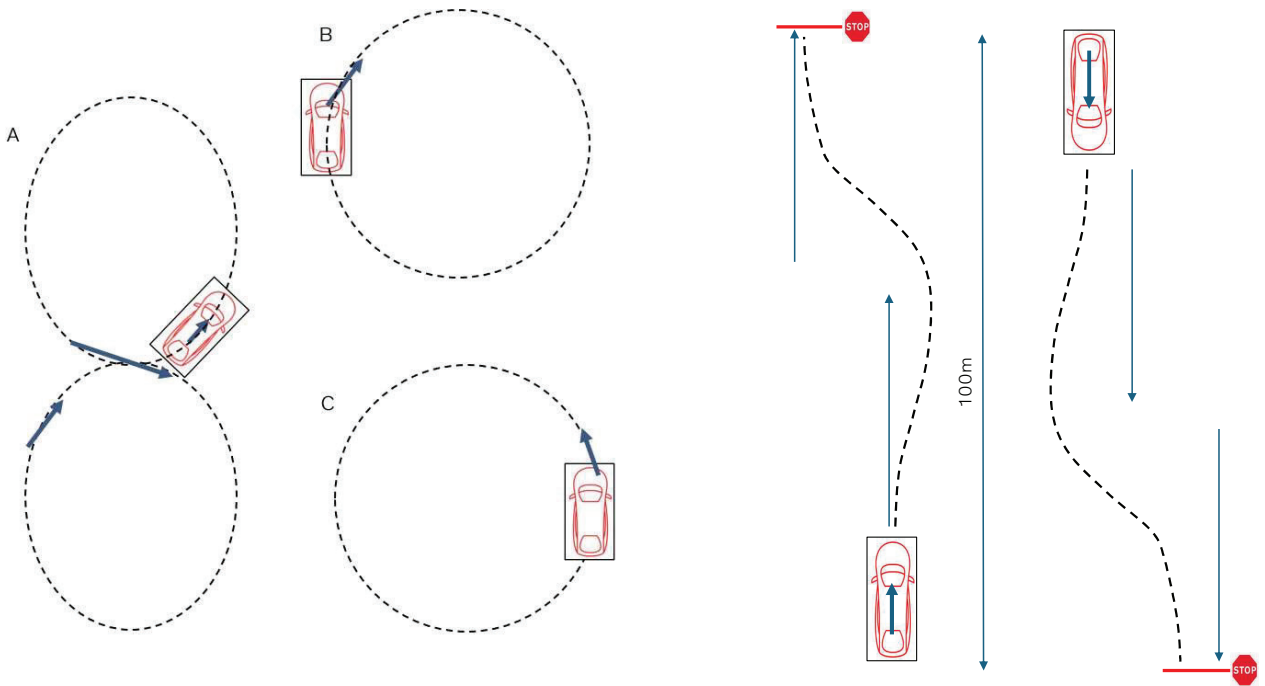
TJ 37140

1. Perform an oil change of the TVDC according to VIDA instructions. If the noise is gone afterward, release the vehicle to the customer. If the noise remains, continue to step 2.
2. Test drive according to the illustration in attachment TJ\_37140\_1.pdf and then follow steps a-e in the text below:
  - a. 1 minute 15-30 km/h (10-20 mph)
  - b. 1 minute 15 km/h (10 mph)
  - c. 1 minute 15 km/h (10 mph)
  - d. 1-time light acceleration 0-80 km/h (0-50 mph)
  - e. 1-time light acceleration 0-80 km/h (0-50 mph)
