## Volvo Car USA LLC

## Technical Journal

| Technical Journal Title<br>Check engine light and DTC - ECM P061C48 | | Ref. No.<br>TJ 36920.6.0 | |

## Technical Journal 36920.6.0

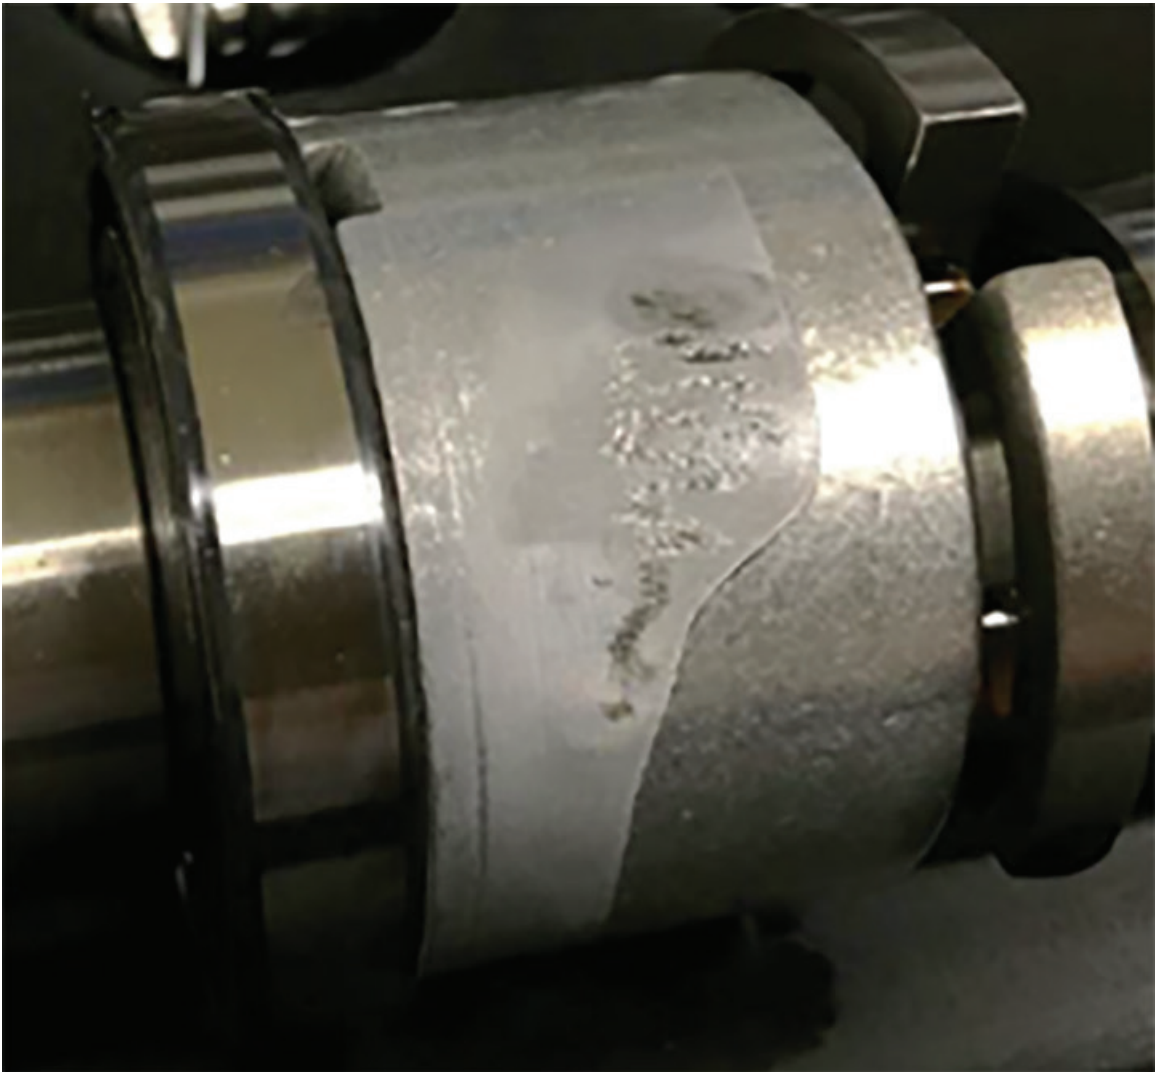
| File Name | File Size |
|---|---|
| TJ_36920_1.png | 0.0899 MB |

1. Change the intake camshaft according to VIDA instructions
- \*2. If part replacement is necessary, follow the updated method in *VIDA >> Information >> Bulletins >> Product Fix/Special Tool Bulletins >> 21 Engine >> 215 Transmission >> Camshaft bushing*
  - \*The camshaft should only be replaced if the sleeve is axially locked. Compare with the attached files, **OK:** *TJ\_36920\_1.MOV* and **NOK:** *TJ\_36920\_2.MOV*
  - Wear on the outside of the camshaft is not a reason to replace the part. Compare with the attached file *TJ\_36920\_1.PNG* for OK reference.

- If a vehicle comes in for a repeat repair with the same DTC, and the intake camshaft has NOT been replaced previously, then replace the intake camshaft.
- If a vehicle built between structure week 2022w01 and 2022w34 comes in with the same DTC and the camshaft is not locked, replace the intake camshaft.
- If the VVT pulley seems loose or has free play, it is NOT a reason to replace the part. Compare with the attached file TJ\_36920\_3.mp4 for OK reference.
