992 GTS THEV- Fire Hazard Warning in Instrument Cluster

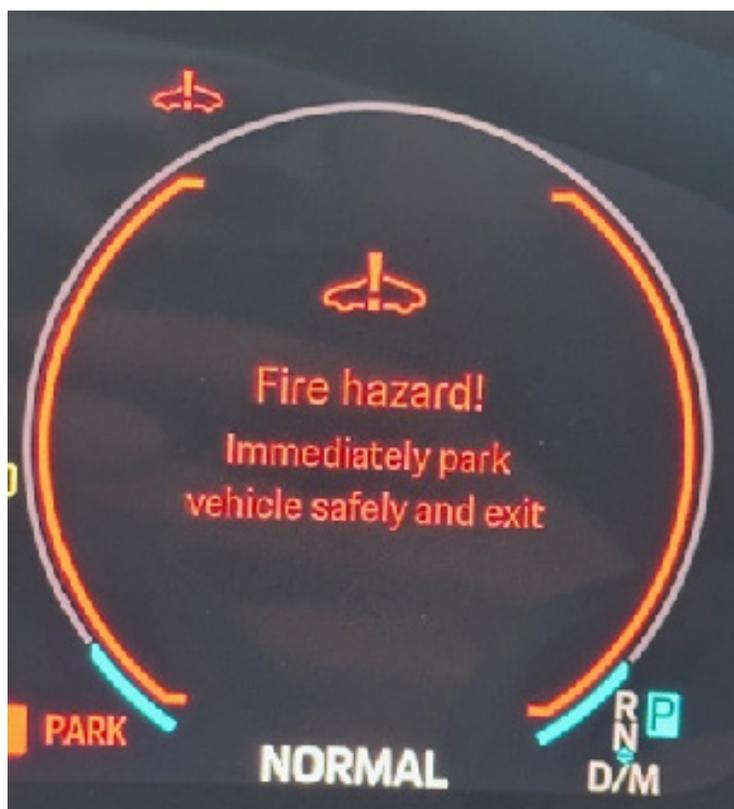
Figure 1

The customer complains of a red Fire Hazard warning in the instrument cluster (Figure 1) and the vehicle will not start.

Analysis has found that an internal software condition causes communication loss between the HV Battery and the BMC in some cases. This causes the internal temperature sensors in the HV battery to report implausible signals in these cases. This condition is more likely to occur in colder ambient conditions on start-up.

To restore the drivability of the affected vehicle, consult Approval and Support Management to replace the HV battery. After replacement, perform the routine "Commissioning of the high-voltage battery" in the Maintenance repairs menu of the High-voltage battery (BECM 001) control unit in the PIWIS Tester to clear any remaining warnings.
