**Noise Symptom - Noises from Around the Steering Shaft: Replace Intermediate Steering Shaft (SY 17/14)**

Model Line: **Macan (95B)**

Concerns: **Intermediate steering shaft**

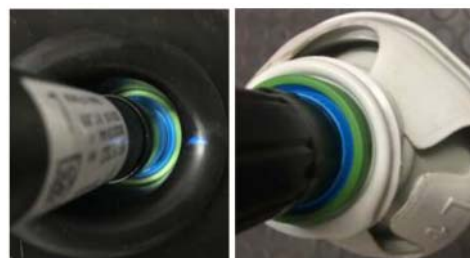
Fig. 1. Left - passenger compartment side, right - engine compartment side

- The intermediate steering shaft has two blue sealing rings, which must be lubricated separately because the lubricant cannot flow effectively from one sealing ring to the other  $\Rightarrow$  Fig. 1. Left - passenger compartment side, right - engine compartment side.
- Lubricate each sealing ring separately and hold the shaft vertically while doing this.
- First lubricate the upper sealing ring, then turn the shaft over and lubricate the lower sealing ring.
- The two rings are visible in the assembly overview shown in Figure 2.
- Both rings are identical. The ring on the passenger compartment side is cut away for clarity. Note the felt insulator in between  $\Rightarrow$  Fig. 2.
