**Macan III R4 – Engine Runs Rough After Refueling**

Models	Model Year	Model Type	VIN Range	Vehicle-Specific Equipment
Macan	As of 2022 up 2024	95BAU1 95BAN1	All	N/A

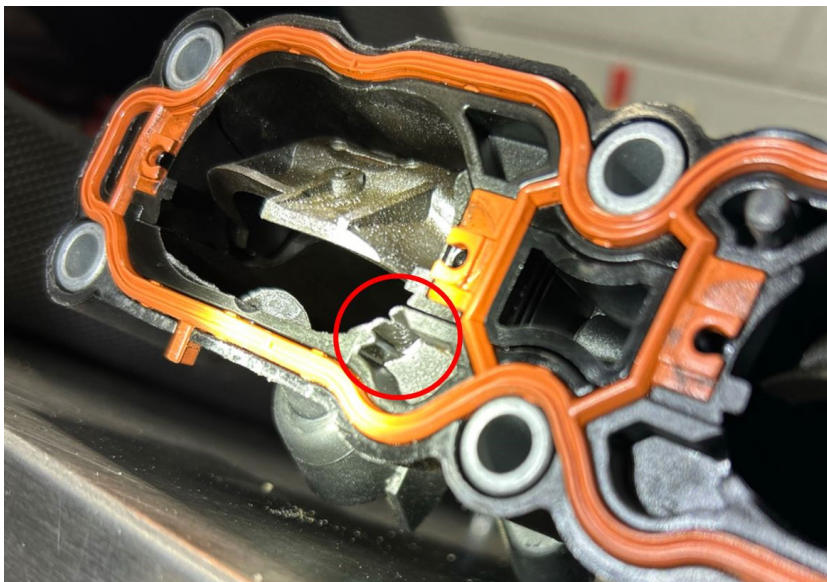
Figure 1

There is a possibility that the intake manifold was not manufactured according to the specifications on 4-cylinder Macan vehicles. As a result, the fuel tank and crankcase vapors vented into the intake may not be evenly distributed between all of the cylinders during the carbon canister purging operation.

The workshop may find misfire faults stored in the DME. Cylinder 1 is predominantly affected in such cases, although misfire faults may also be found on other cylinders.

1. Remove the intake manifold and inspect for signs of manufacturing errors.  
--> The inlet for the cleaned blow-by gasses from the oil separator to the intake manifold should be completely open. See the below image for an example of a blocked (incorrect) inlet. Be sure to take picture documentation of all findings.

2. If the intake manifold exhibits the blocked inlet(s), please replace the intake manifold => WM 244619 - *Removing and installing intake-air distributor.*
3. If the intake manifold appears to be manufactured to specification, or if the rough running condition persists after replacing the intake manifold, please continue with other diagnosis.
