Front Air Spring Strut Leaking - Yellow or Red Warning Message in Instrument Cluster: Check Plastic Welded Seam on Air Spring Strut (43/25)

Model Line: **Cayenne (9YA / 9YB)**

Model Year: **2023**

Concerns: **Front air spring strut**

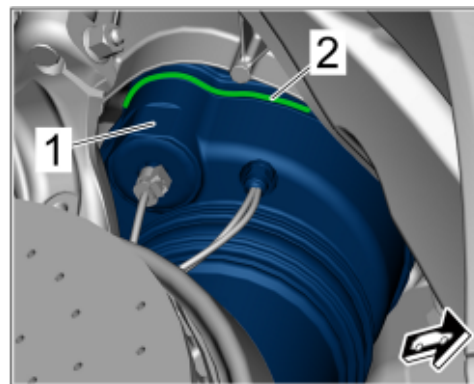
Plastic welded seam on the air spring strut

Assessment		Action
(✓)	Both front air spring struts show no leakage at the plastic weld seam.	The action described in this technical information is not applicable and does not provide any remedy. Continue troubleshooting in some other way.
(x)	<p>One of the two front air spring struts is leaking at the plastic weld seam. ⇒ <i>Plastic welded seam leaking</i></p>

Work Procedure: 1 Check plastic welded seam ⇒ *Plastic welded seam on the air spring strut -2-* on the front air spring struts ⇒ *Plastic welded seam on the air spring strut -1-* with water emulsion and replace **both** front air spring struts (left and right) if necessary.

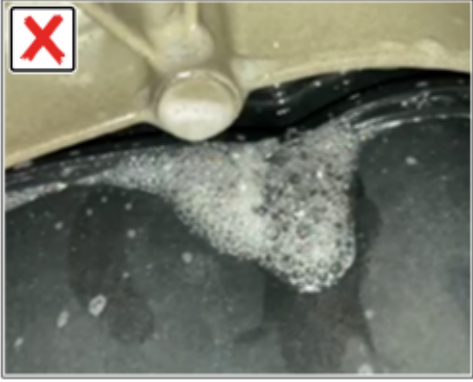
<p><i>Plastic welded seam leaking</i></p>	<p>Front air spring strut is not OK.</p> <p>Replace both front air spring struts (left and right).</p> <p>For procedure, see: ⇒ <i>Workshop Manual '433019A4 Removing and installing front air spring strut'</i></p>
