Red Warning Message "Vehicle Electrical System Malfunctioning" in the Instrument Cluster in Conjunction with the Fault Memory Entry "B114811" in the Rear-End Electronics Control Unit (SY 37/25)

Model Line: **Cayenne (9YA / 9YB)**

Model Year: **As of 2018 up to 2025**

Concerns: **Signal line terminal 15**

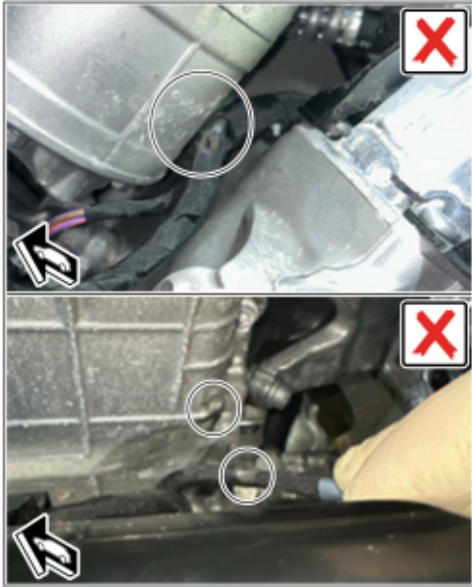
Cause: The signal line for terminal 15 may be resting on the air-conditioning compressor and the oil pan due to the line routing. This can lead to damage to the bandaging of the wire harness and the electrical lines over the service life.

Malfunction and short circuits may be caused depending on the damage present. As a planned safety response, a short circuit at terminal 15 can possibly cause deactivation of the engine by the control unit.

<i>Abrasion point for air-conditioning compressor and oil pan</i>	The wire harness is not OK . Repair wire harness. Then continue with Step ⇒ 3.

Remedial Action: If there is a customer complaint, check wire harness in air-conditioning compressor and oil pan area and repair if necessary.
